# STRUCTURAL ASSESSMENT REPORT

COLLAPSE OF SCAFFOLDING, AT THE SITE OF  
THE NEW CUSTOMS & EXCISE BUILDING  
GOVERNMENT CAMPUS, RICHMOND STREET  
PORT OF SPAIN

DATED: 30<sup>TH</sup> OCTOBER, 2006

THE DESIGNS ENGINEERING BRANCH  
MINISTRY OF WORKS AND TRANSPORT

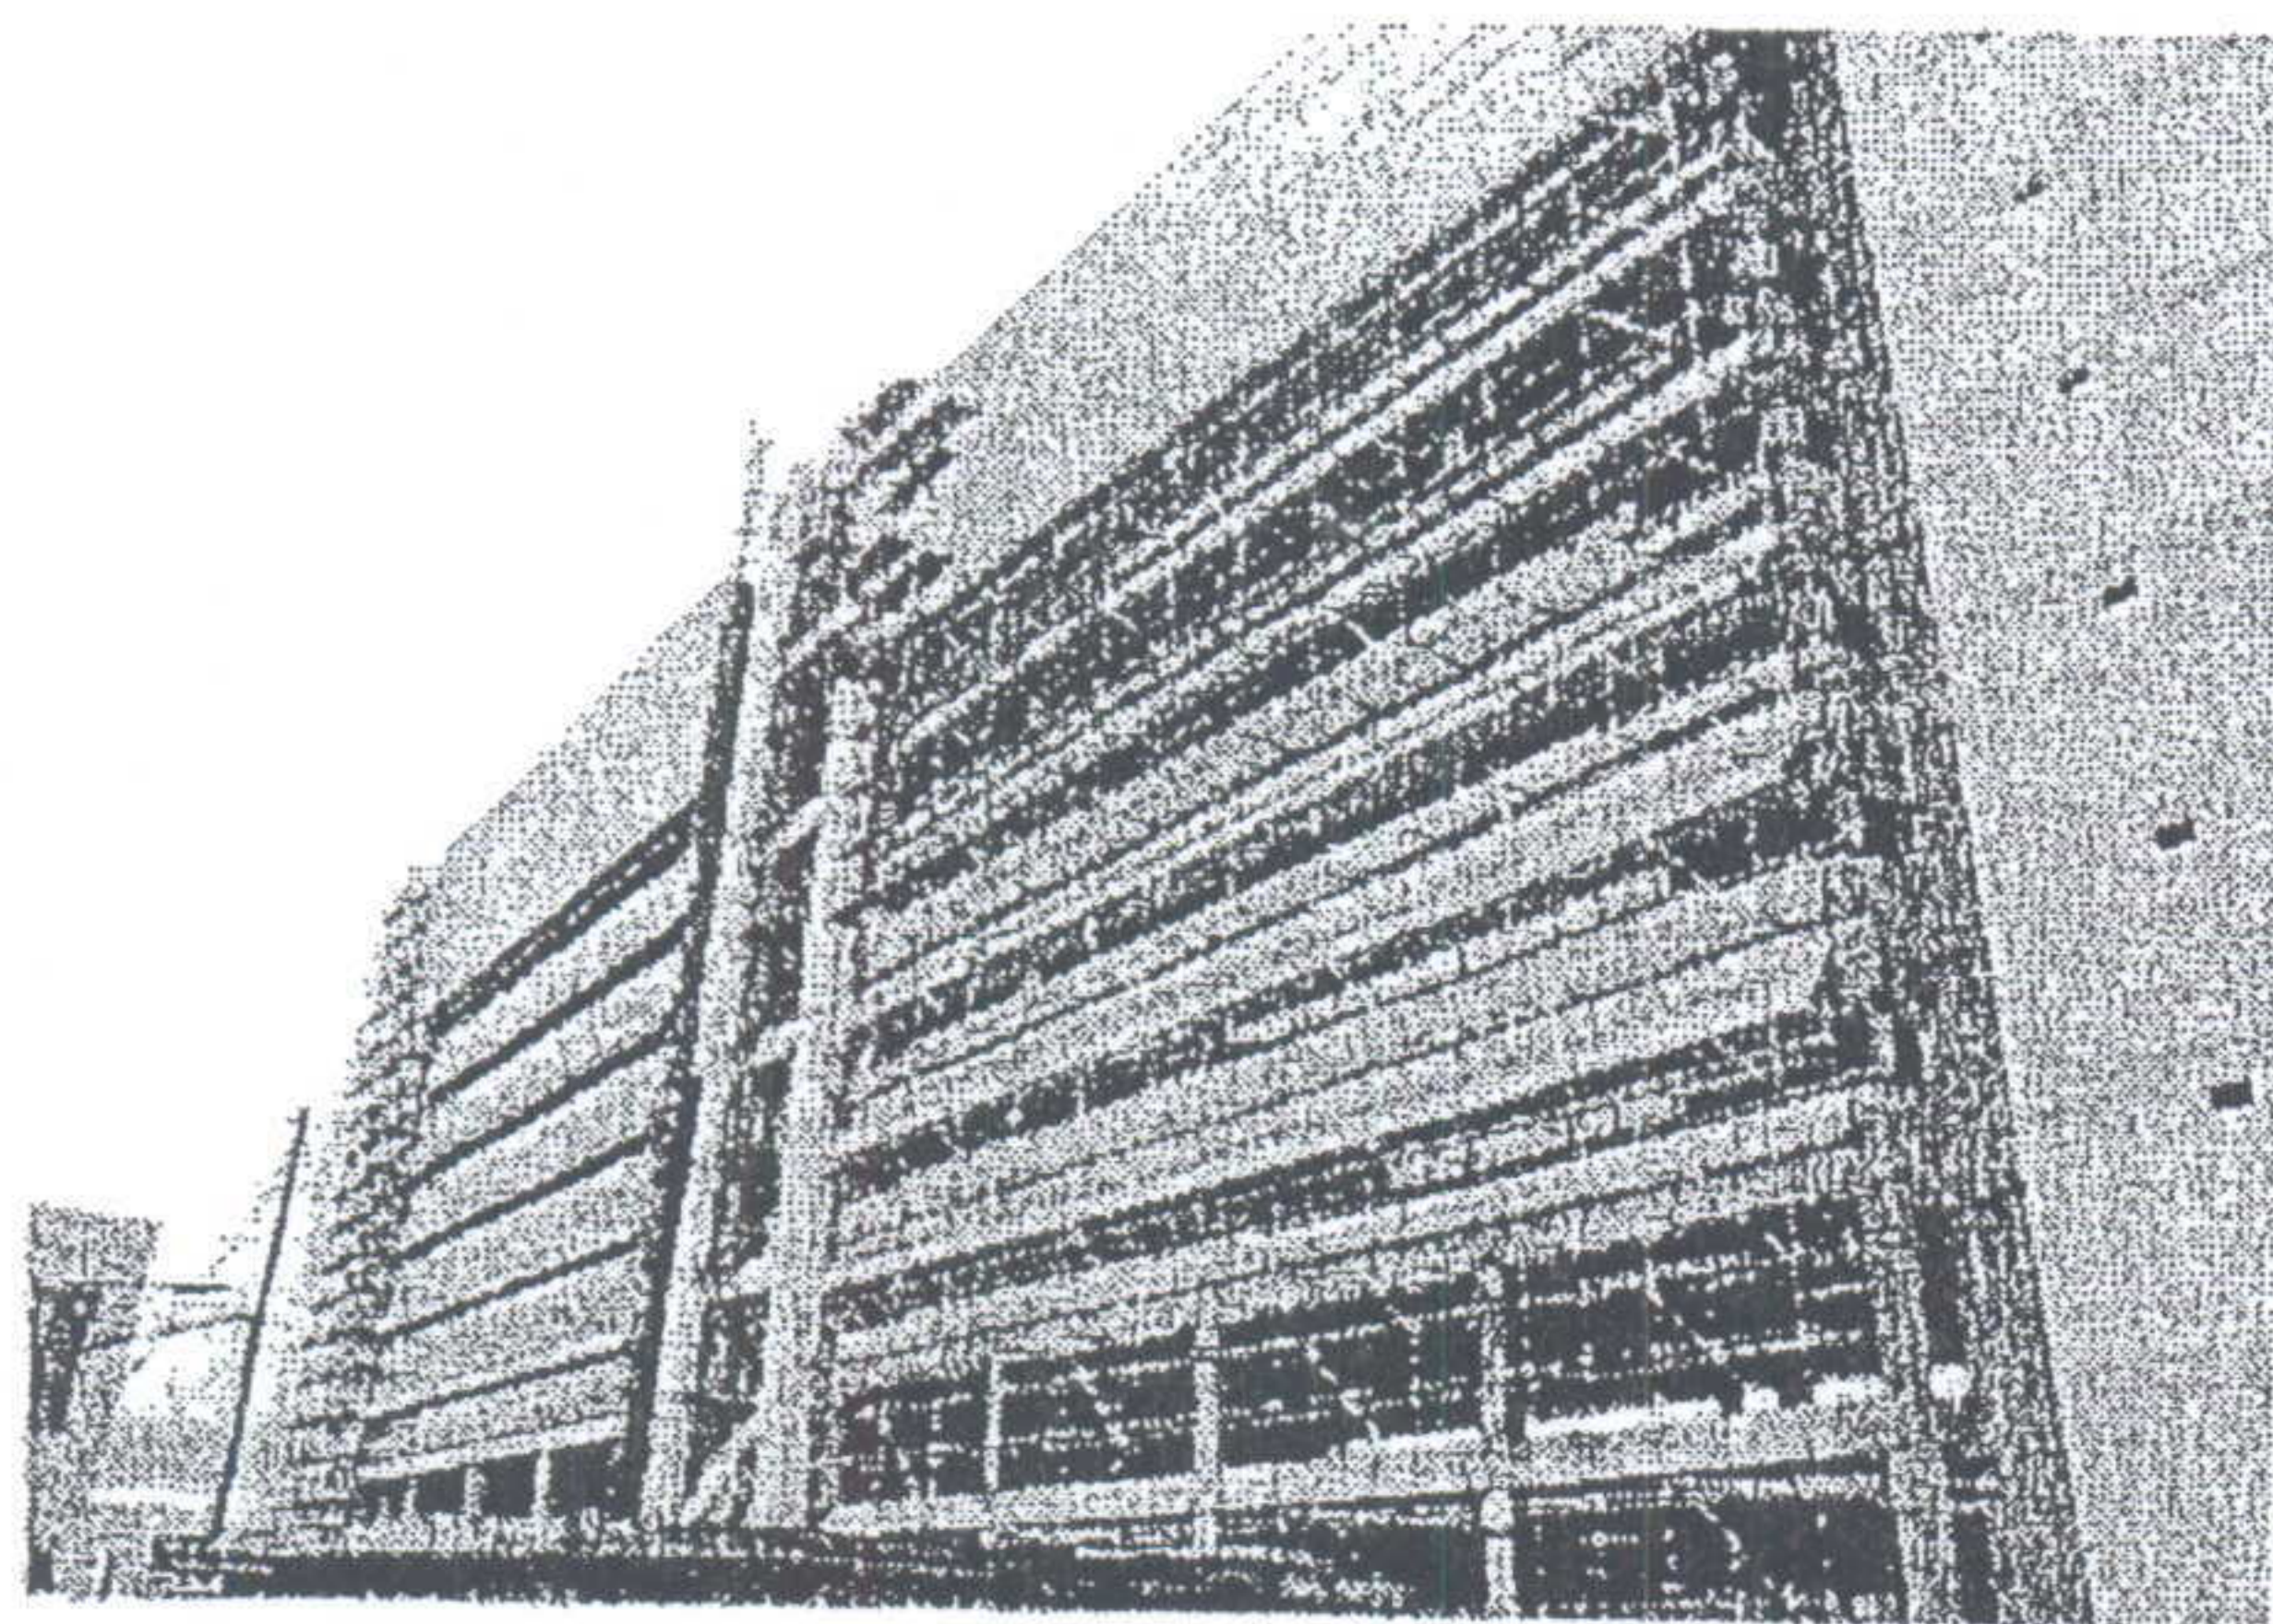
- It should be noted that persons on site indicated that the remaining scaffolding was erected in a similar manner to the collapsed section (see appendix I, pic. 3, 4 & 5 ). It appears that all scaffolding erected on and around the building utilized the Kwikstage scaffolding system (see appendix I, pic 6).

Pic. 3 West side New Customs and Excise Building.  
Note scaffolding erected on south side building

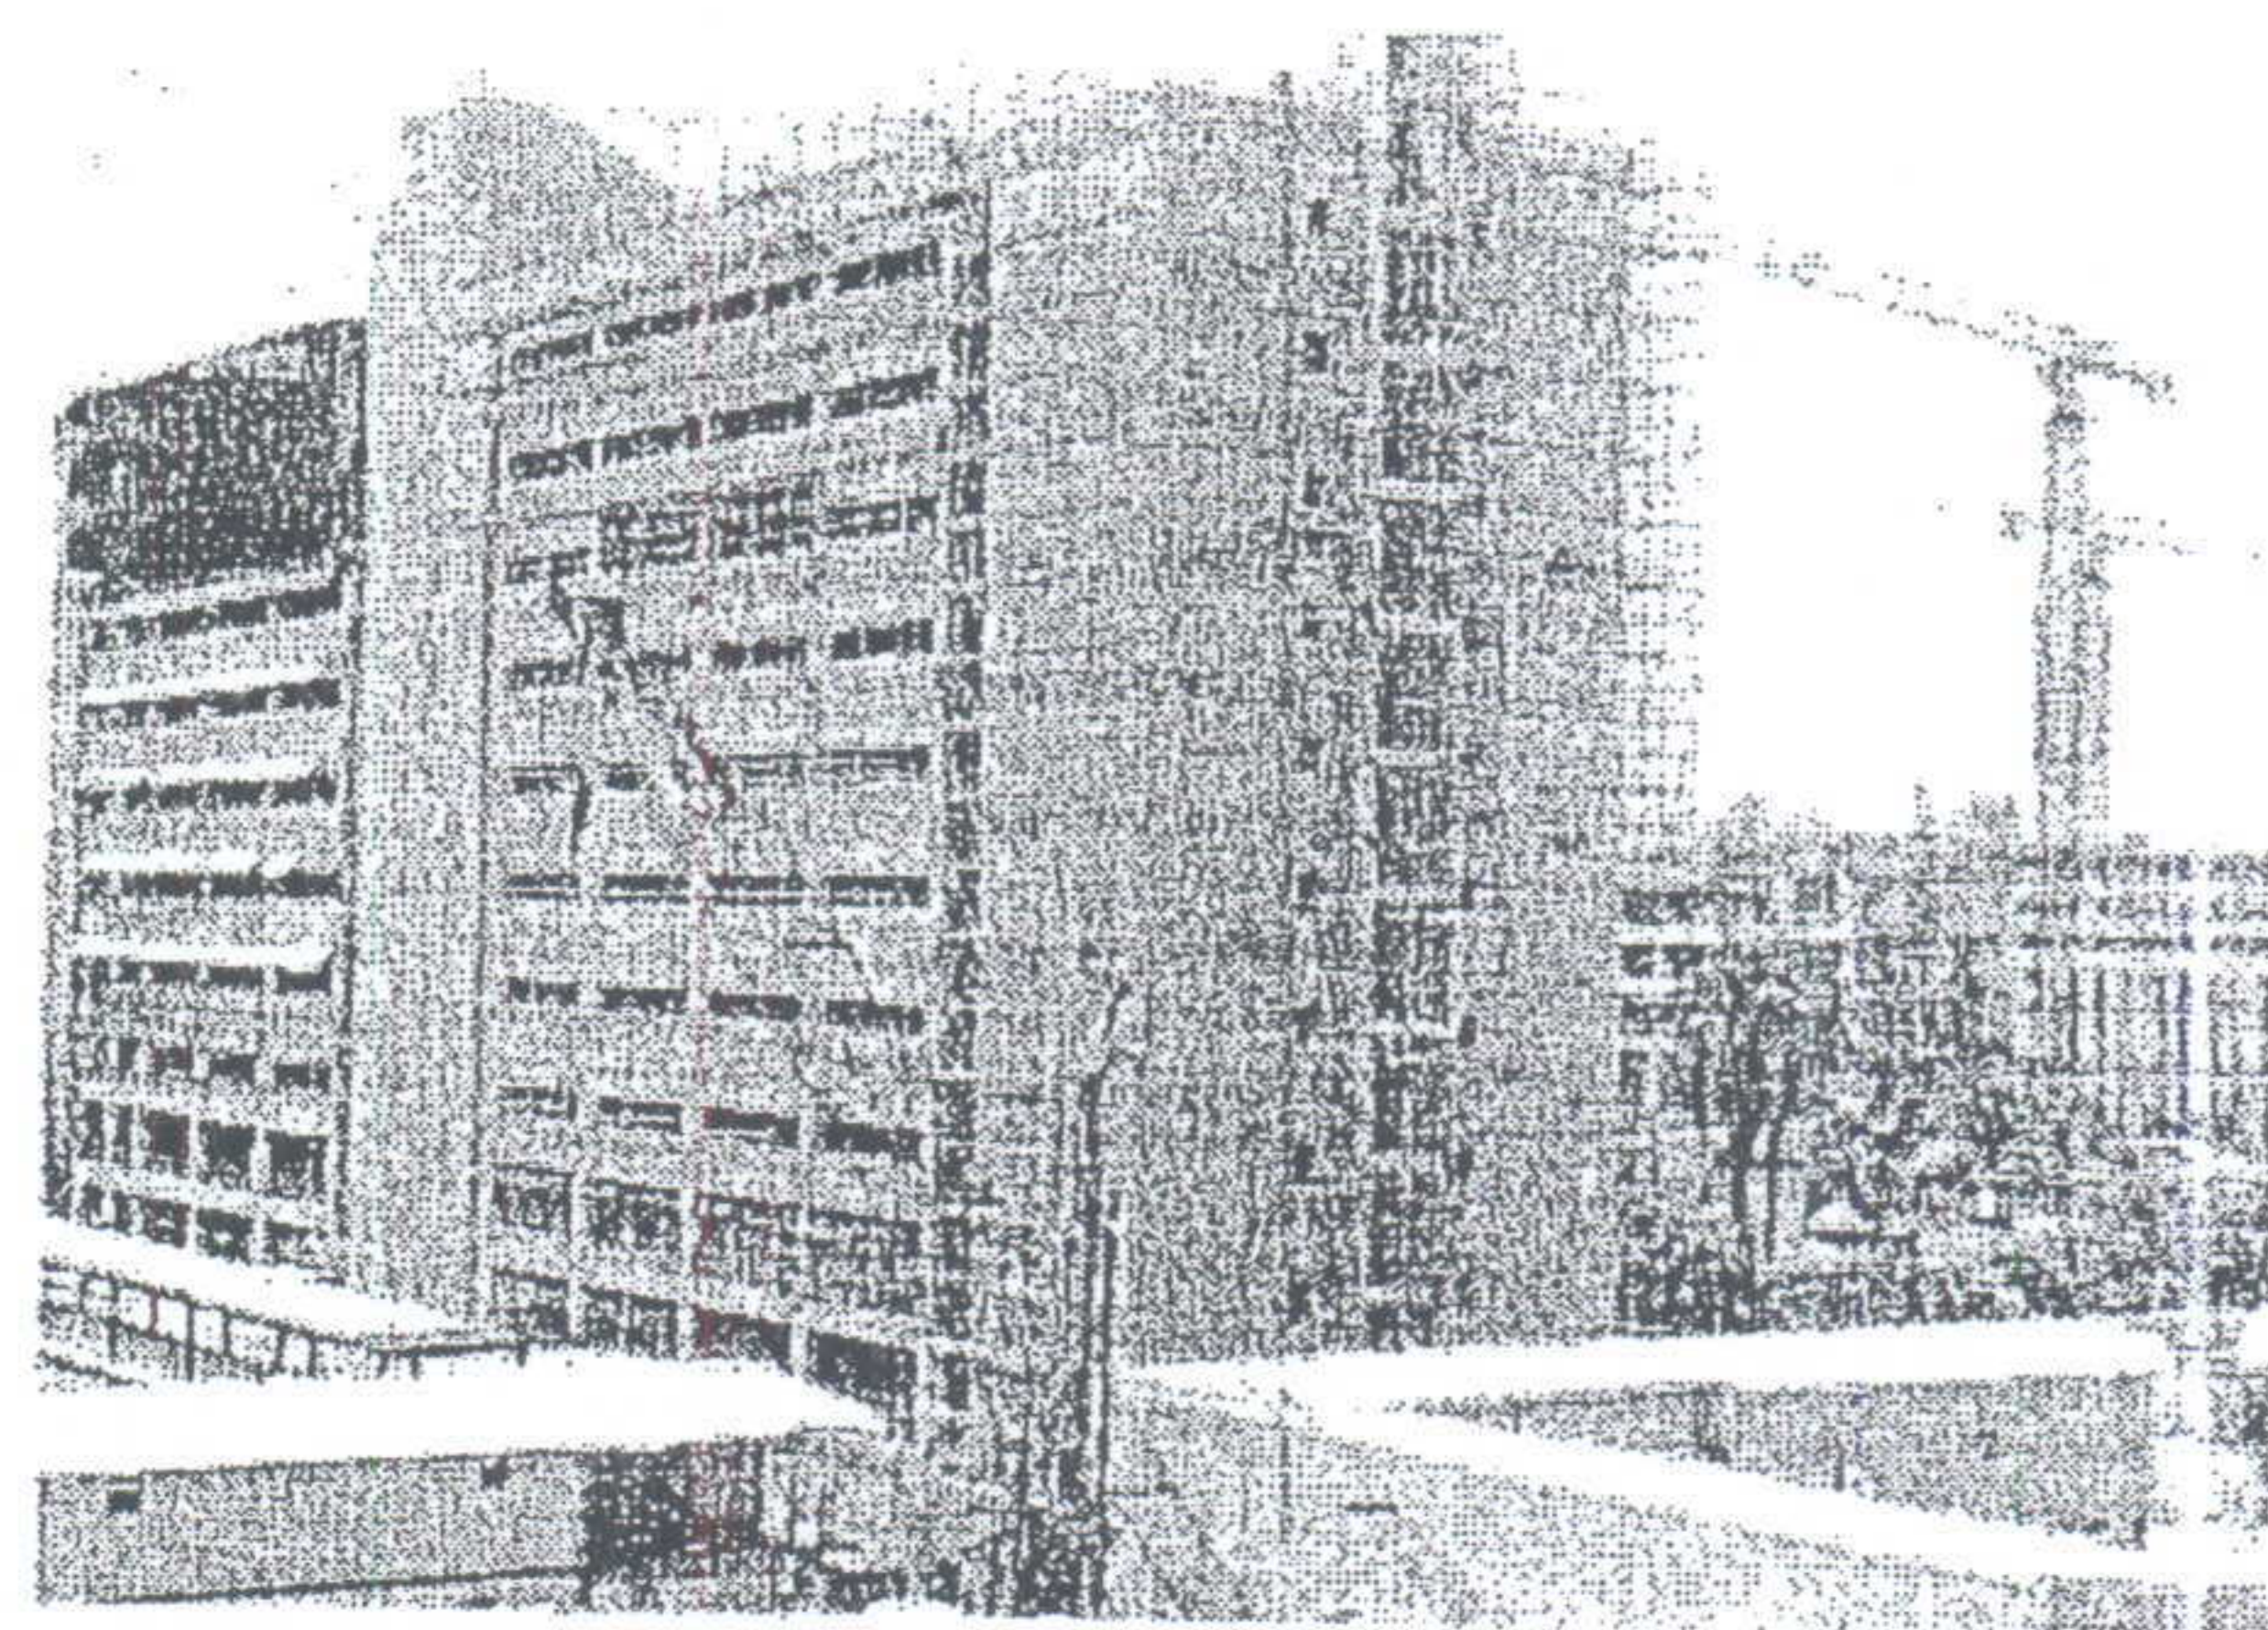
Pic. 4 North side New Customs and Excise Building.

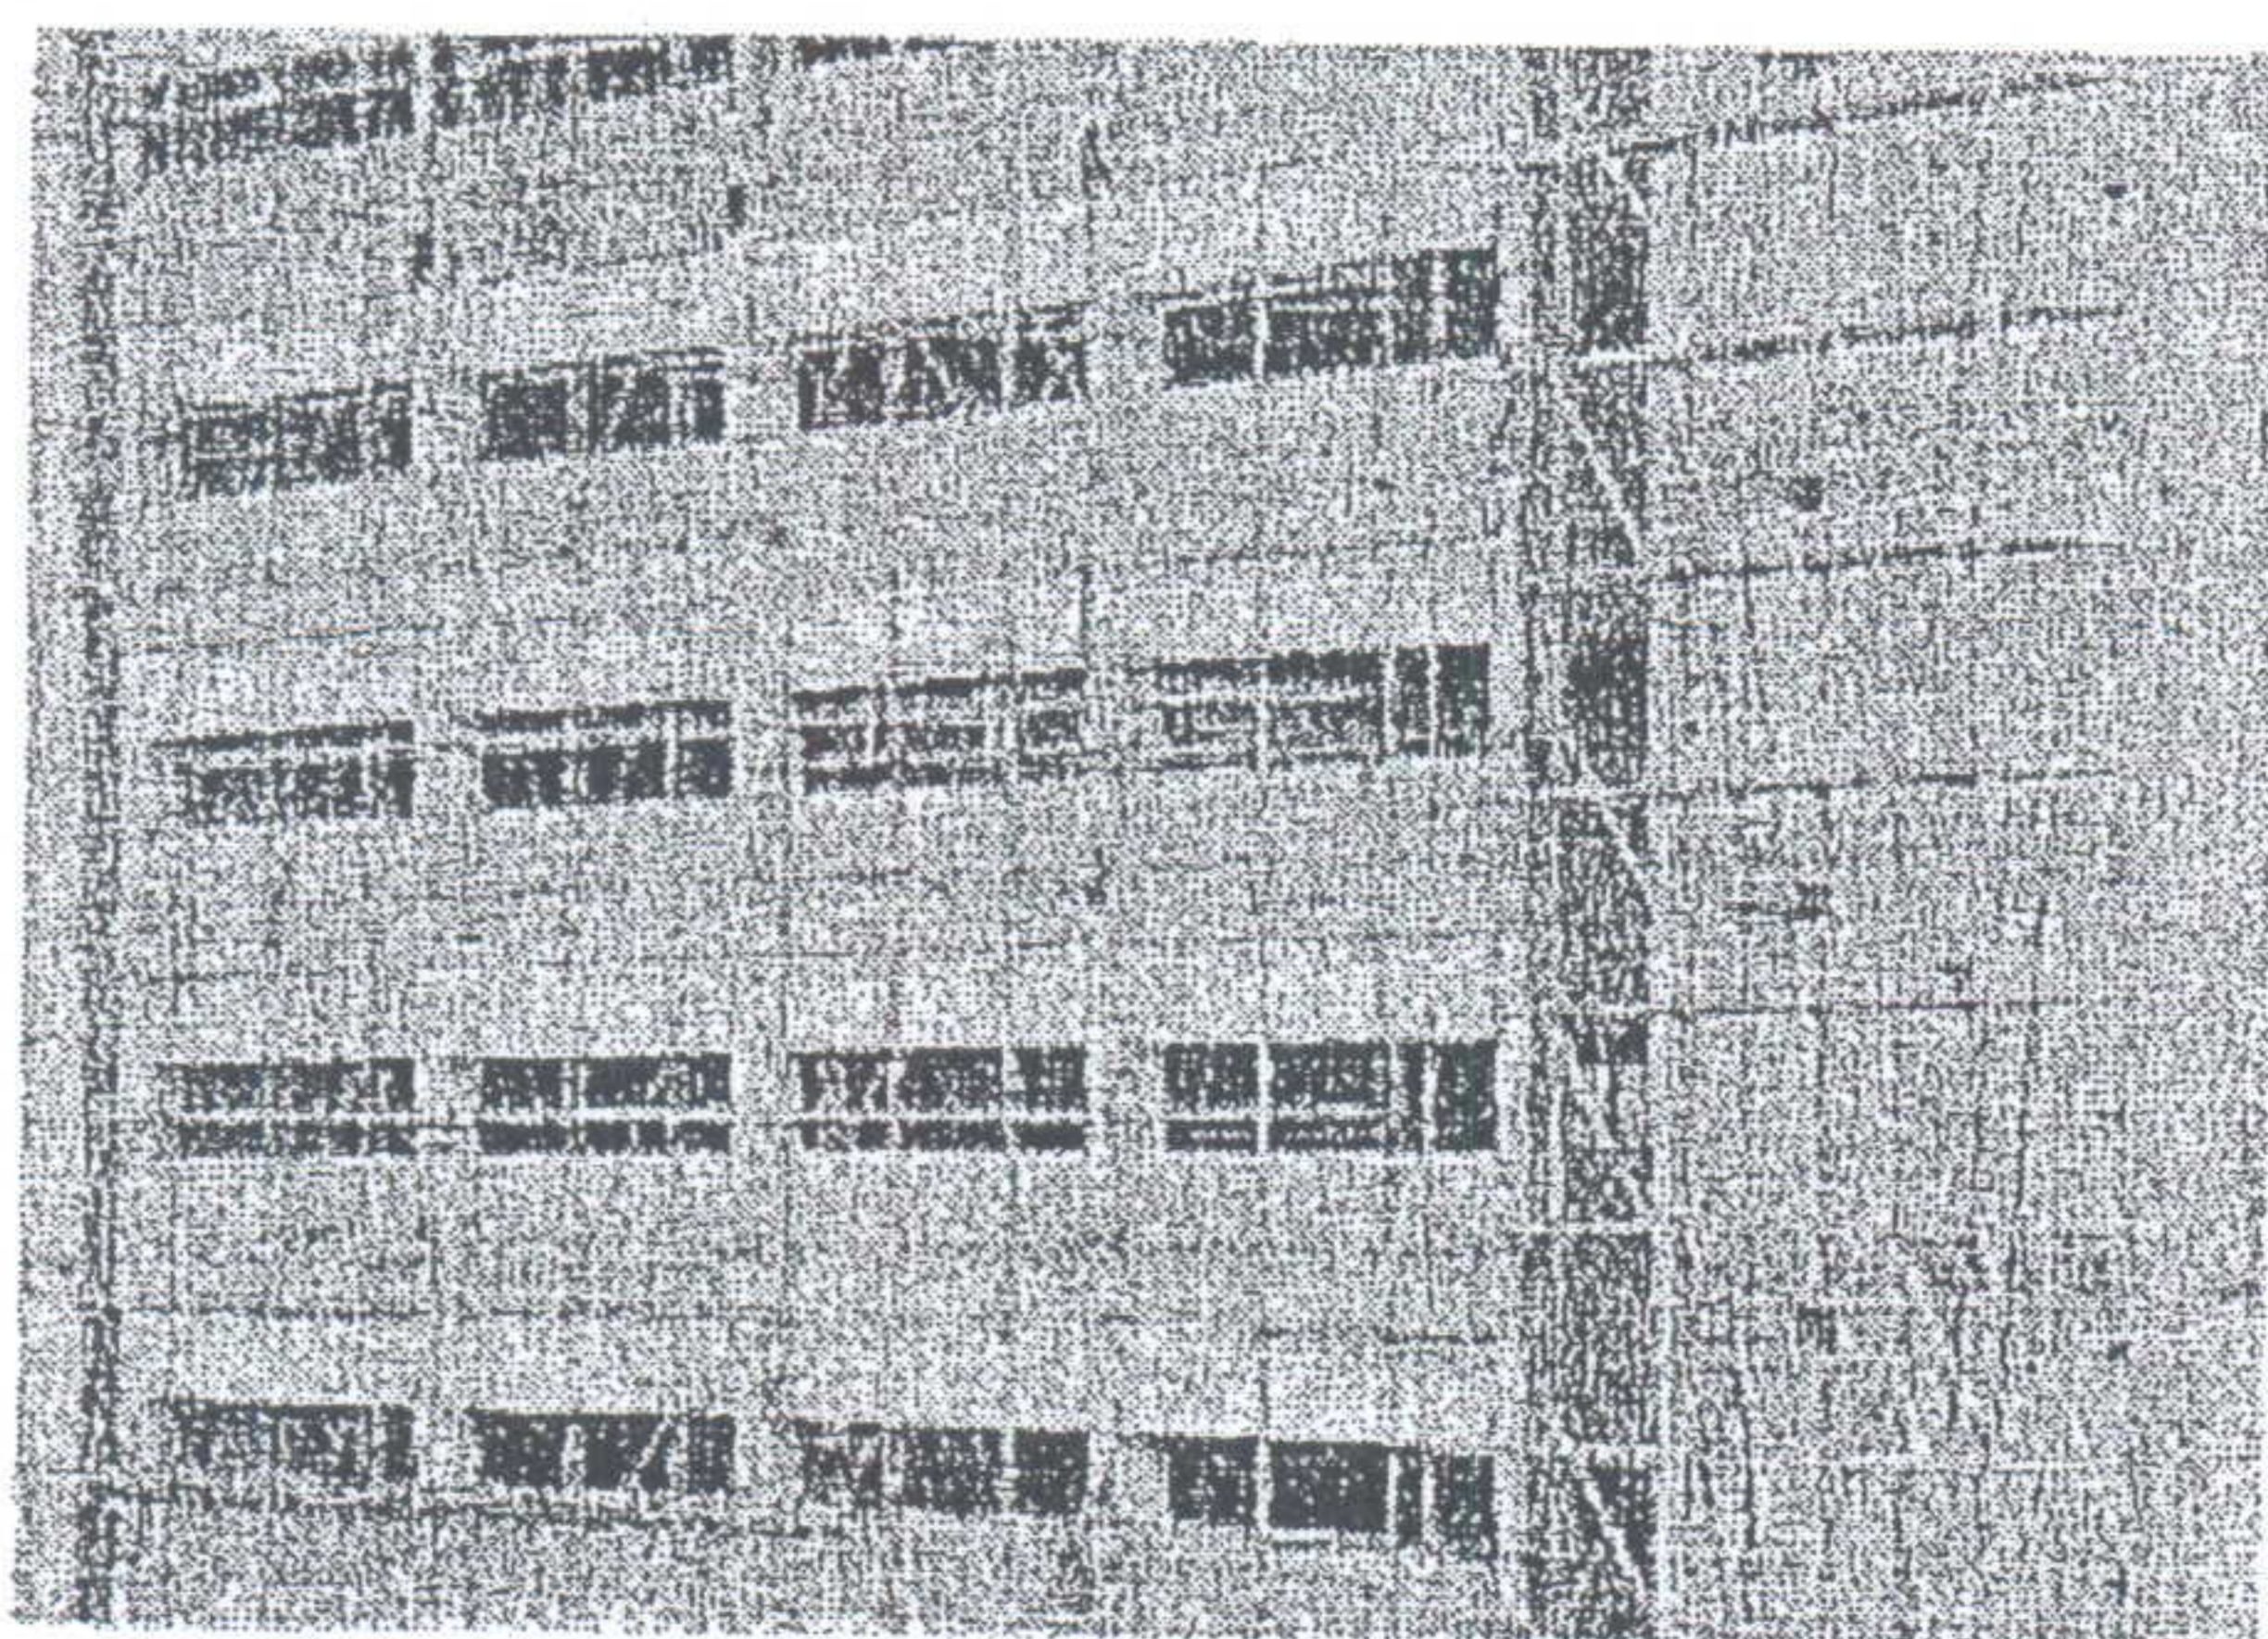
Pic. 5 Closer view of scaffolding on the north east side of building

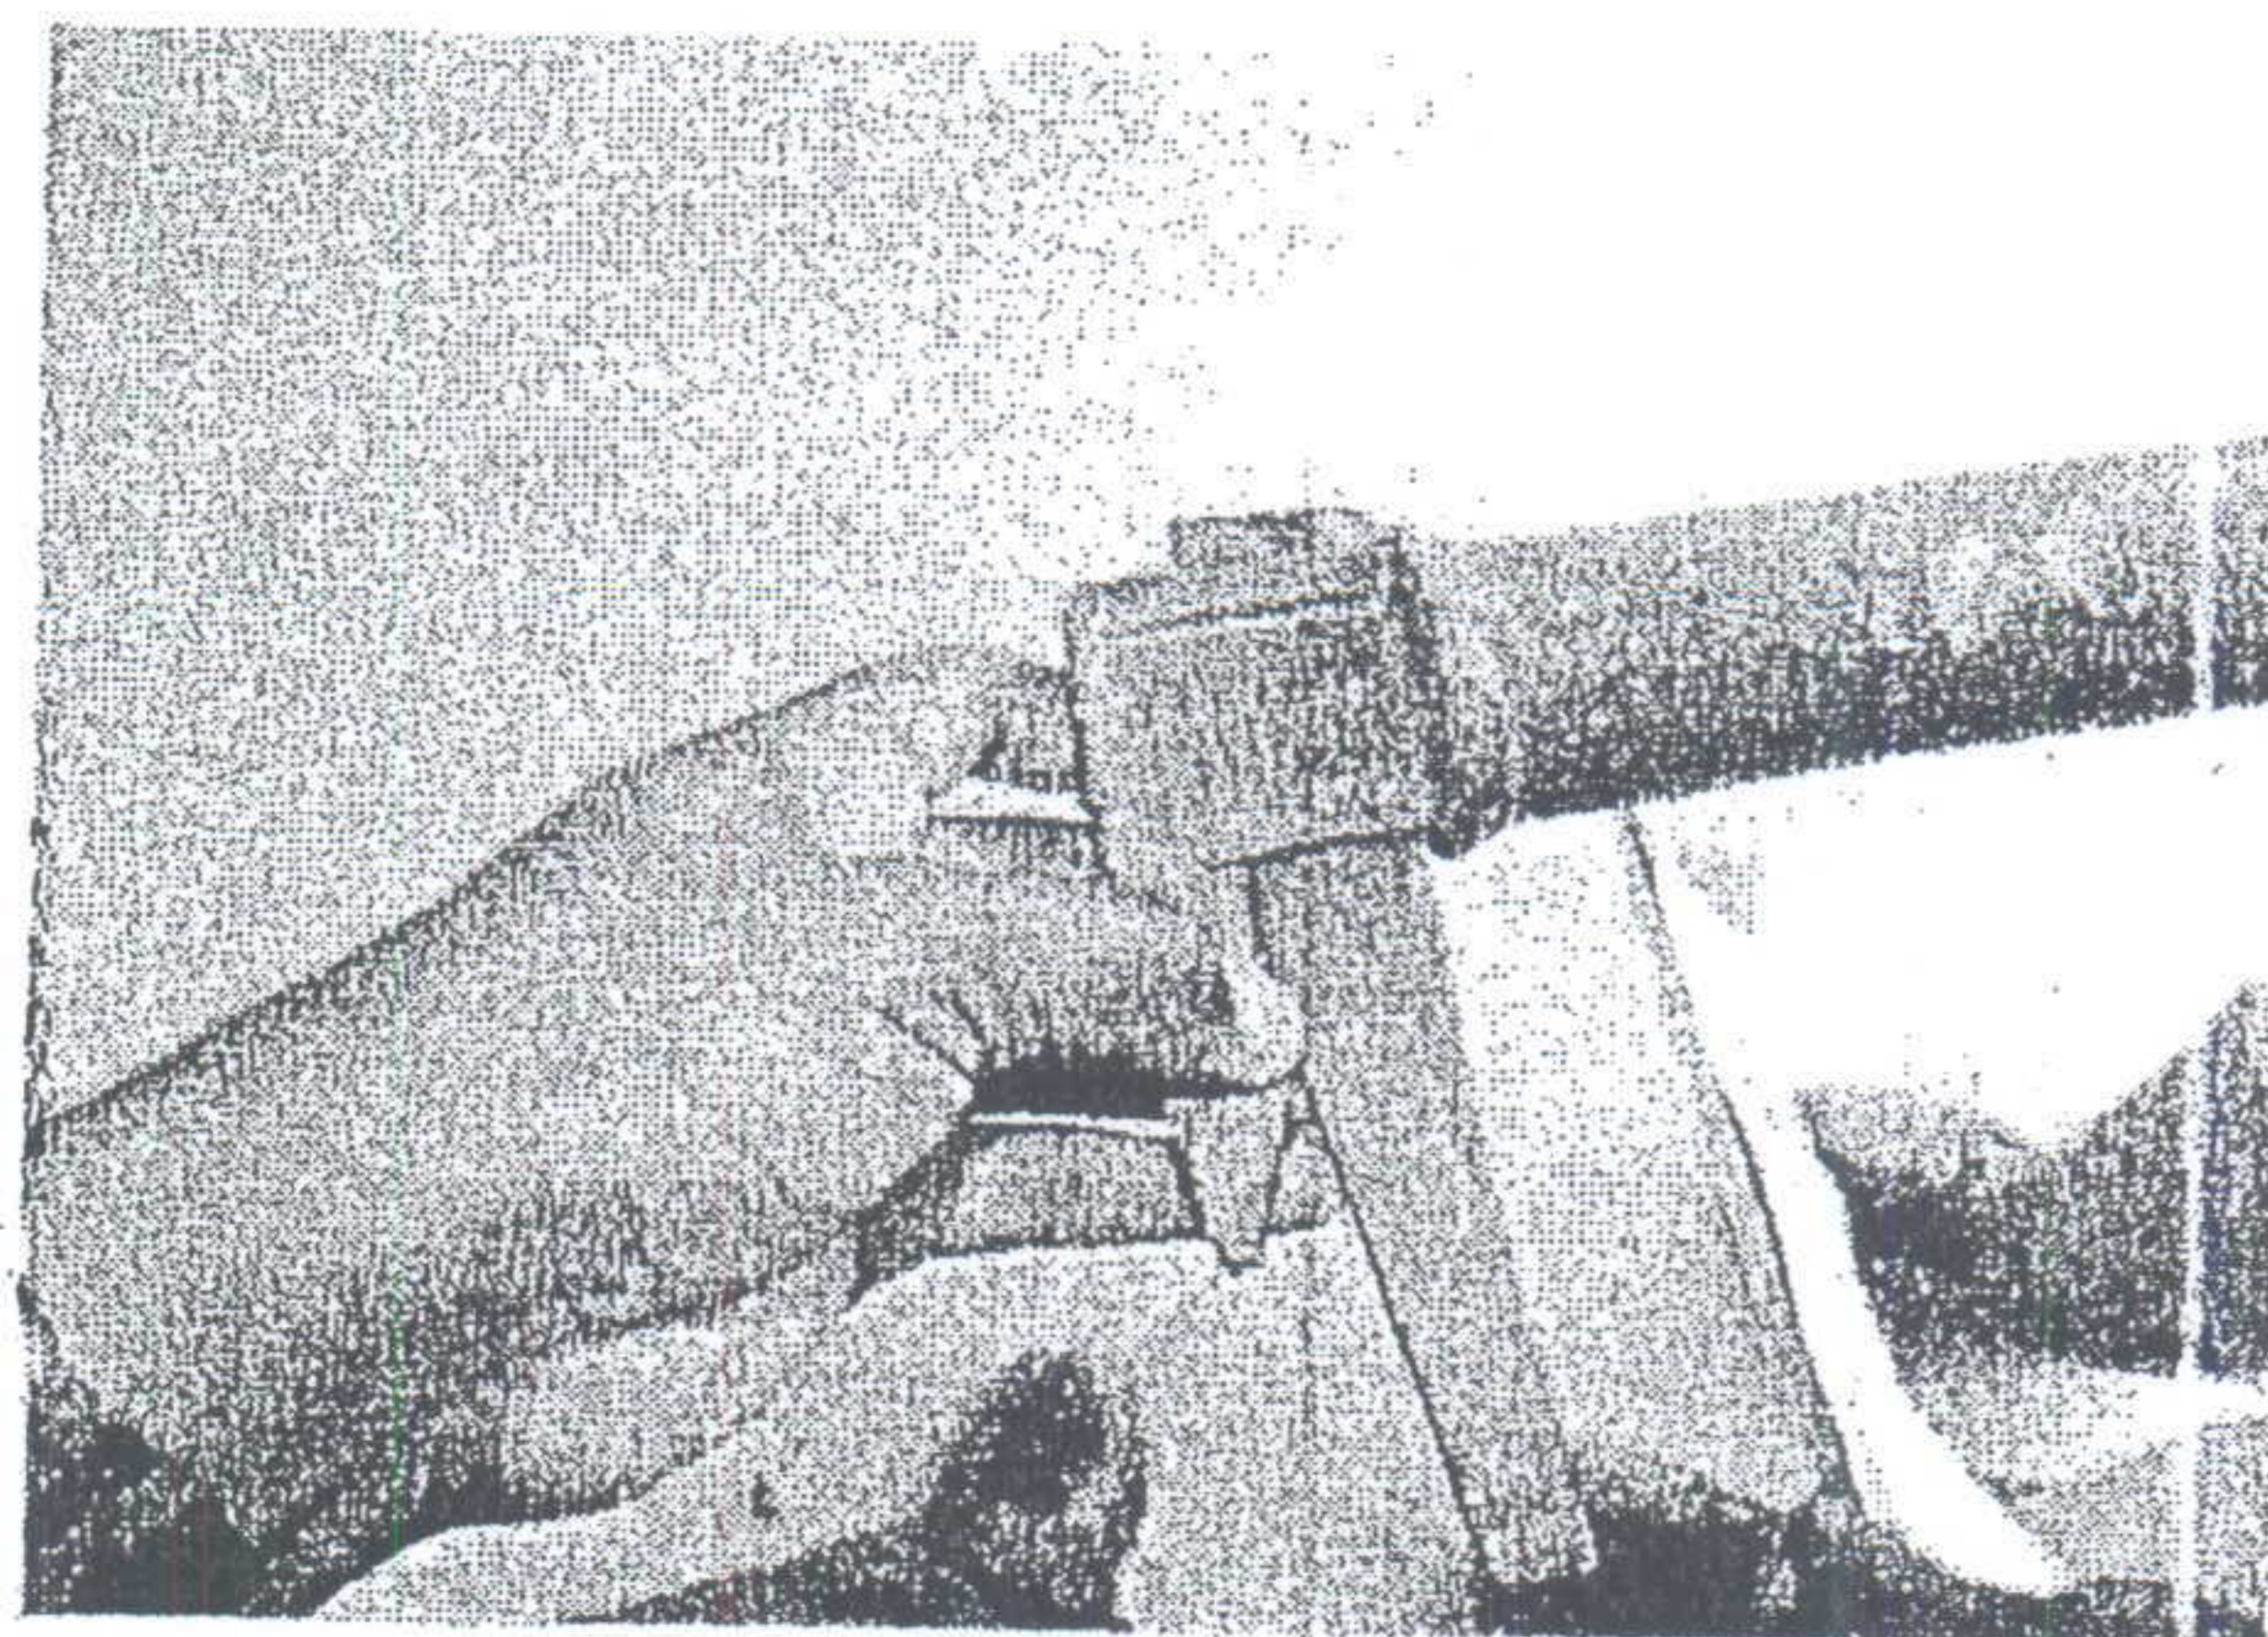
Pic. 6 End of ledger taken from collapsed debris.  
Note system brand embossed on end.

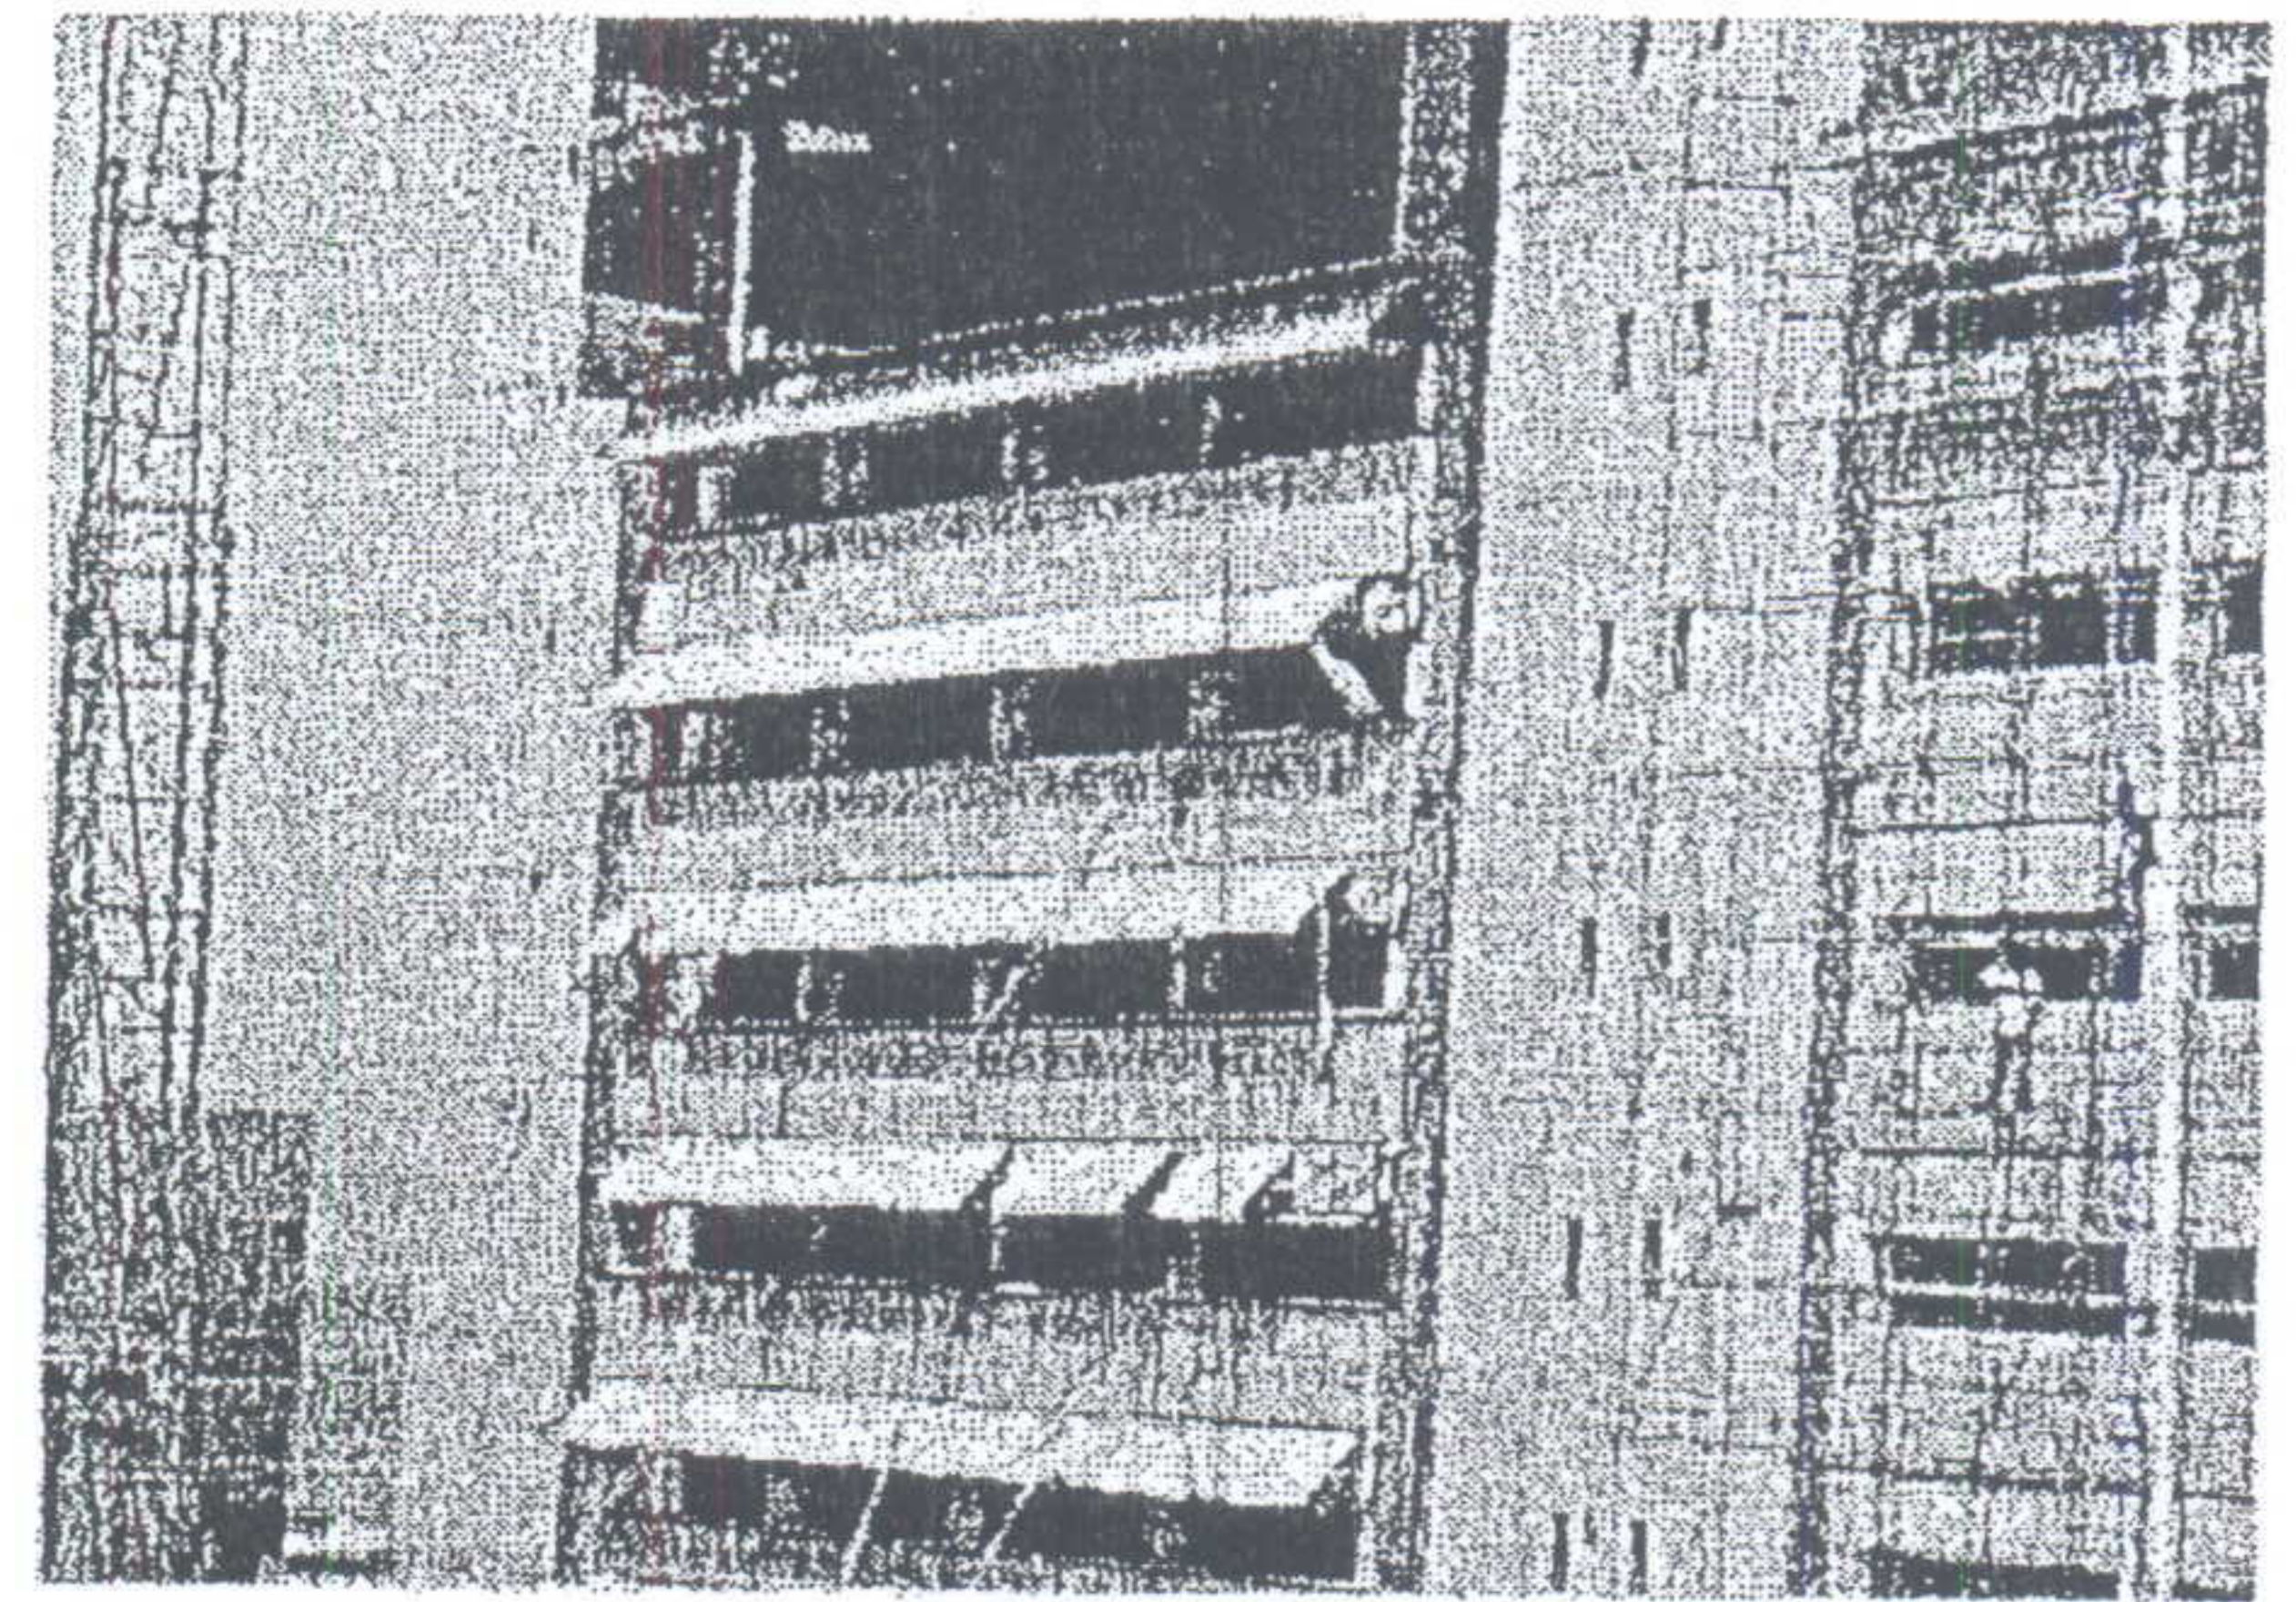
- i. No tie-members between the 6<sup>th</sup> floor or 7<sup>th</sup> storey and the roof of the building (see appendix I, pic 8. 15 & 16. ).
- ii. The scaffolding being restrained for movement away from the building but free to move towards the building.

Pic. 8 The collapsed section of scaffolding. Note tie members visible on building.

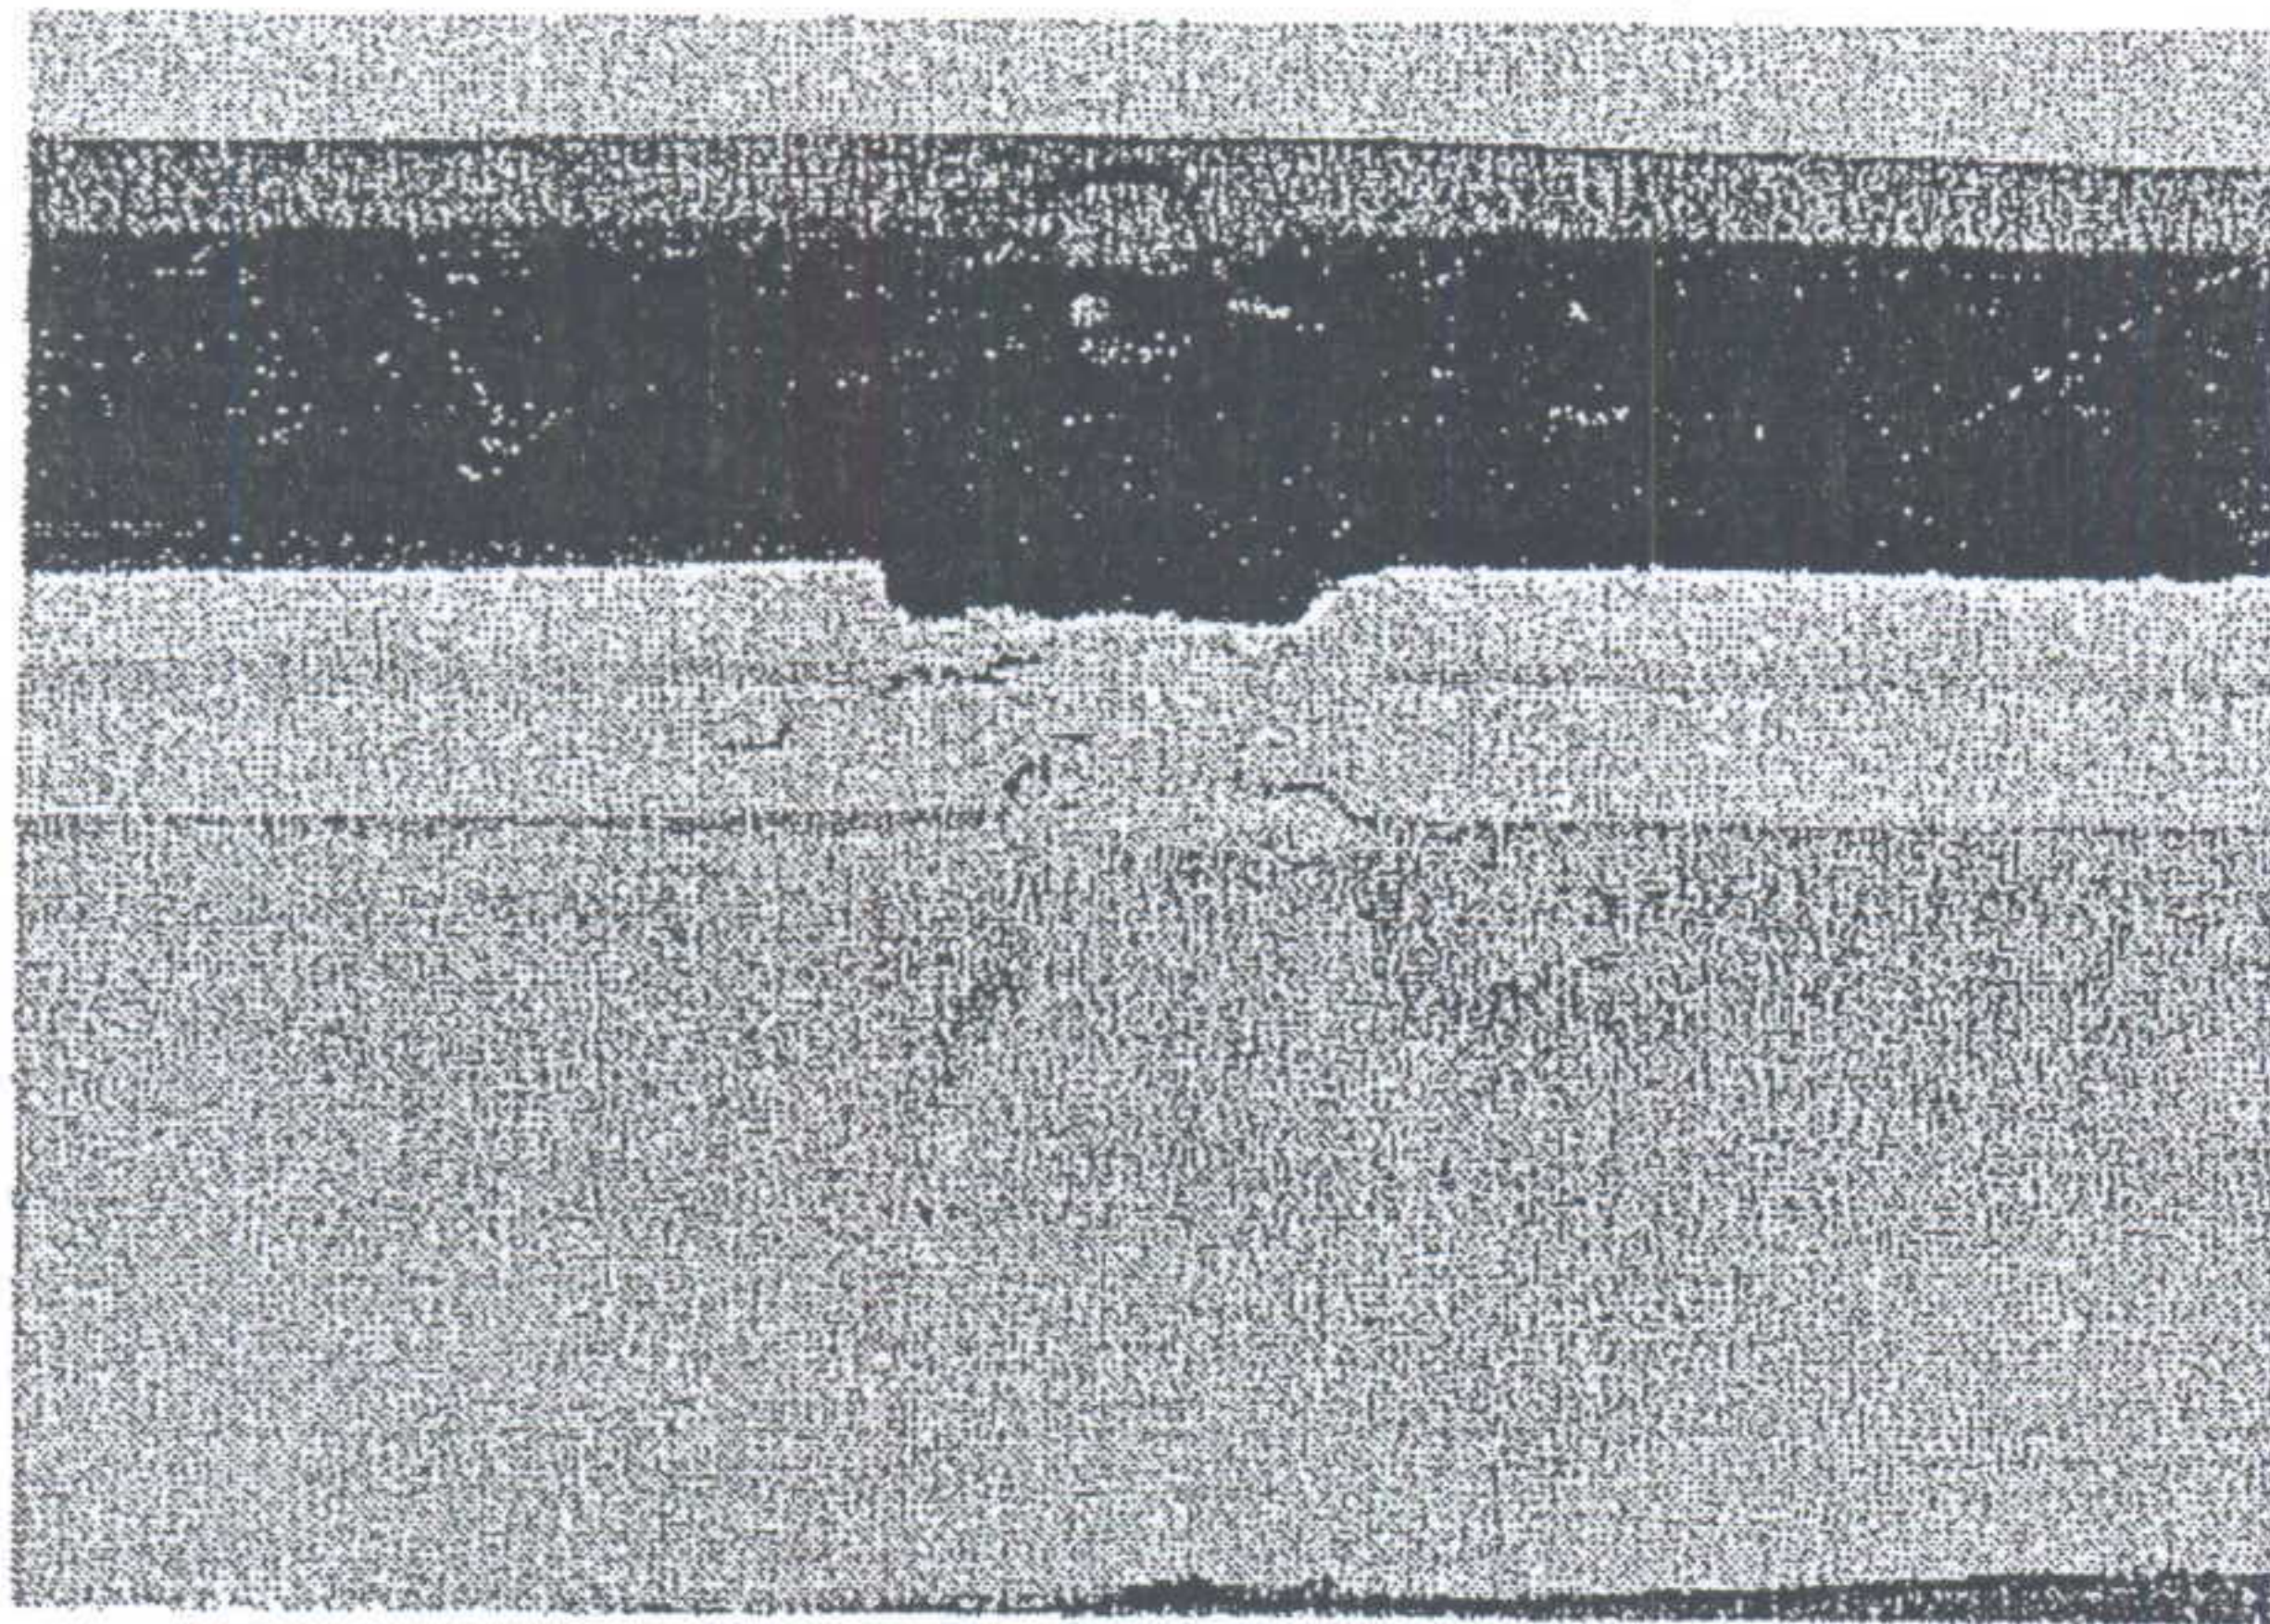
Pic. 9 Damage to mortar finish, center of parapet wall, south east side of roof, after collapse. Note lack of bolt holes or bolts.
