# STRUCTURAL ASSESSMENT REPORT

COLLAPSE OF SCAFFOLDING, AT THE SITE OF  
THE NEW CUSTOMS & EXCISE BUILDING  
GOVERNMENT CAMPUS, RICHMOND STREET  
PORT OF SPAIN

DATED: 30<sup>TH</sup> OCTOBER, 2006

THE DESIGNS ENGINEERING BRANCH  
MINISTRY OF WORKS AND TRANSPORT

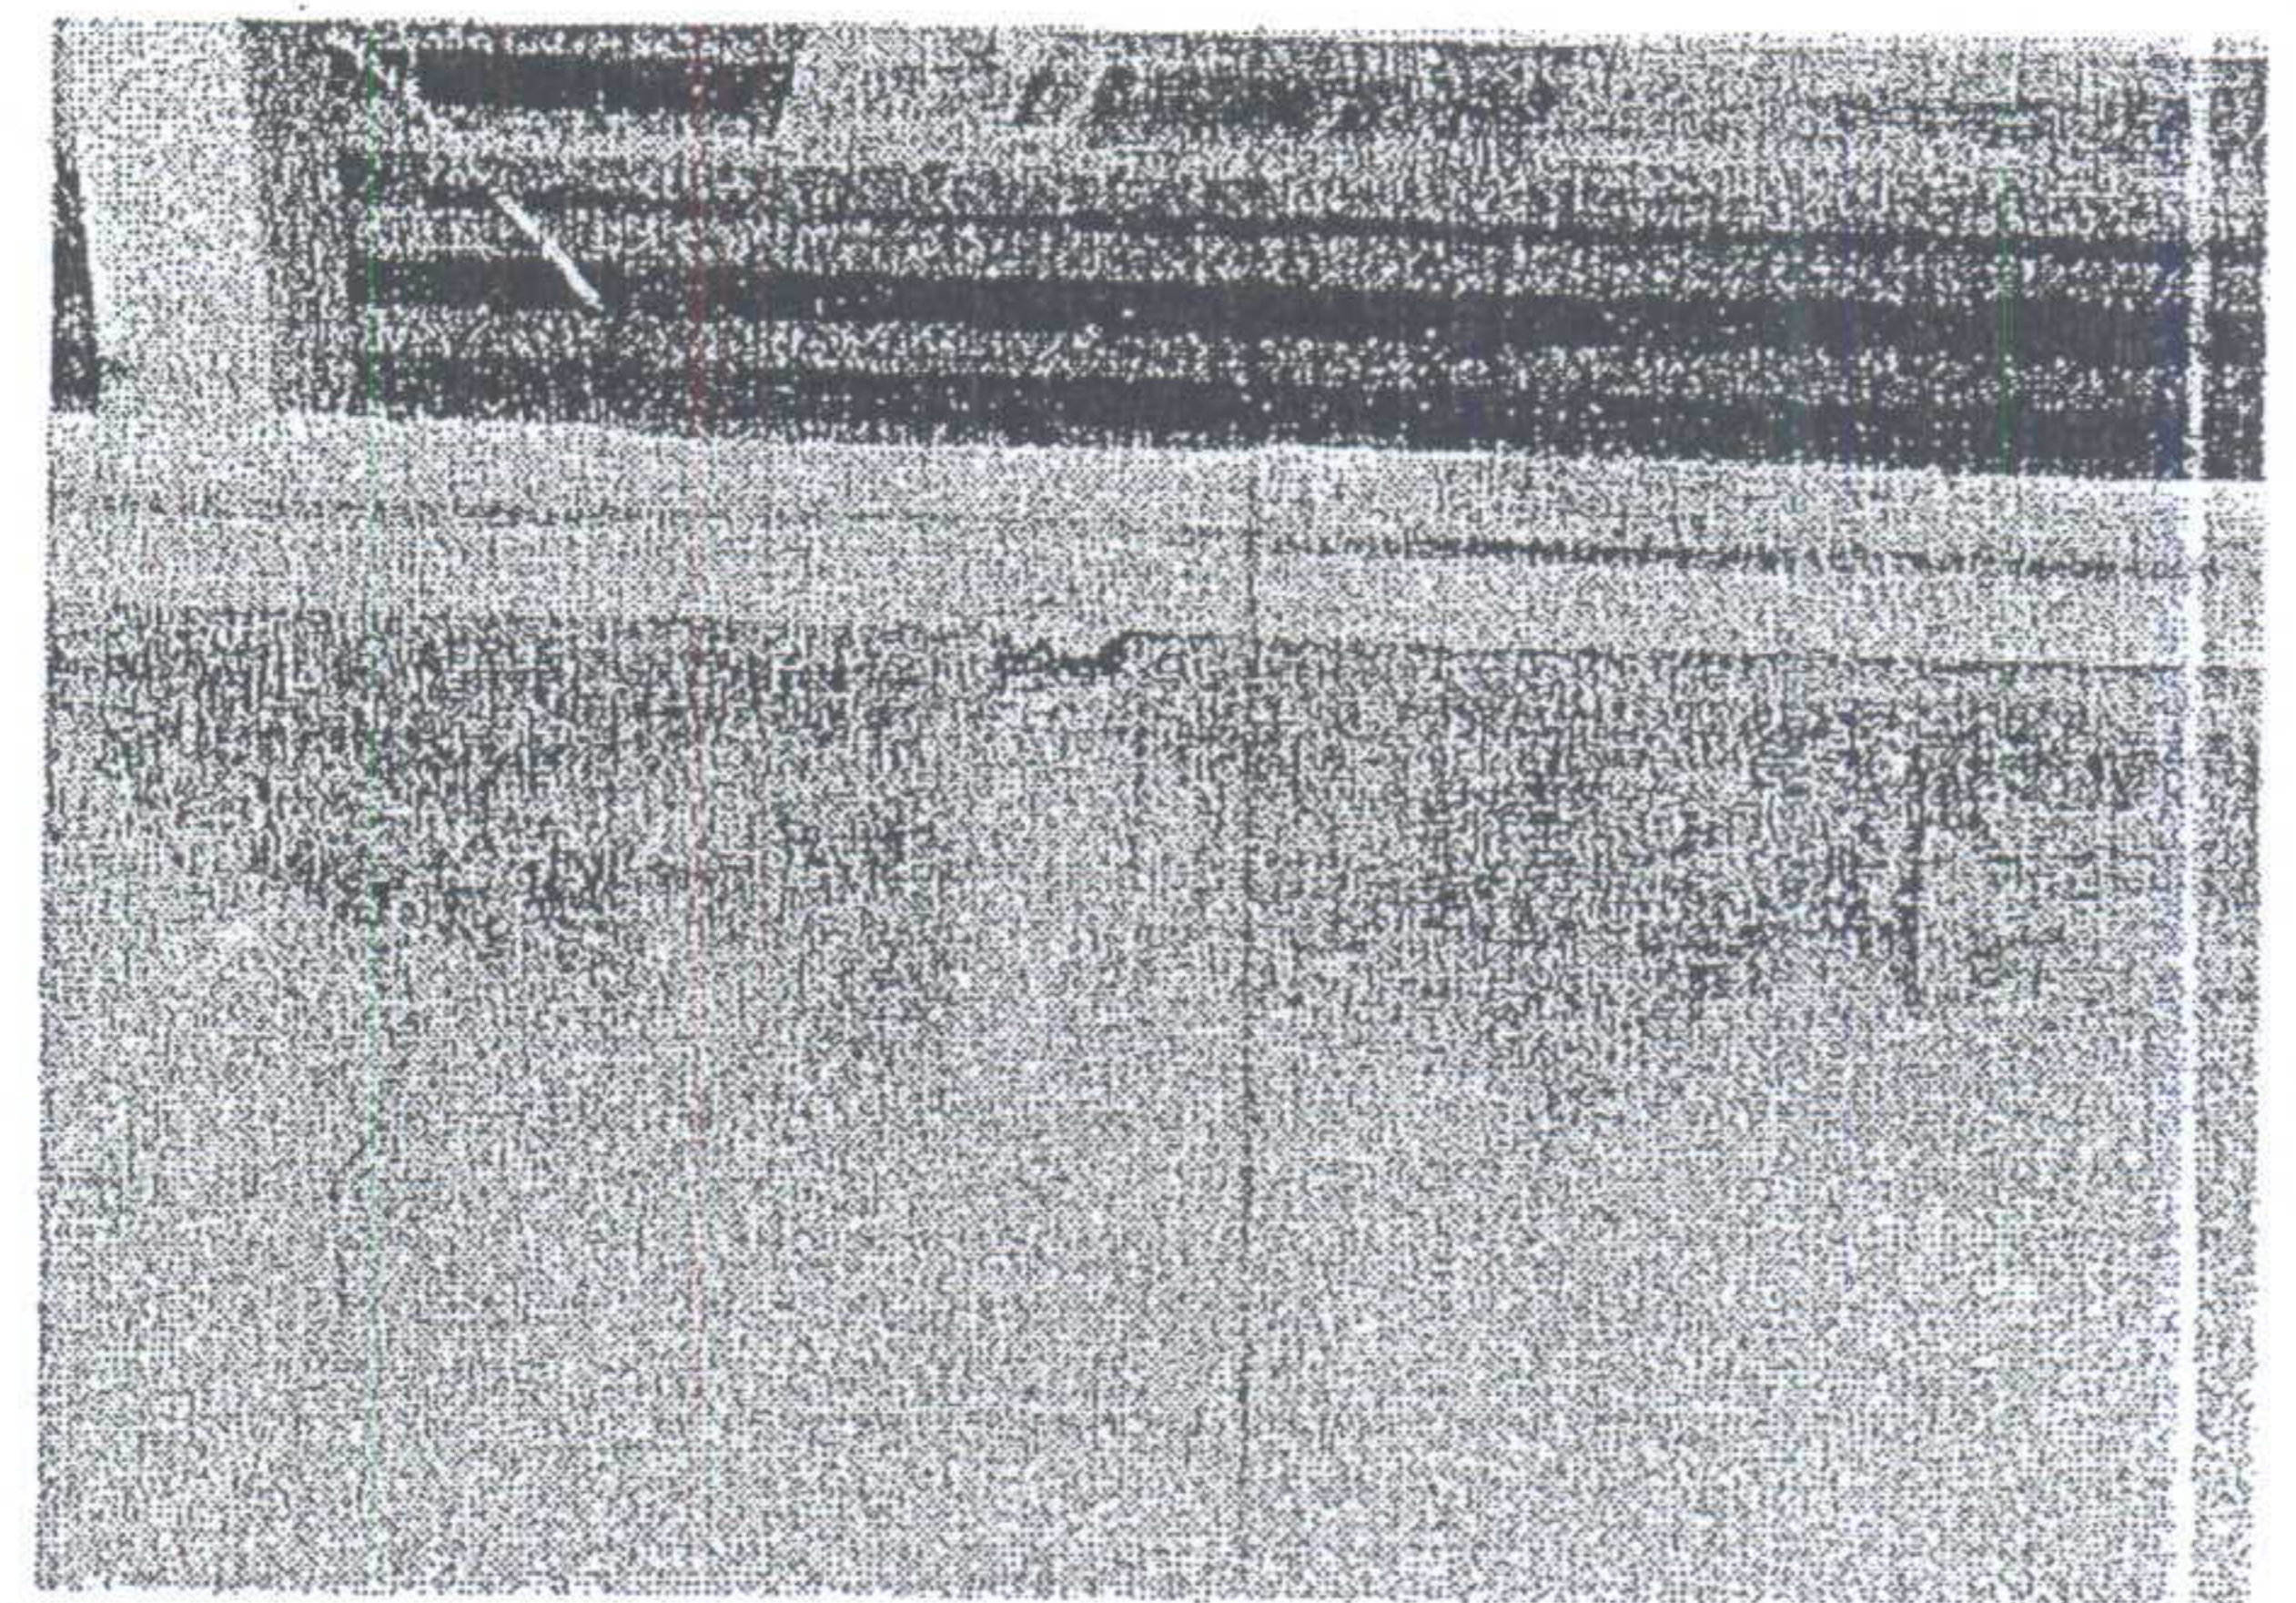
Pic.10 Damage to mortar finish left side parapet wall, south east side on roof, after collapse. Note lack of bolt holes or bolts.

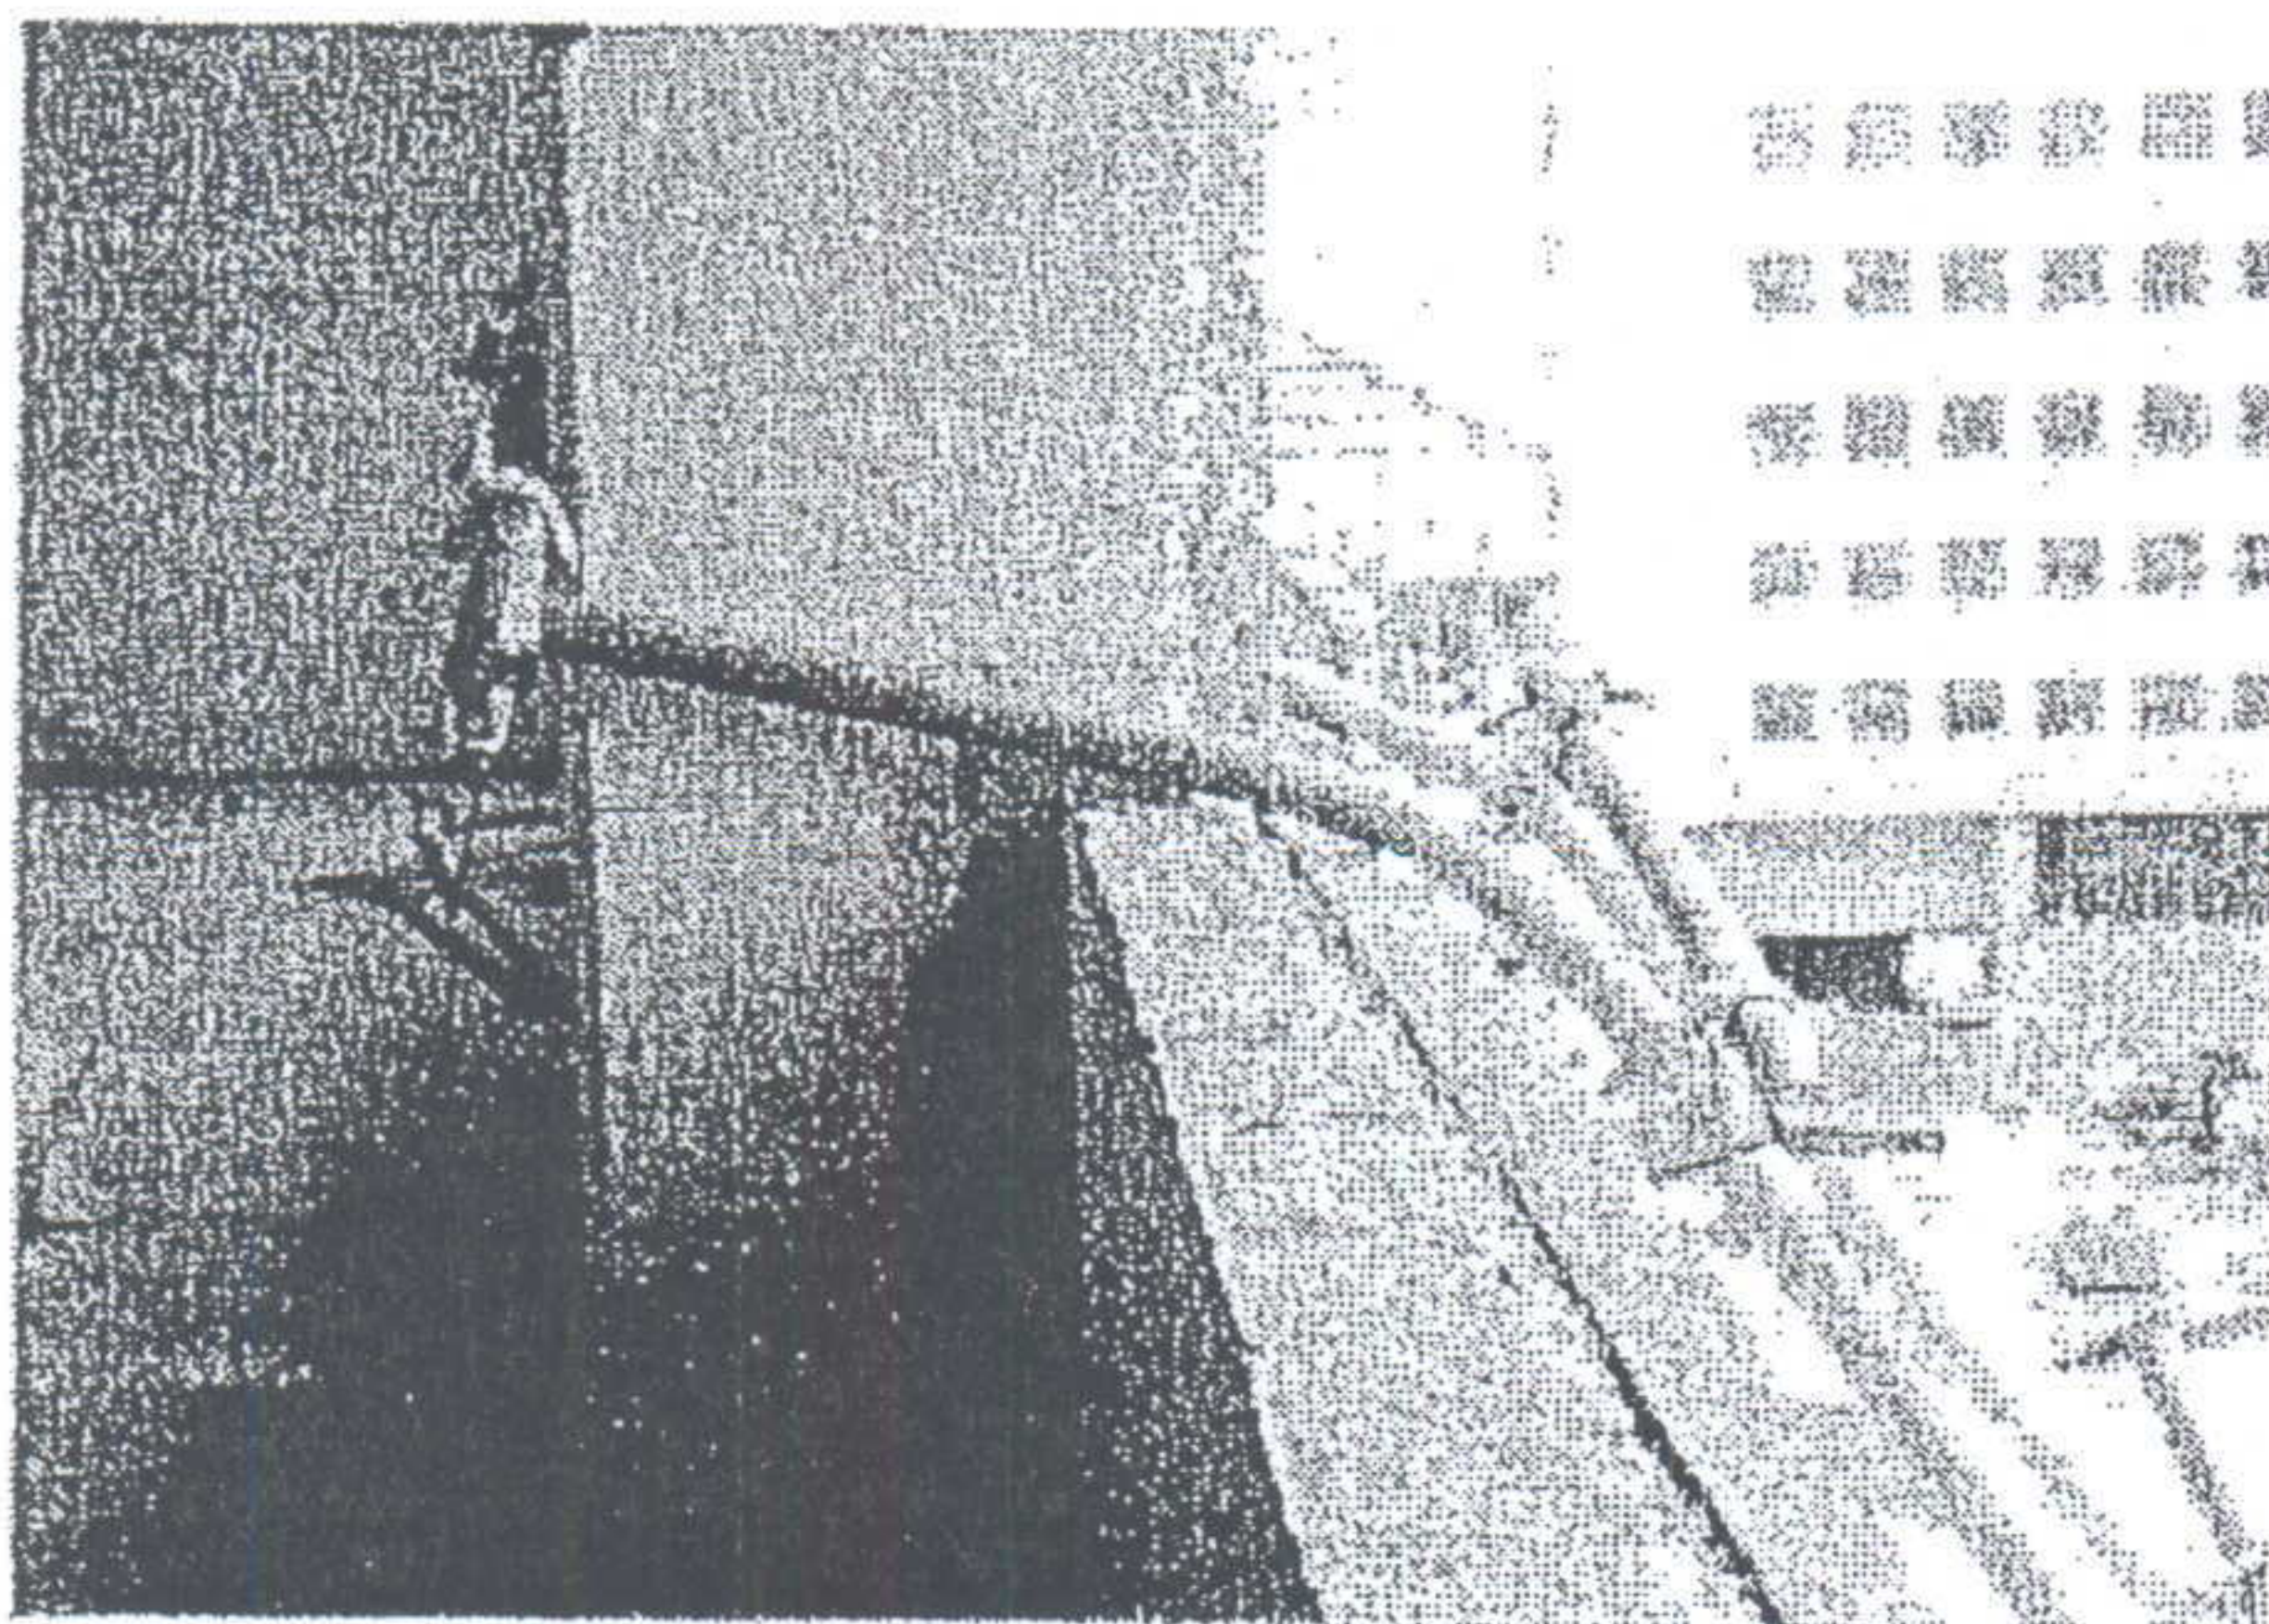
Pic. 11 Typical anchorages to column after collapse. Note the outer clamps and pipes on tie members away from column face.

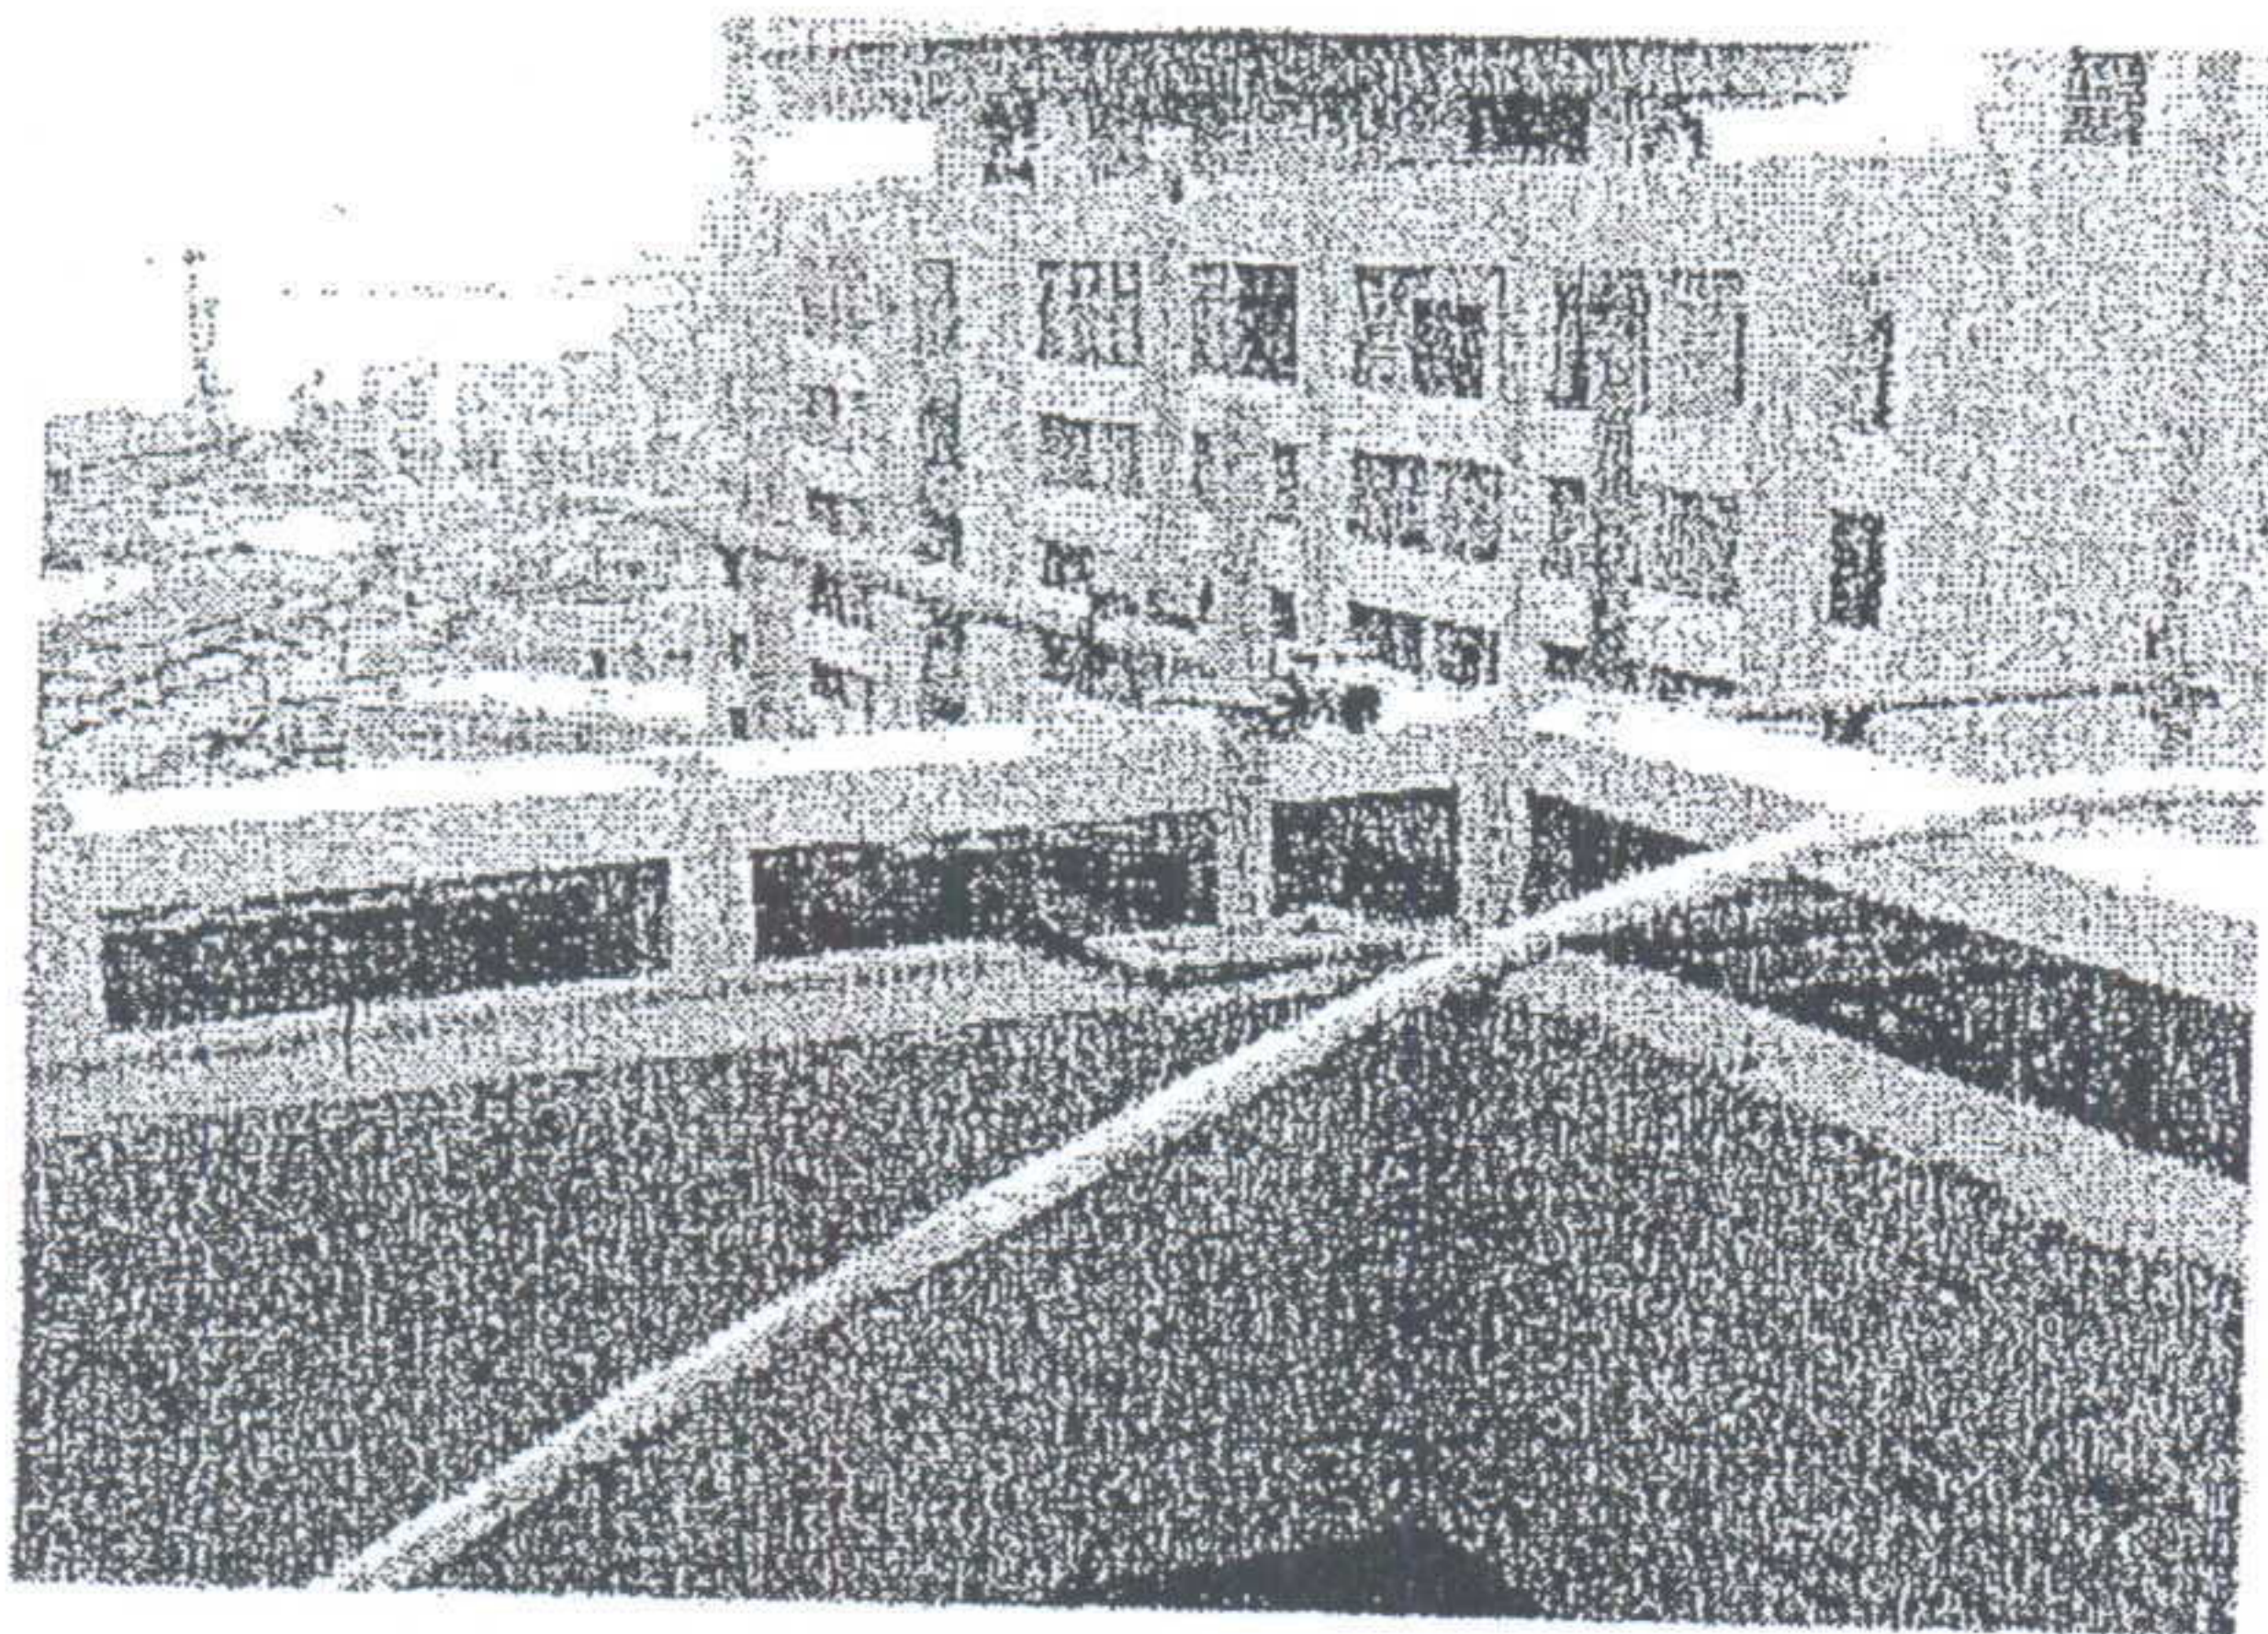
Pic. 13 Reported typical tie at roof level, before solar panels installed. Note plate bolted to parapet wall.

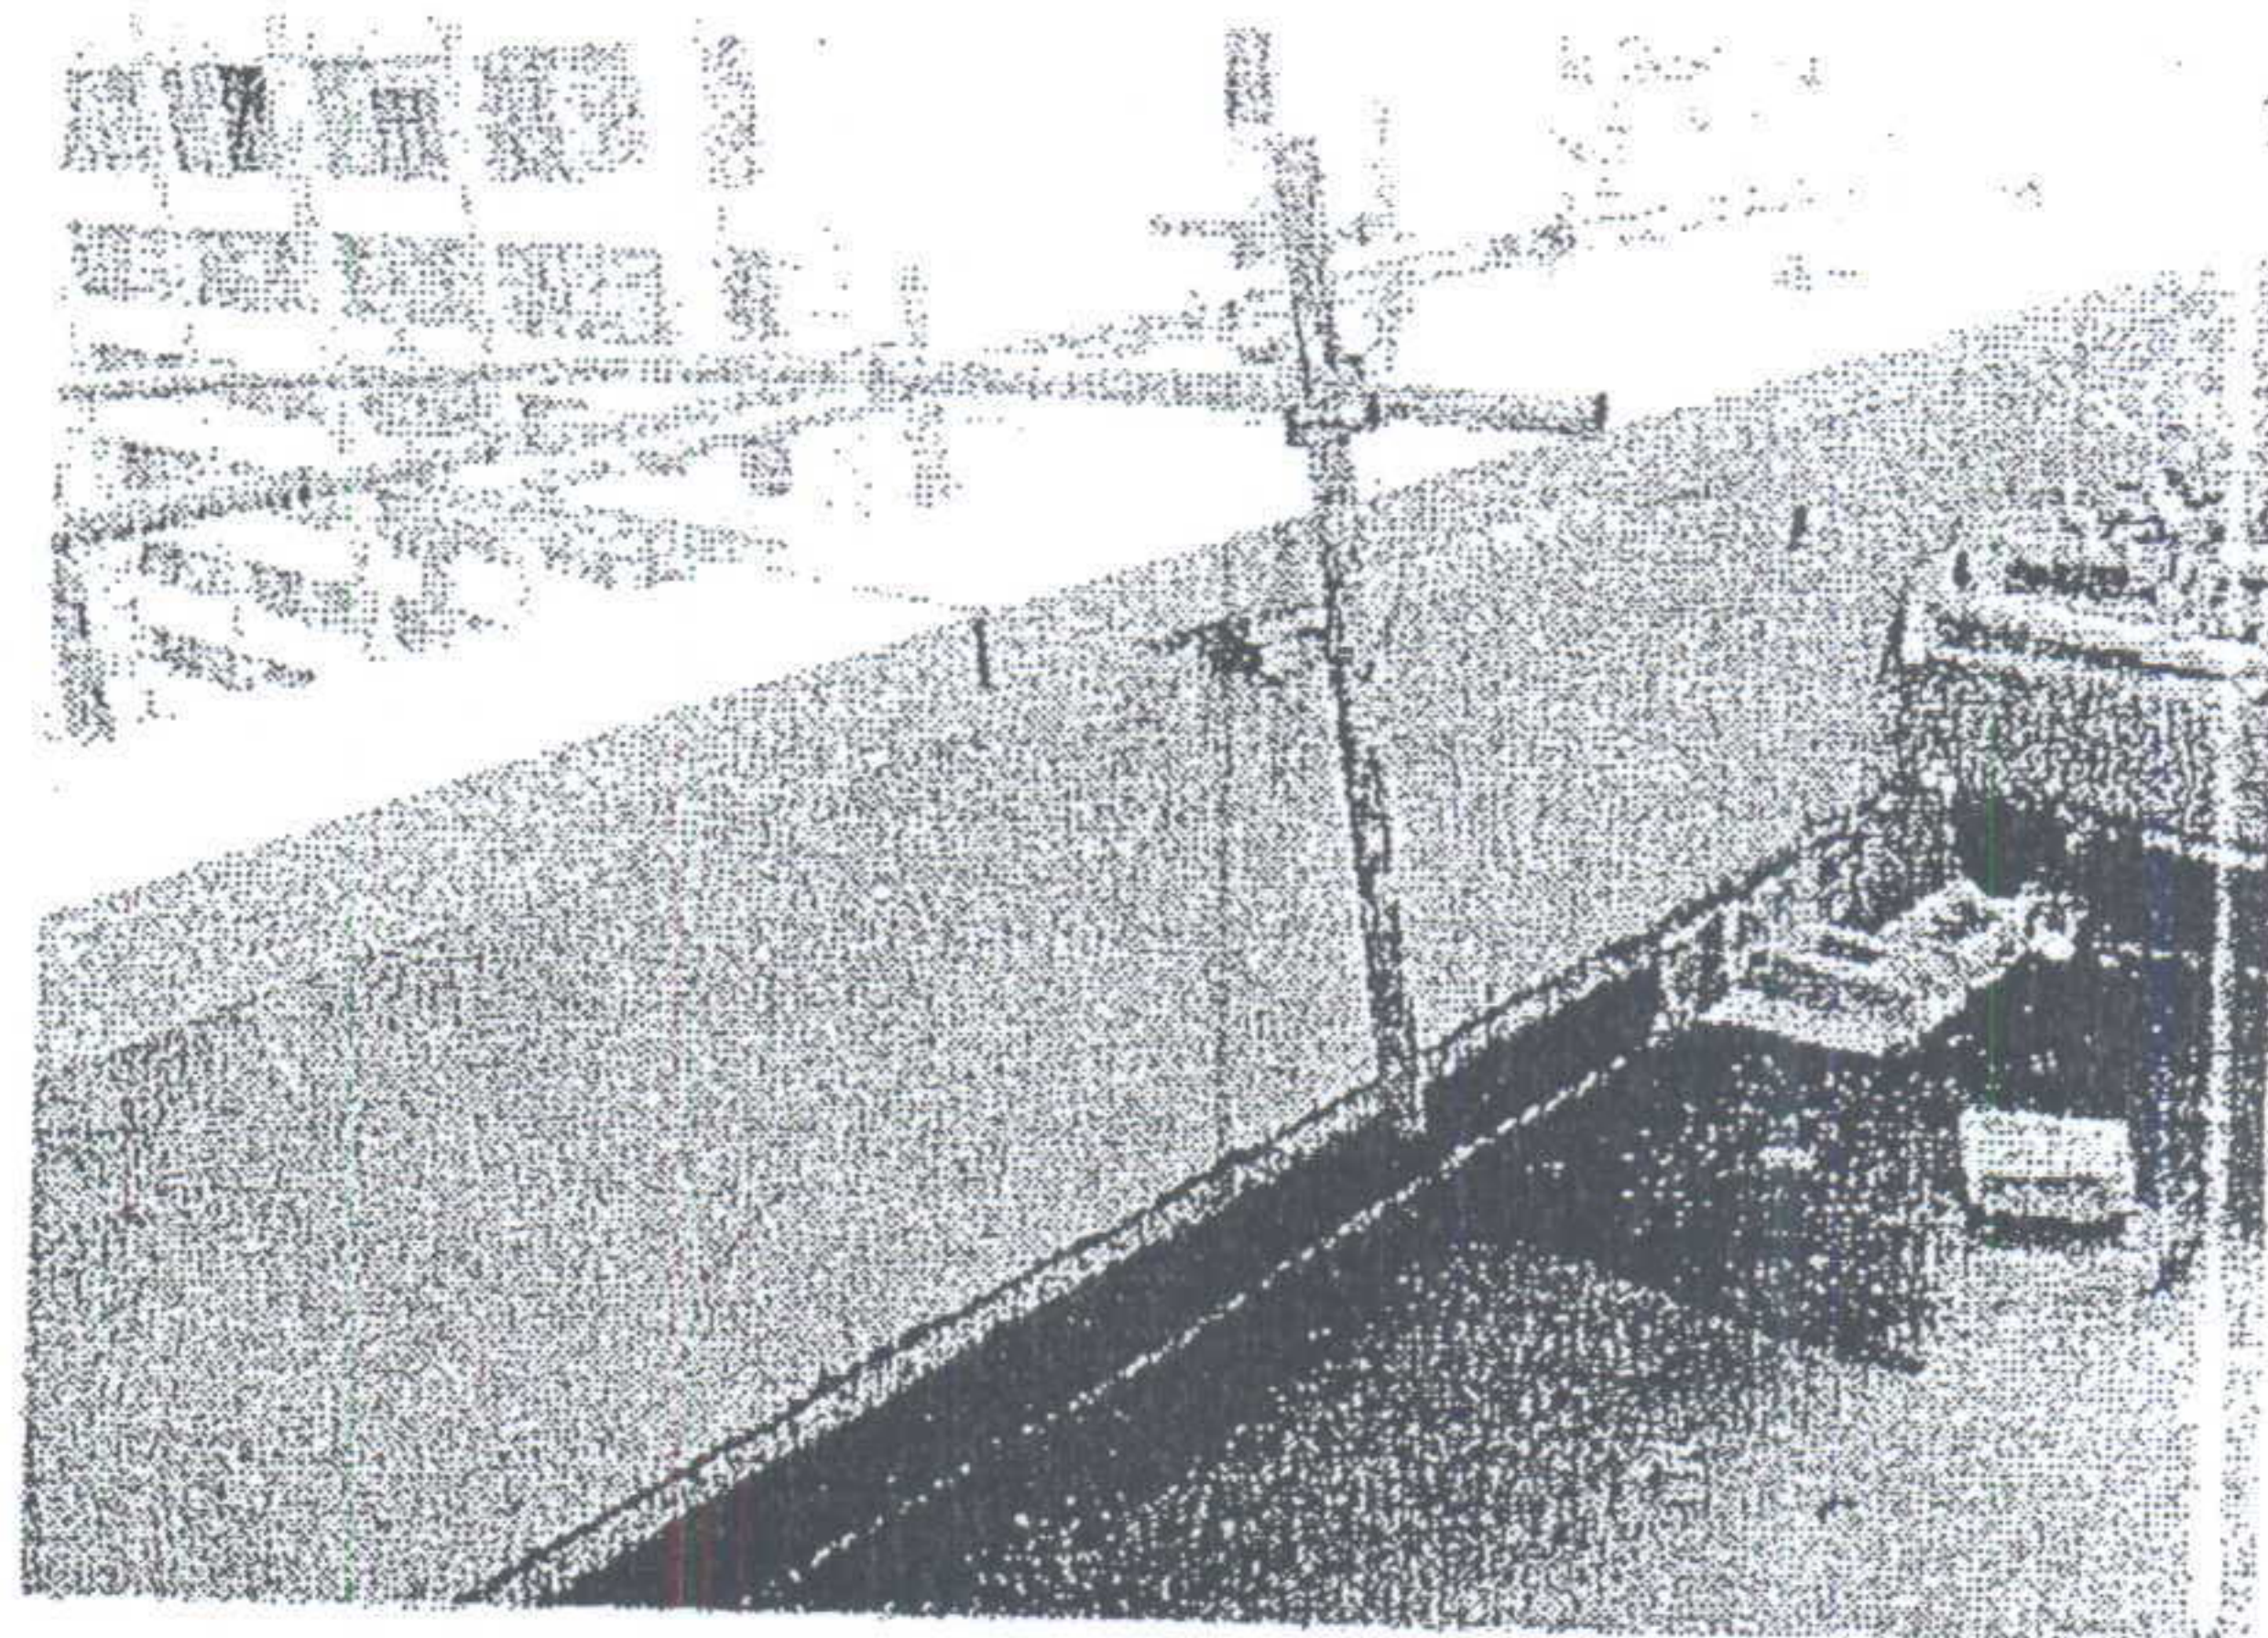
Pic. 14 Reported typical change to tie at roof level, after solar panels installed. Note ties are not bolted to parapet wall.

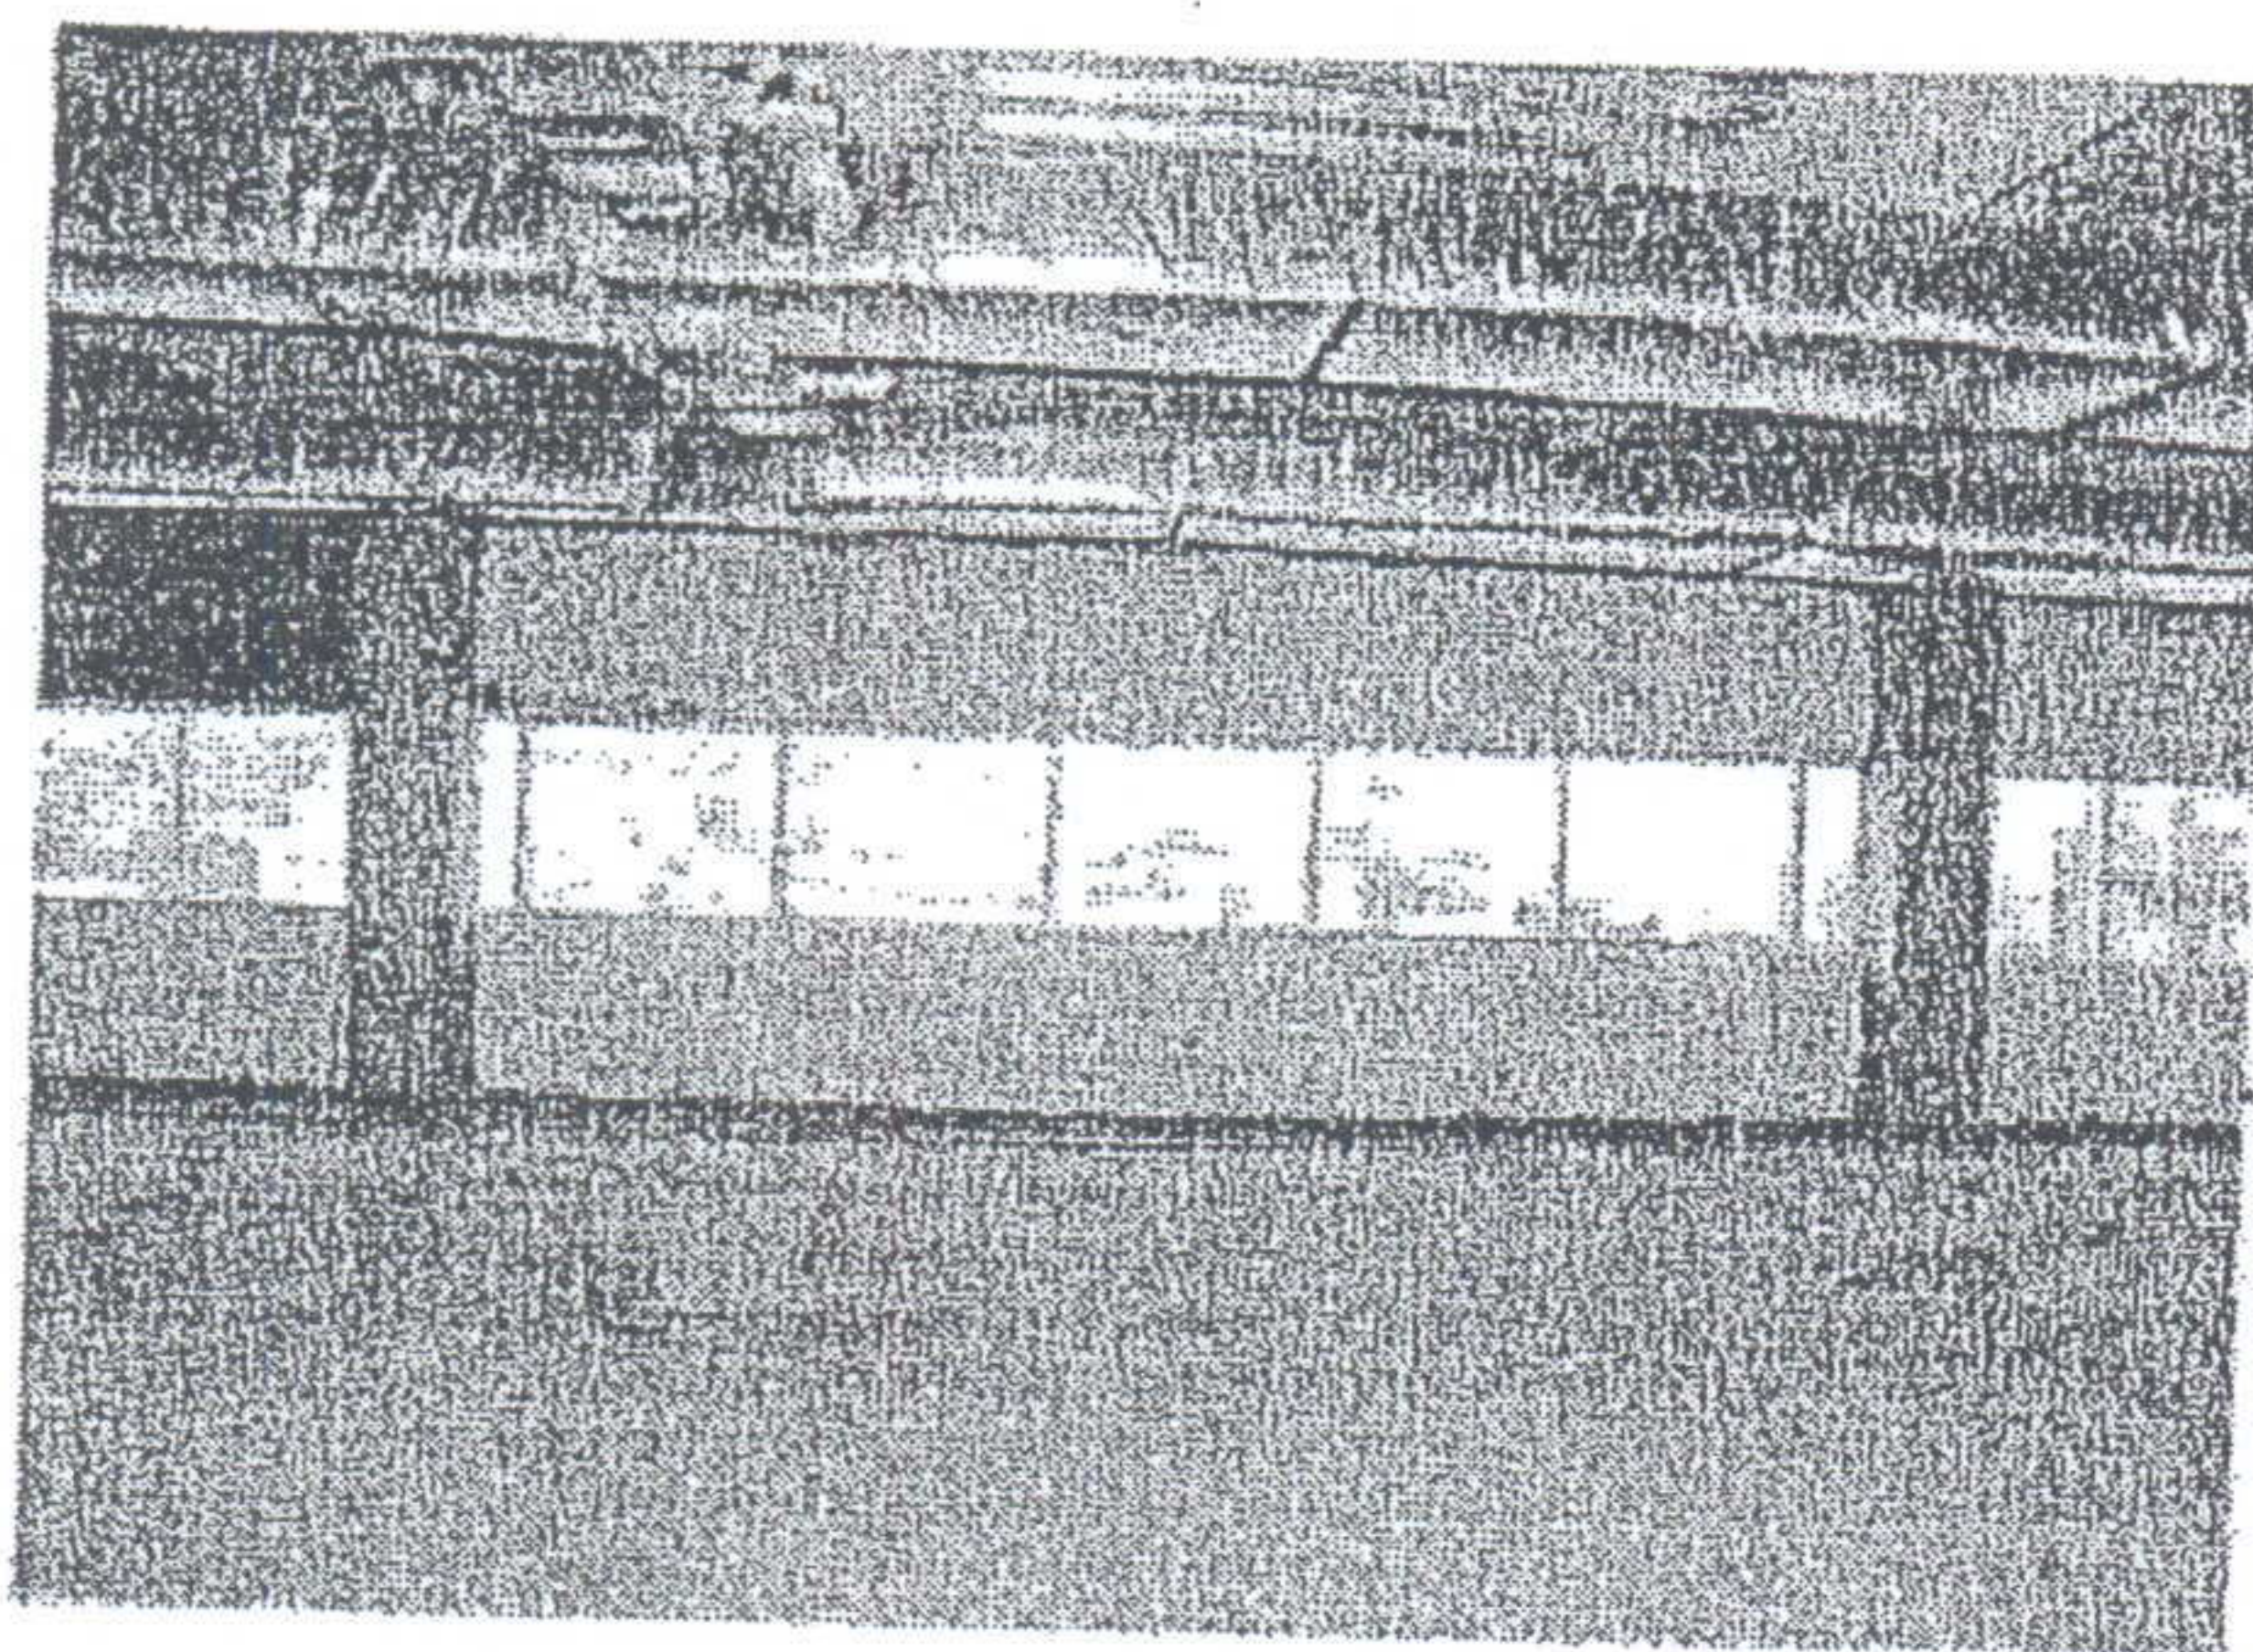
- i. No tie-members between the 6<sup>th</sup> floor or 7<sup>th</sup> storey and the roof of the building (see appendix I, pic 8. 15 & 16. ).
- ii. The scaffolding being restrained for movement away from the building but free to move towards the building.

Pic. 15 Typical south east side of floor, after solar panels are installed.

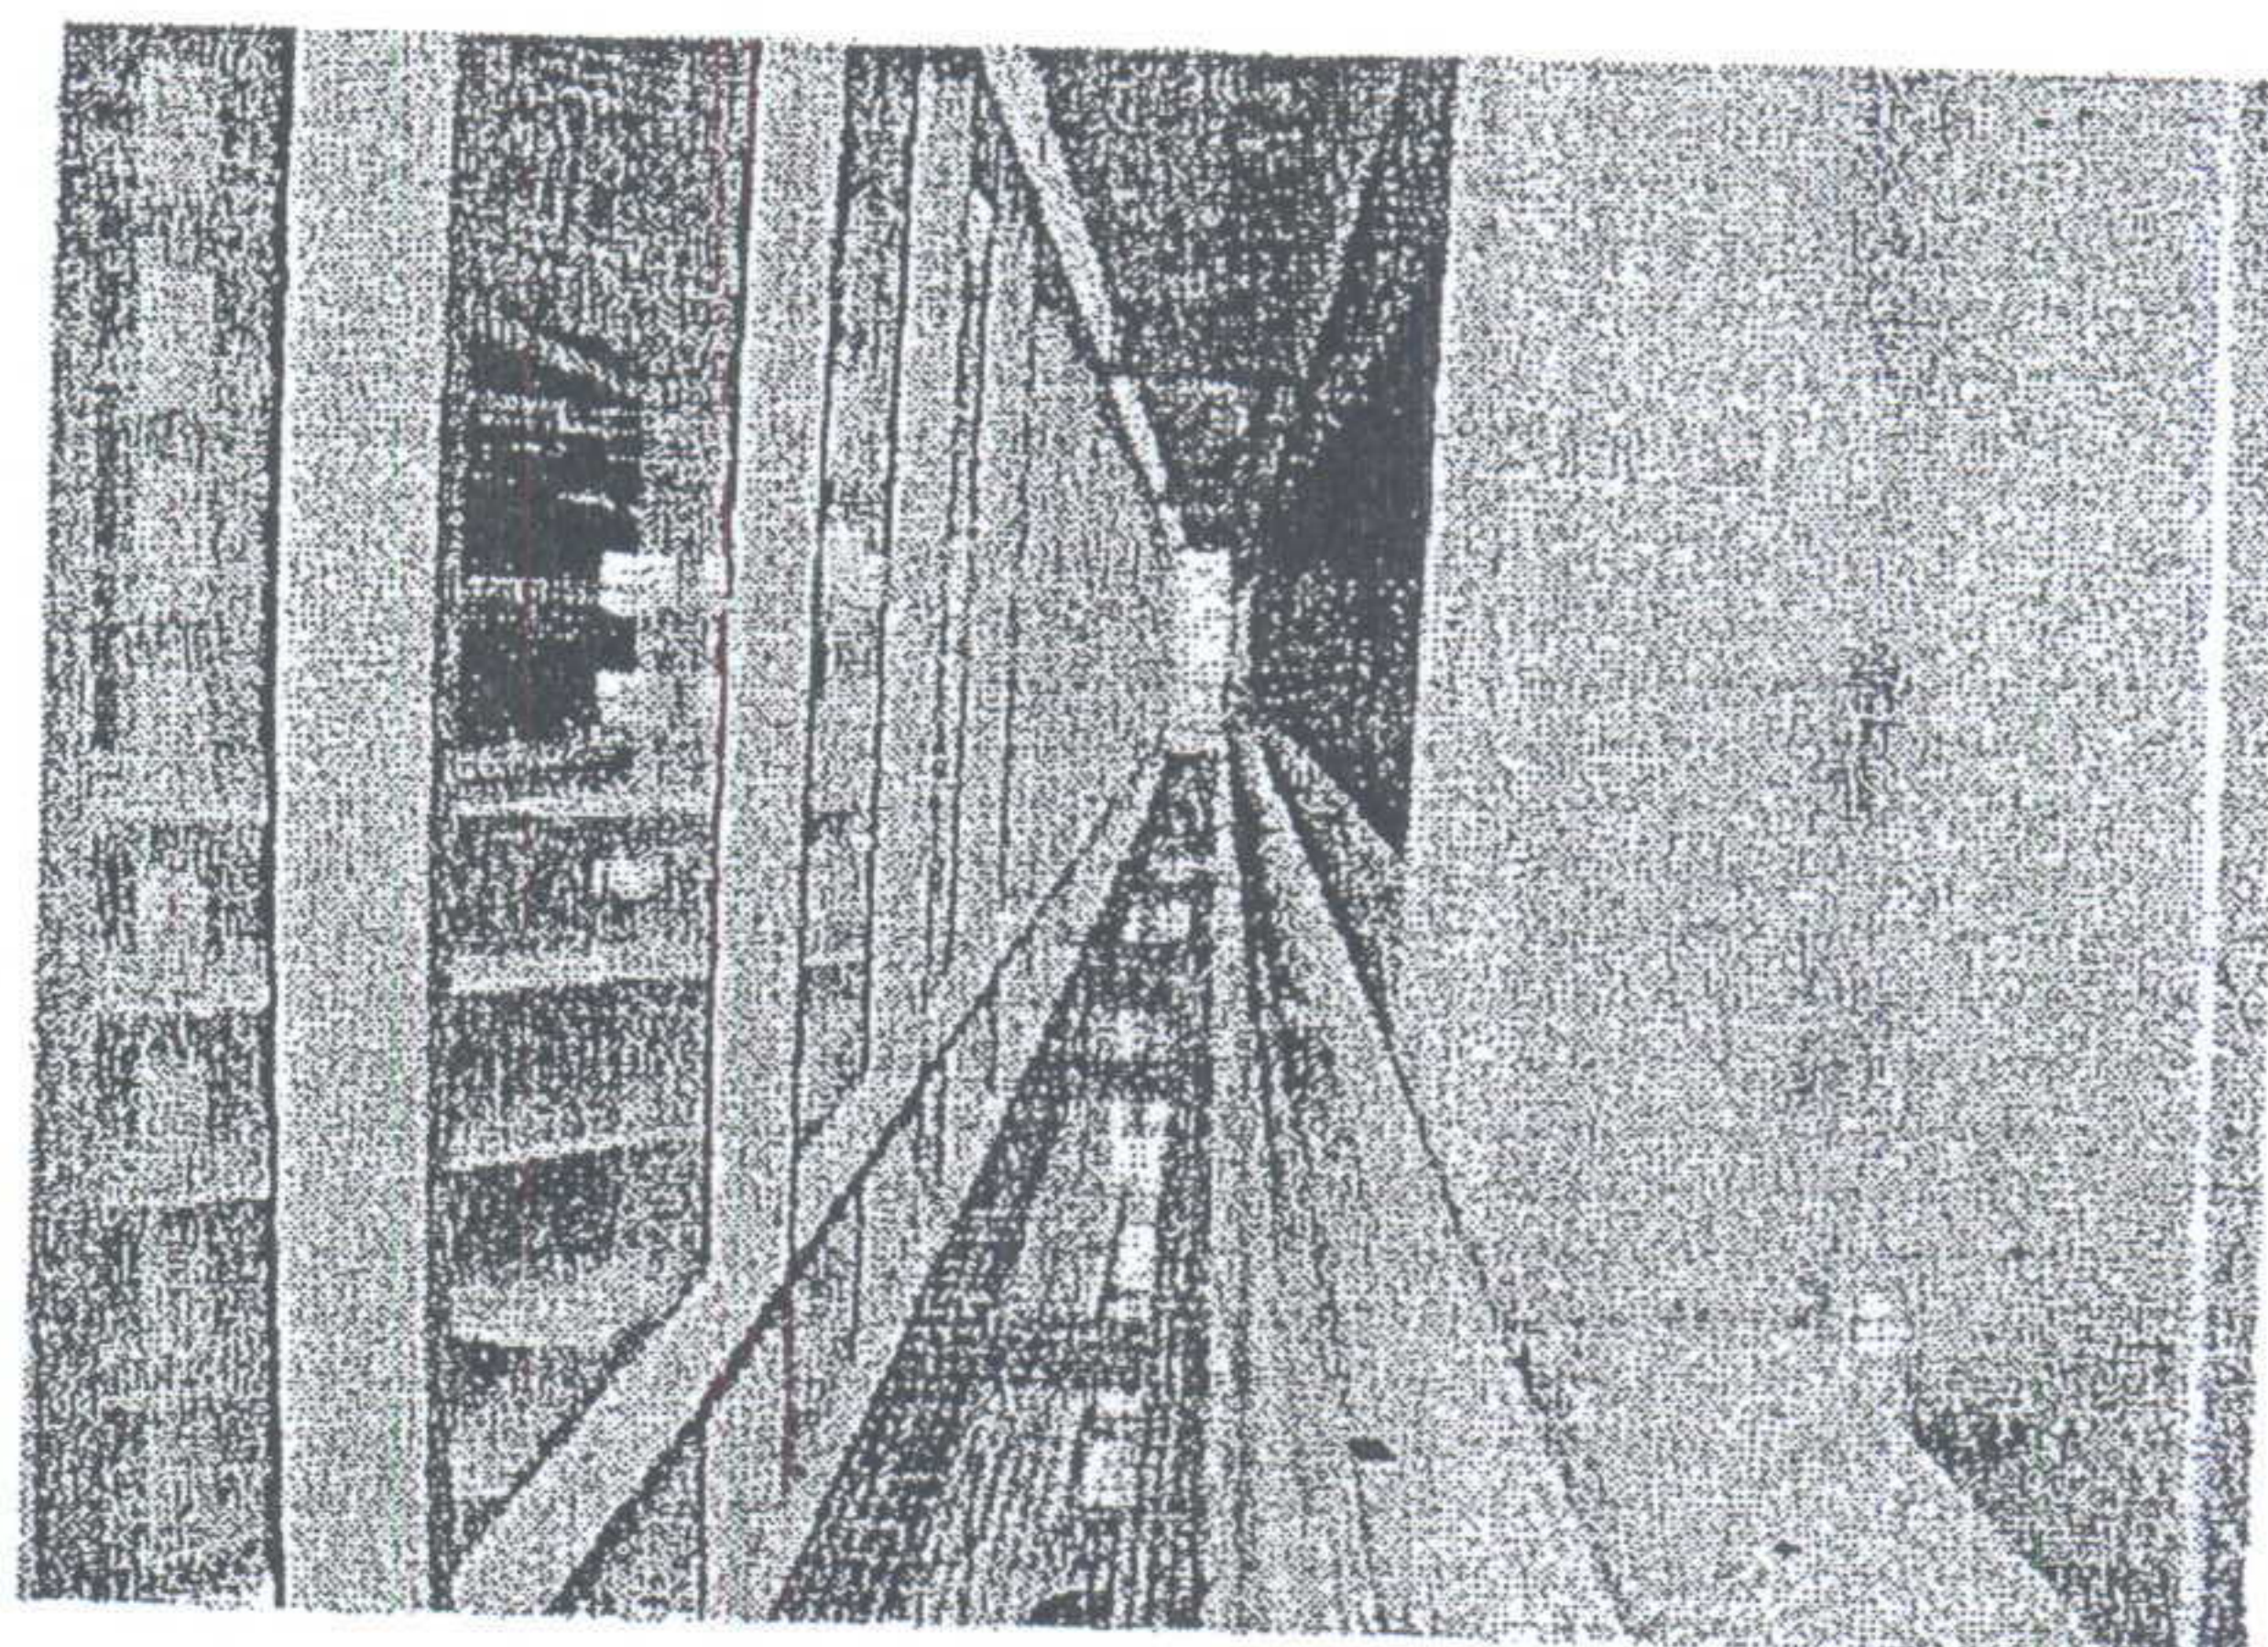
Pic. 16 Typical space between outer face of column and solar panel. Note no sign of tie members.
