# STRUCTURAL ASSESSMENT REPORT

COLLAPSE OF SCAFFOLDING, AT THE SITE OF  
THE NEW CUSTOMS & EXCISE BUILDING  
GOVERNMENT CAMPUS, RICHMOND STREET  
PORT OF SPAIN

DATED: 30<sup>TH</sup> OCTOBER, 2006

THE DESIGNS ENGINEERING BRANCH  
MINISTRY OF WORKS AND TRANSPORT

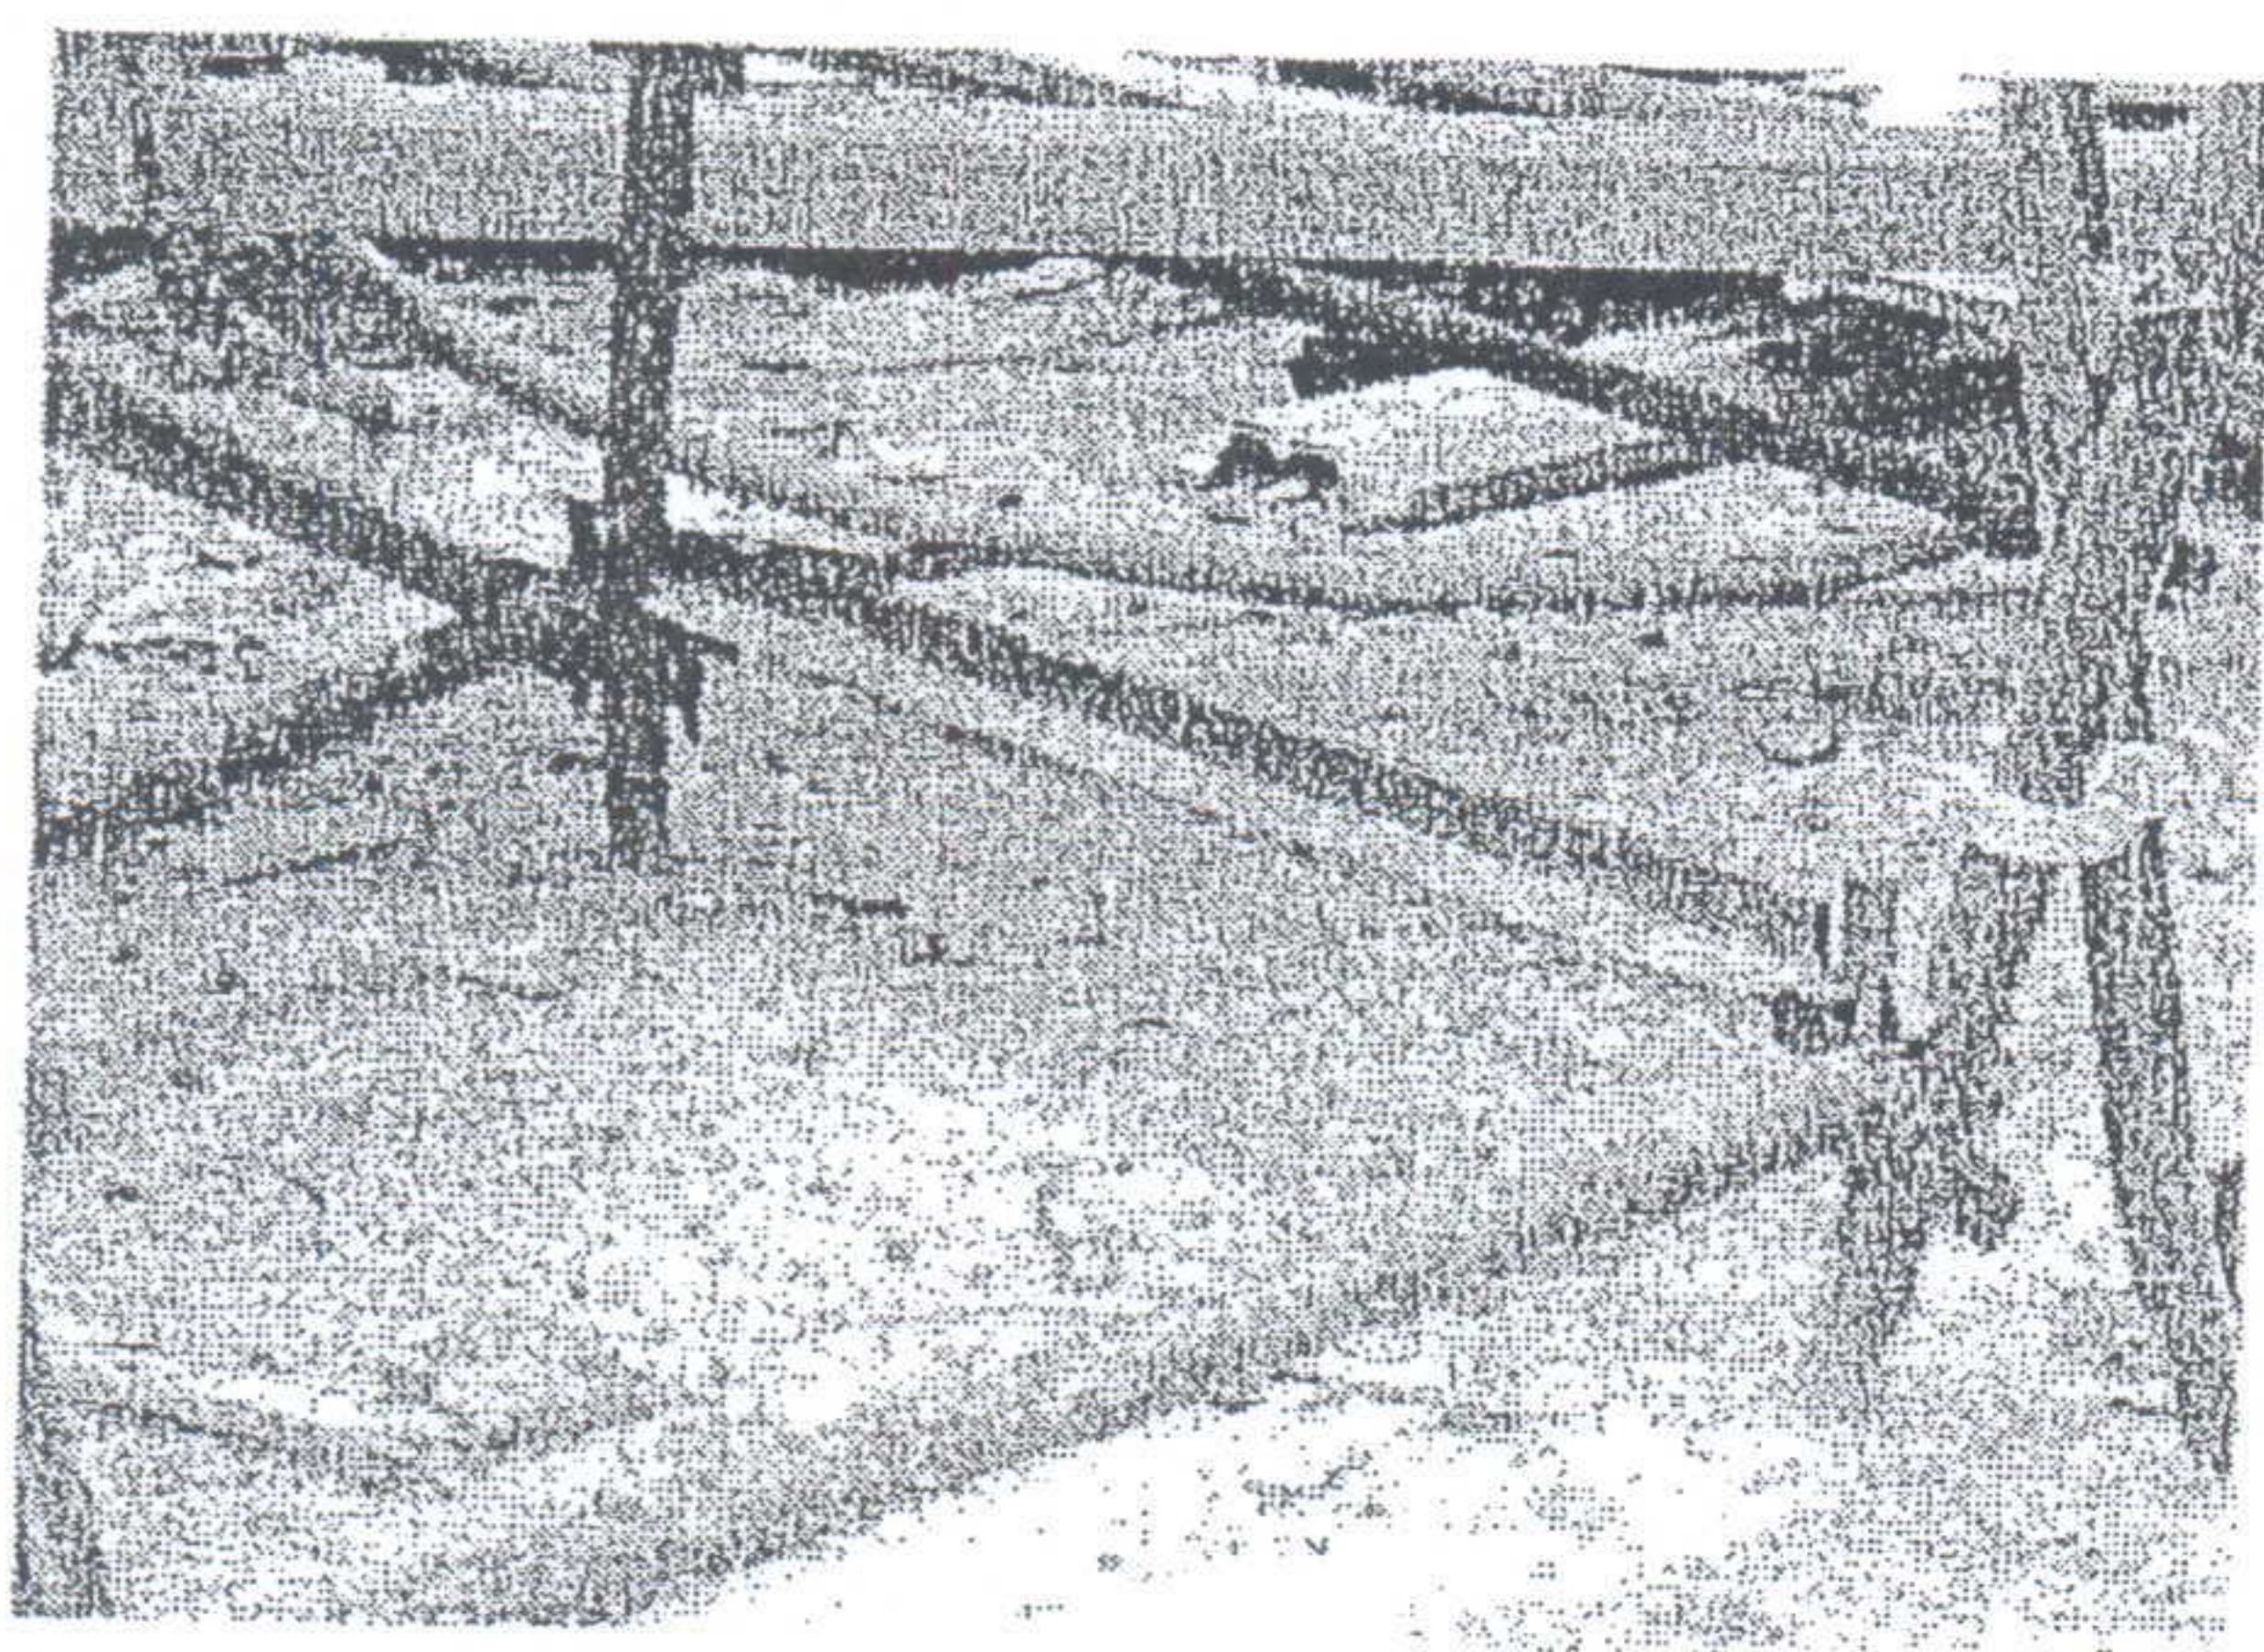
However, on examination of the debris there was no evidence of the use of base plates or any equivalent components (as outlined in clause 9: Baseplates) at the base of the structure (see appendix I, pic. 17 to 20)

The entire system was located on a suspended reinforced concrete slab that had an uneven surface. The lack of base plates would have made leveling the first lift or vertical components of the structure extremely difficult. If this concrete surface was sloped or graded to facilitate the drainage of water, leveling the vertical components without base plates would have been even more difficult (see appendix I, pic. 17 to 20; Appendix IV, pg 4 "THE COMPONENTS", Adjustable Base and Head Jack).

Pic. 17 The south base of collapsed scaffolding. Note lack of base plates or equivalent components.

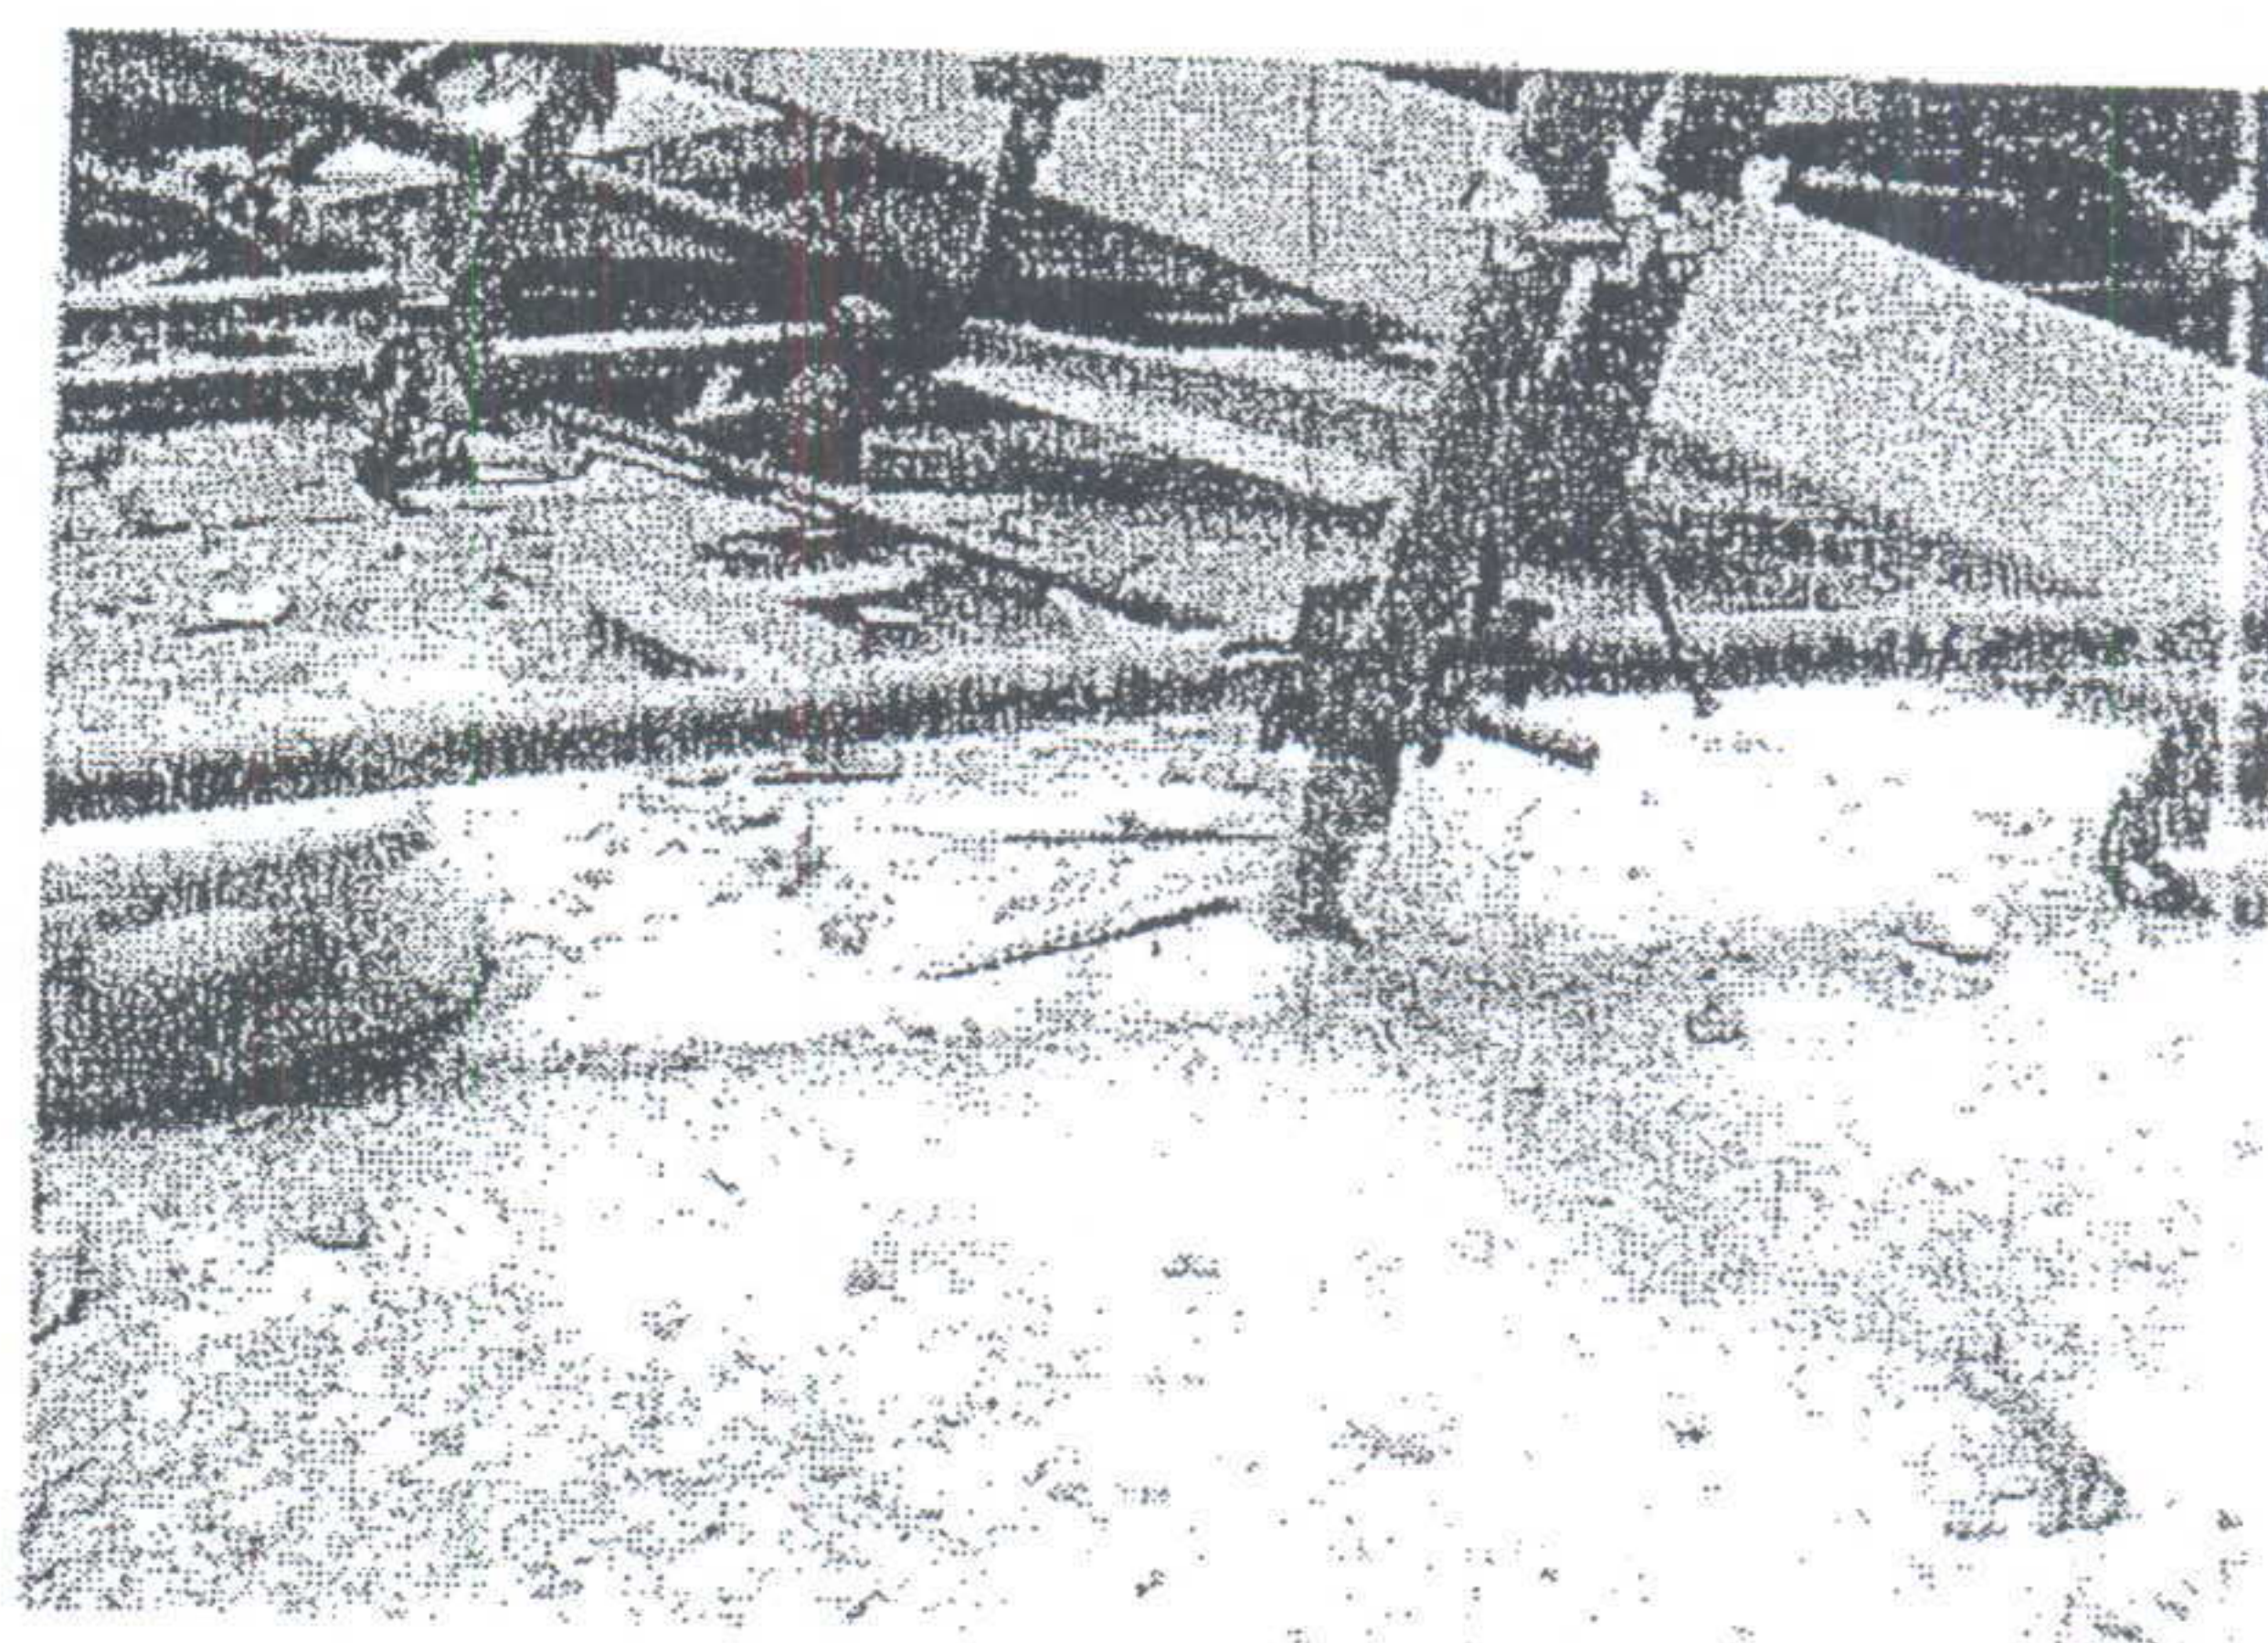
Pic. 18 The base, southern area of collapsed scaffolding. Note lack of base plates.

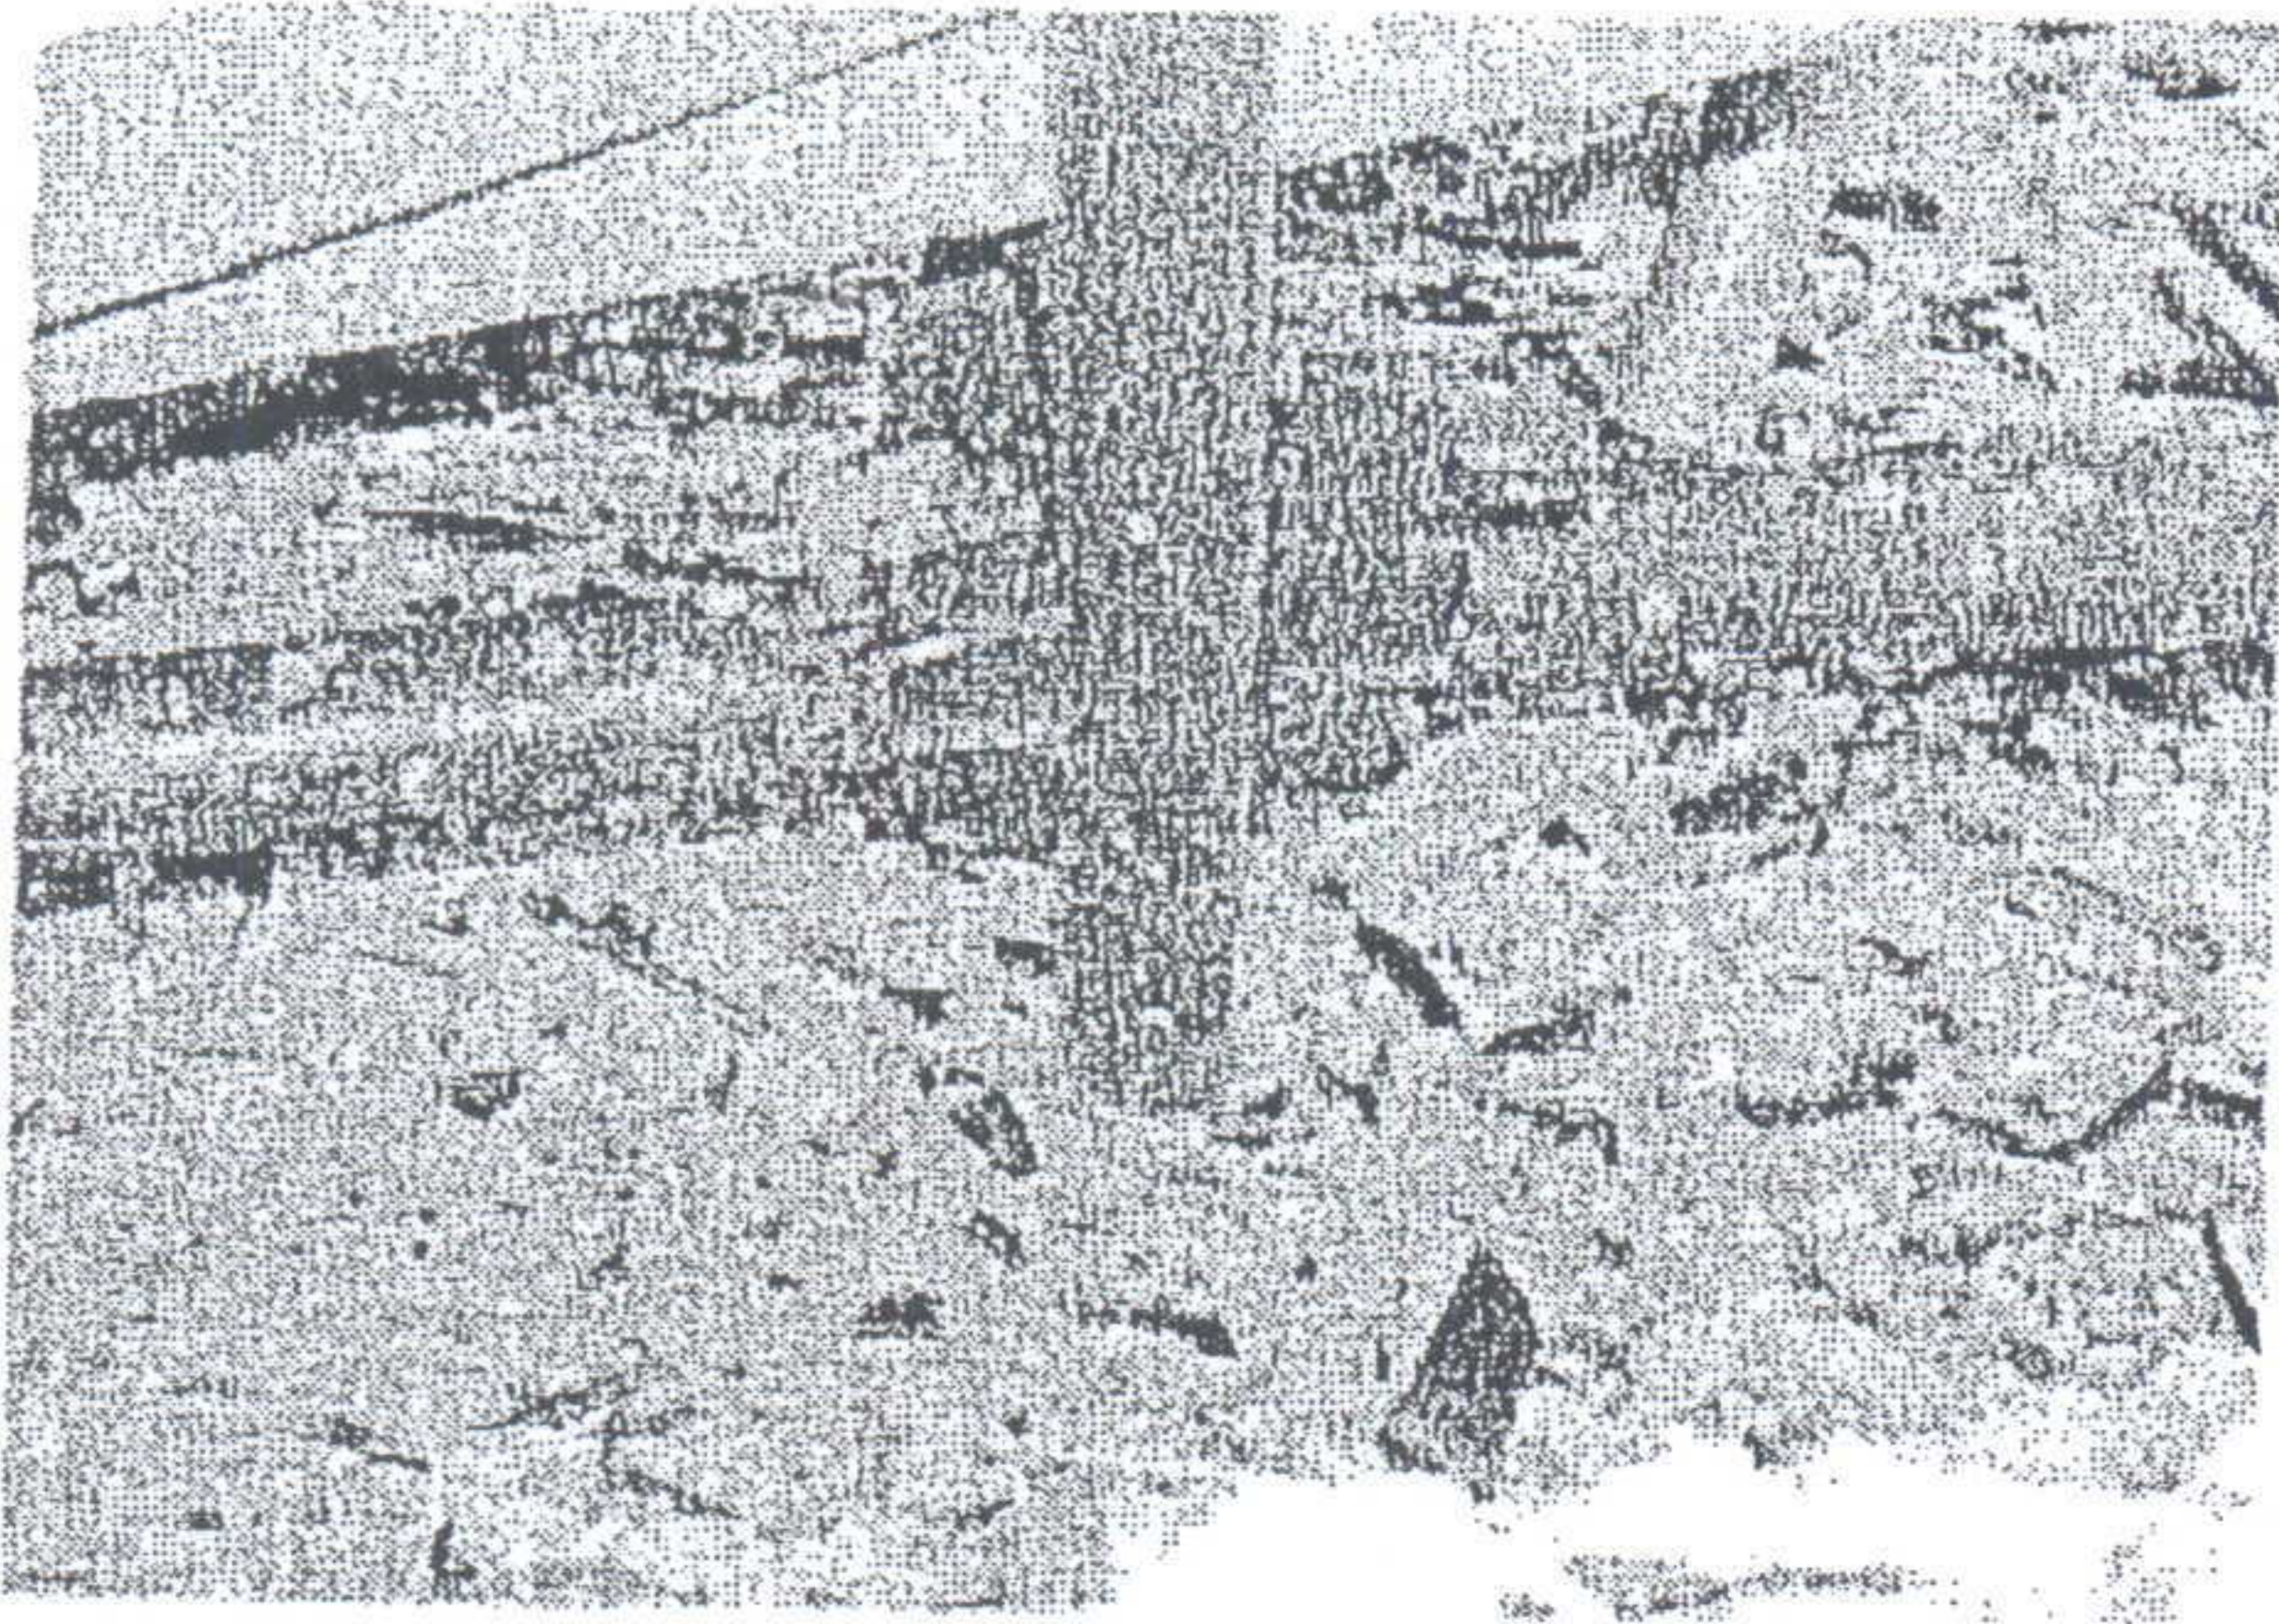
Pic. 19 Typical base of collapsed scaffolding.  
Note lack of base plates.

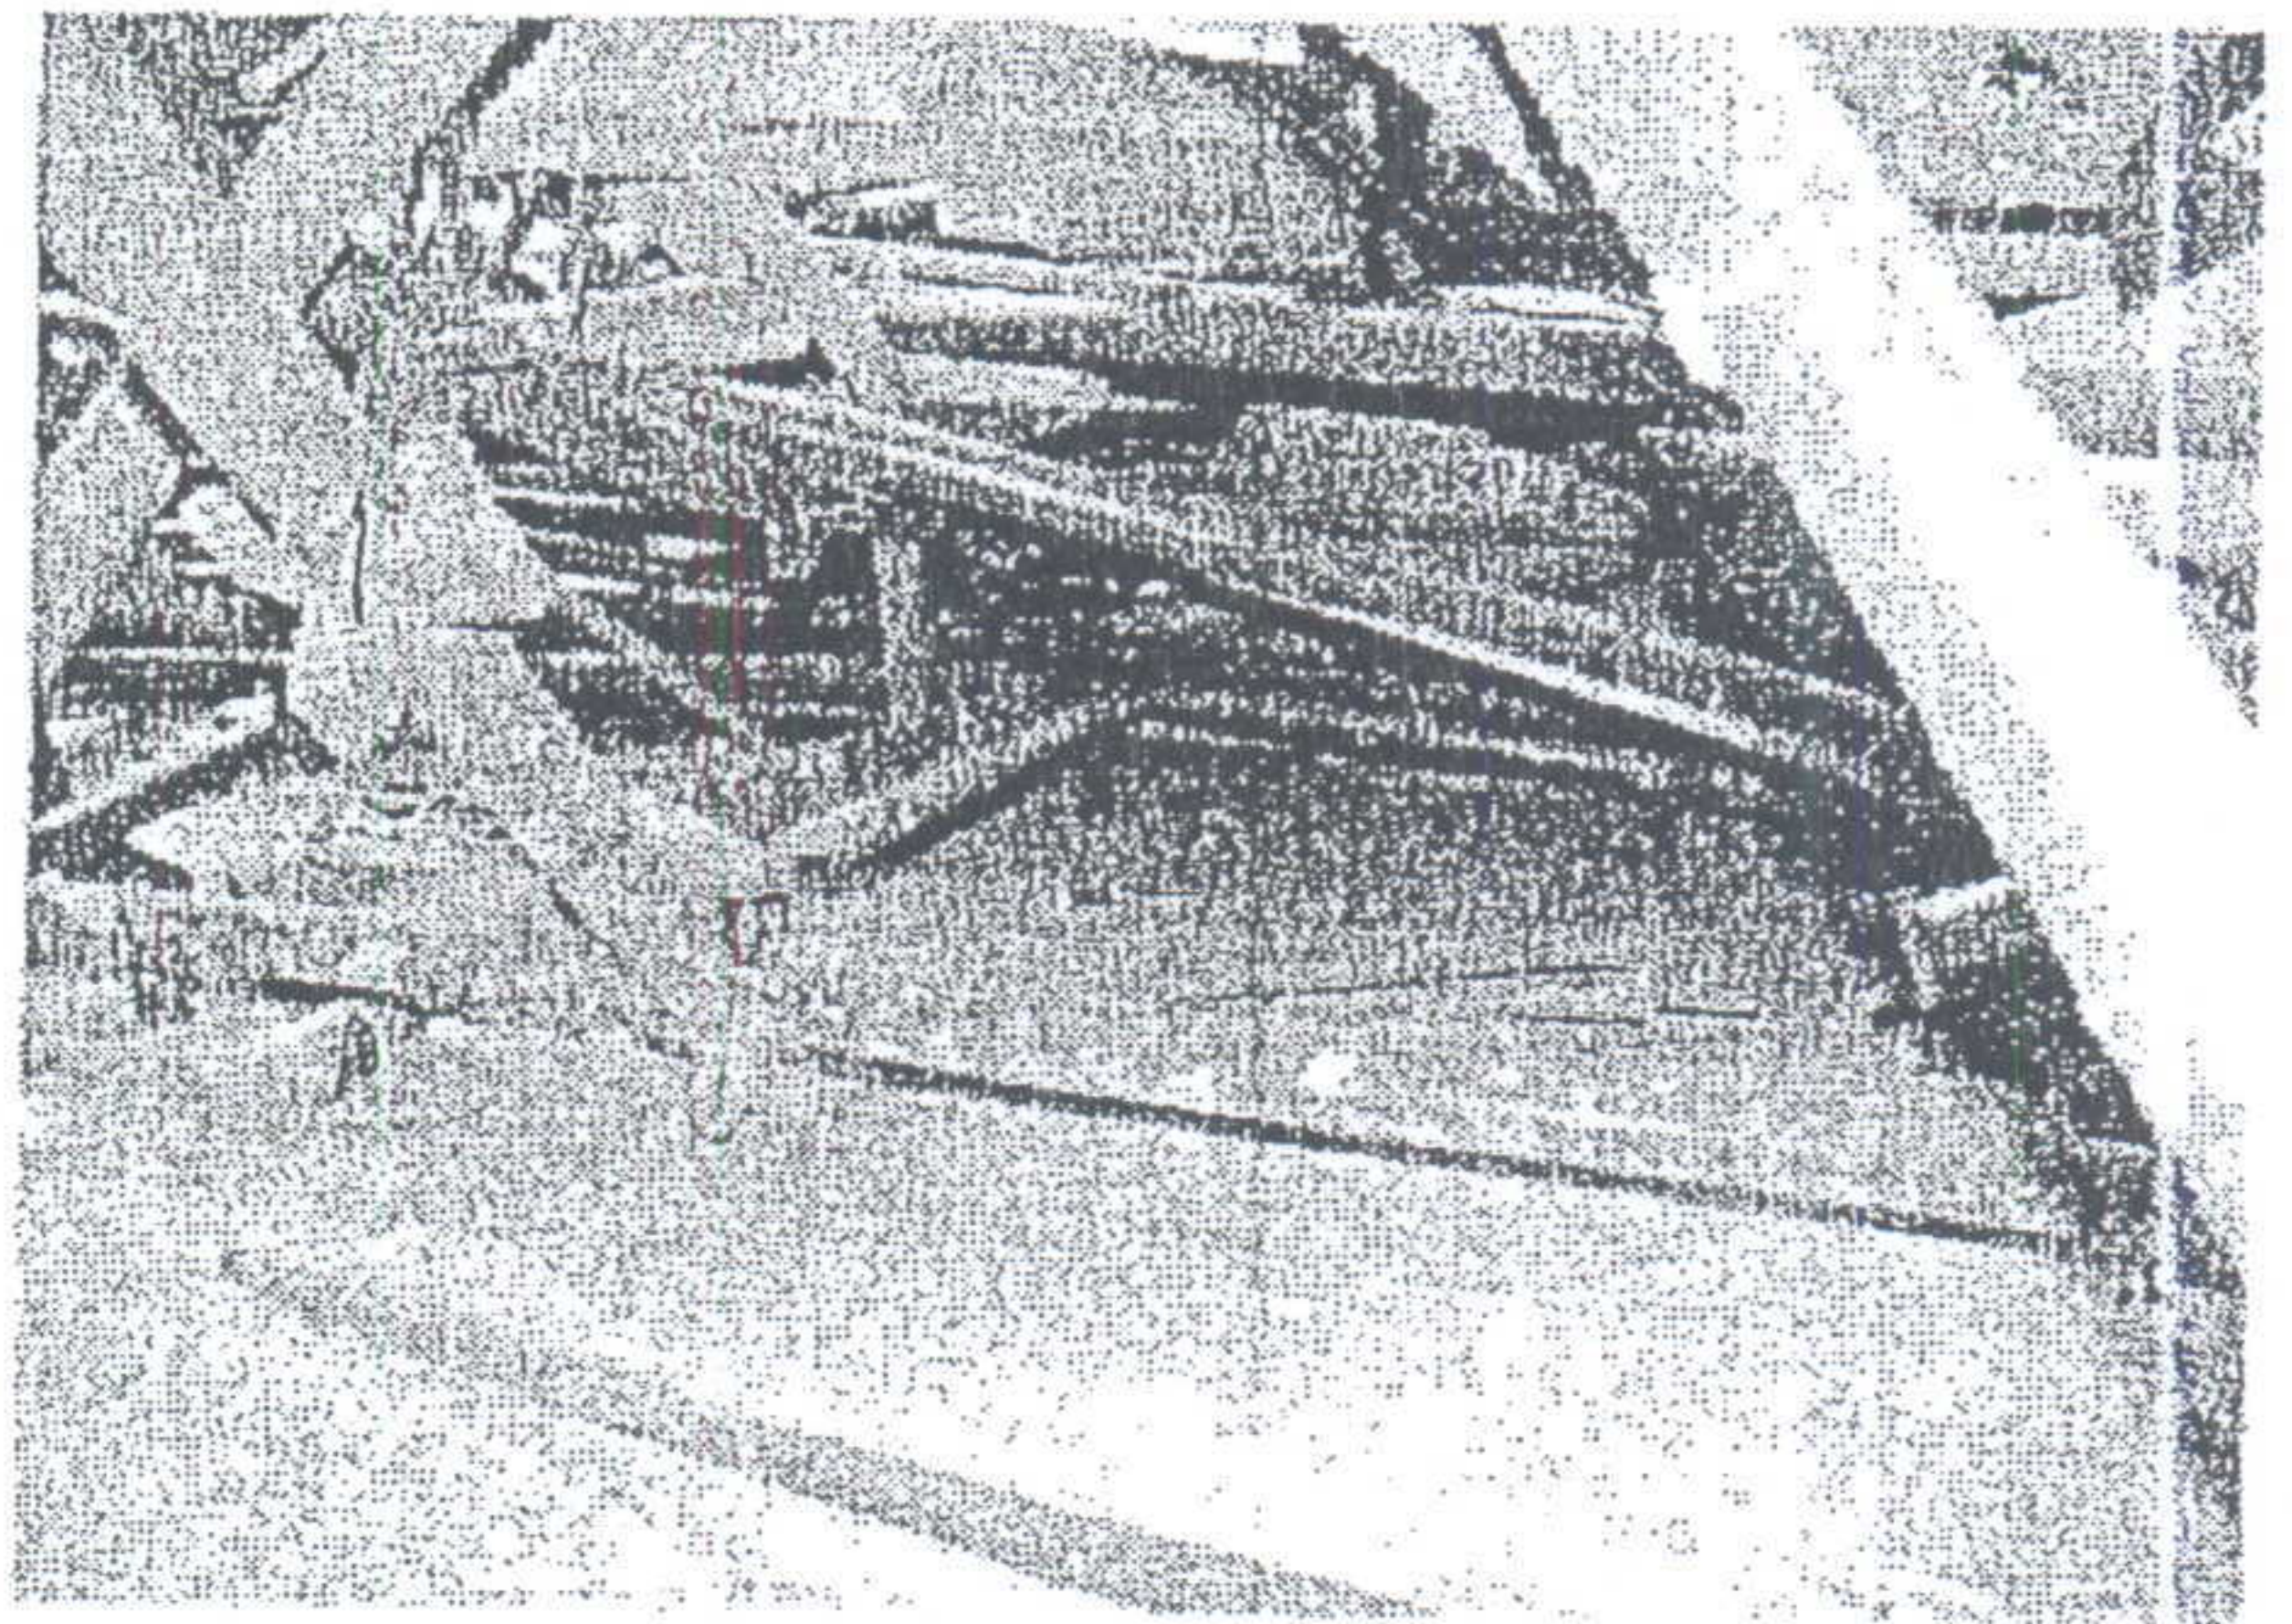
Pic. 20 The base, north section of collapsed scaffolding.  
Note lack of base plates or equivalent components.

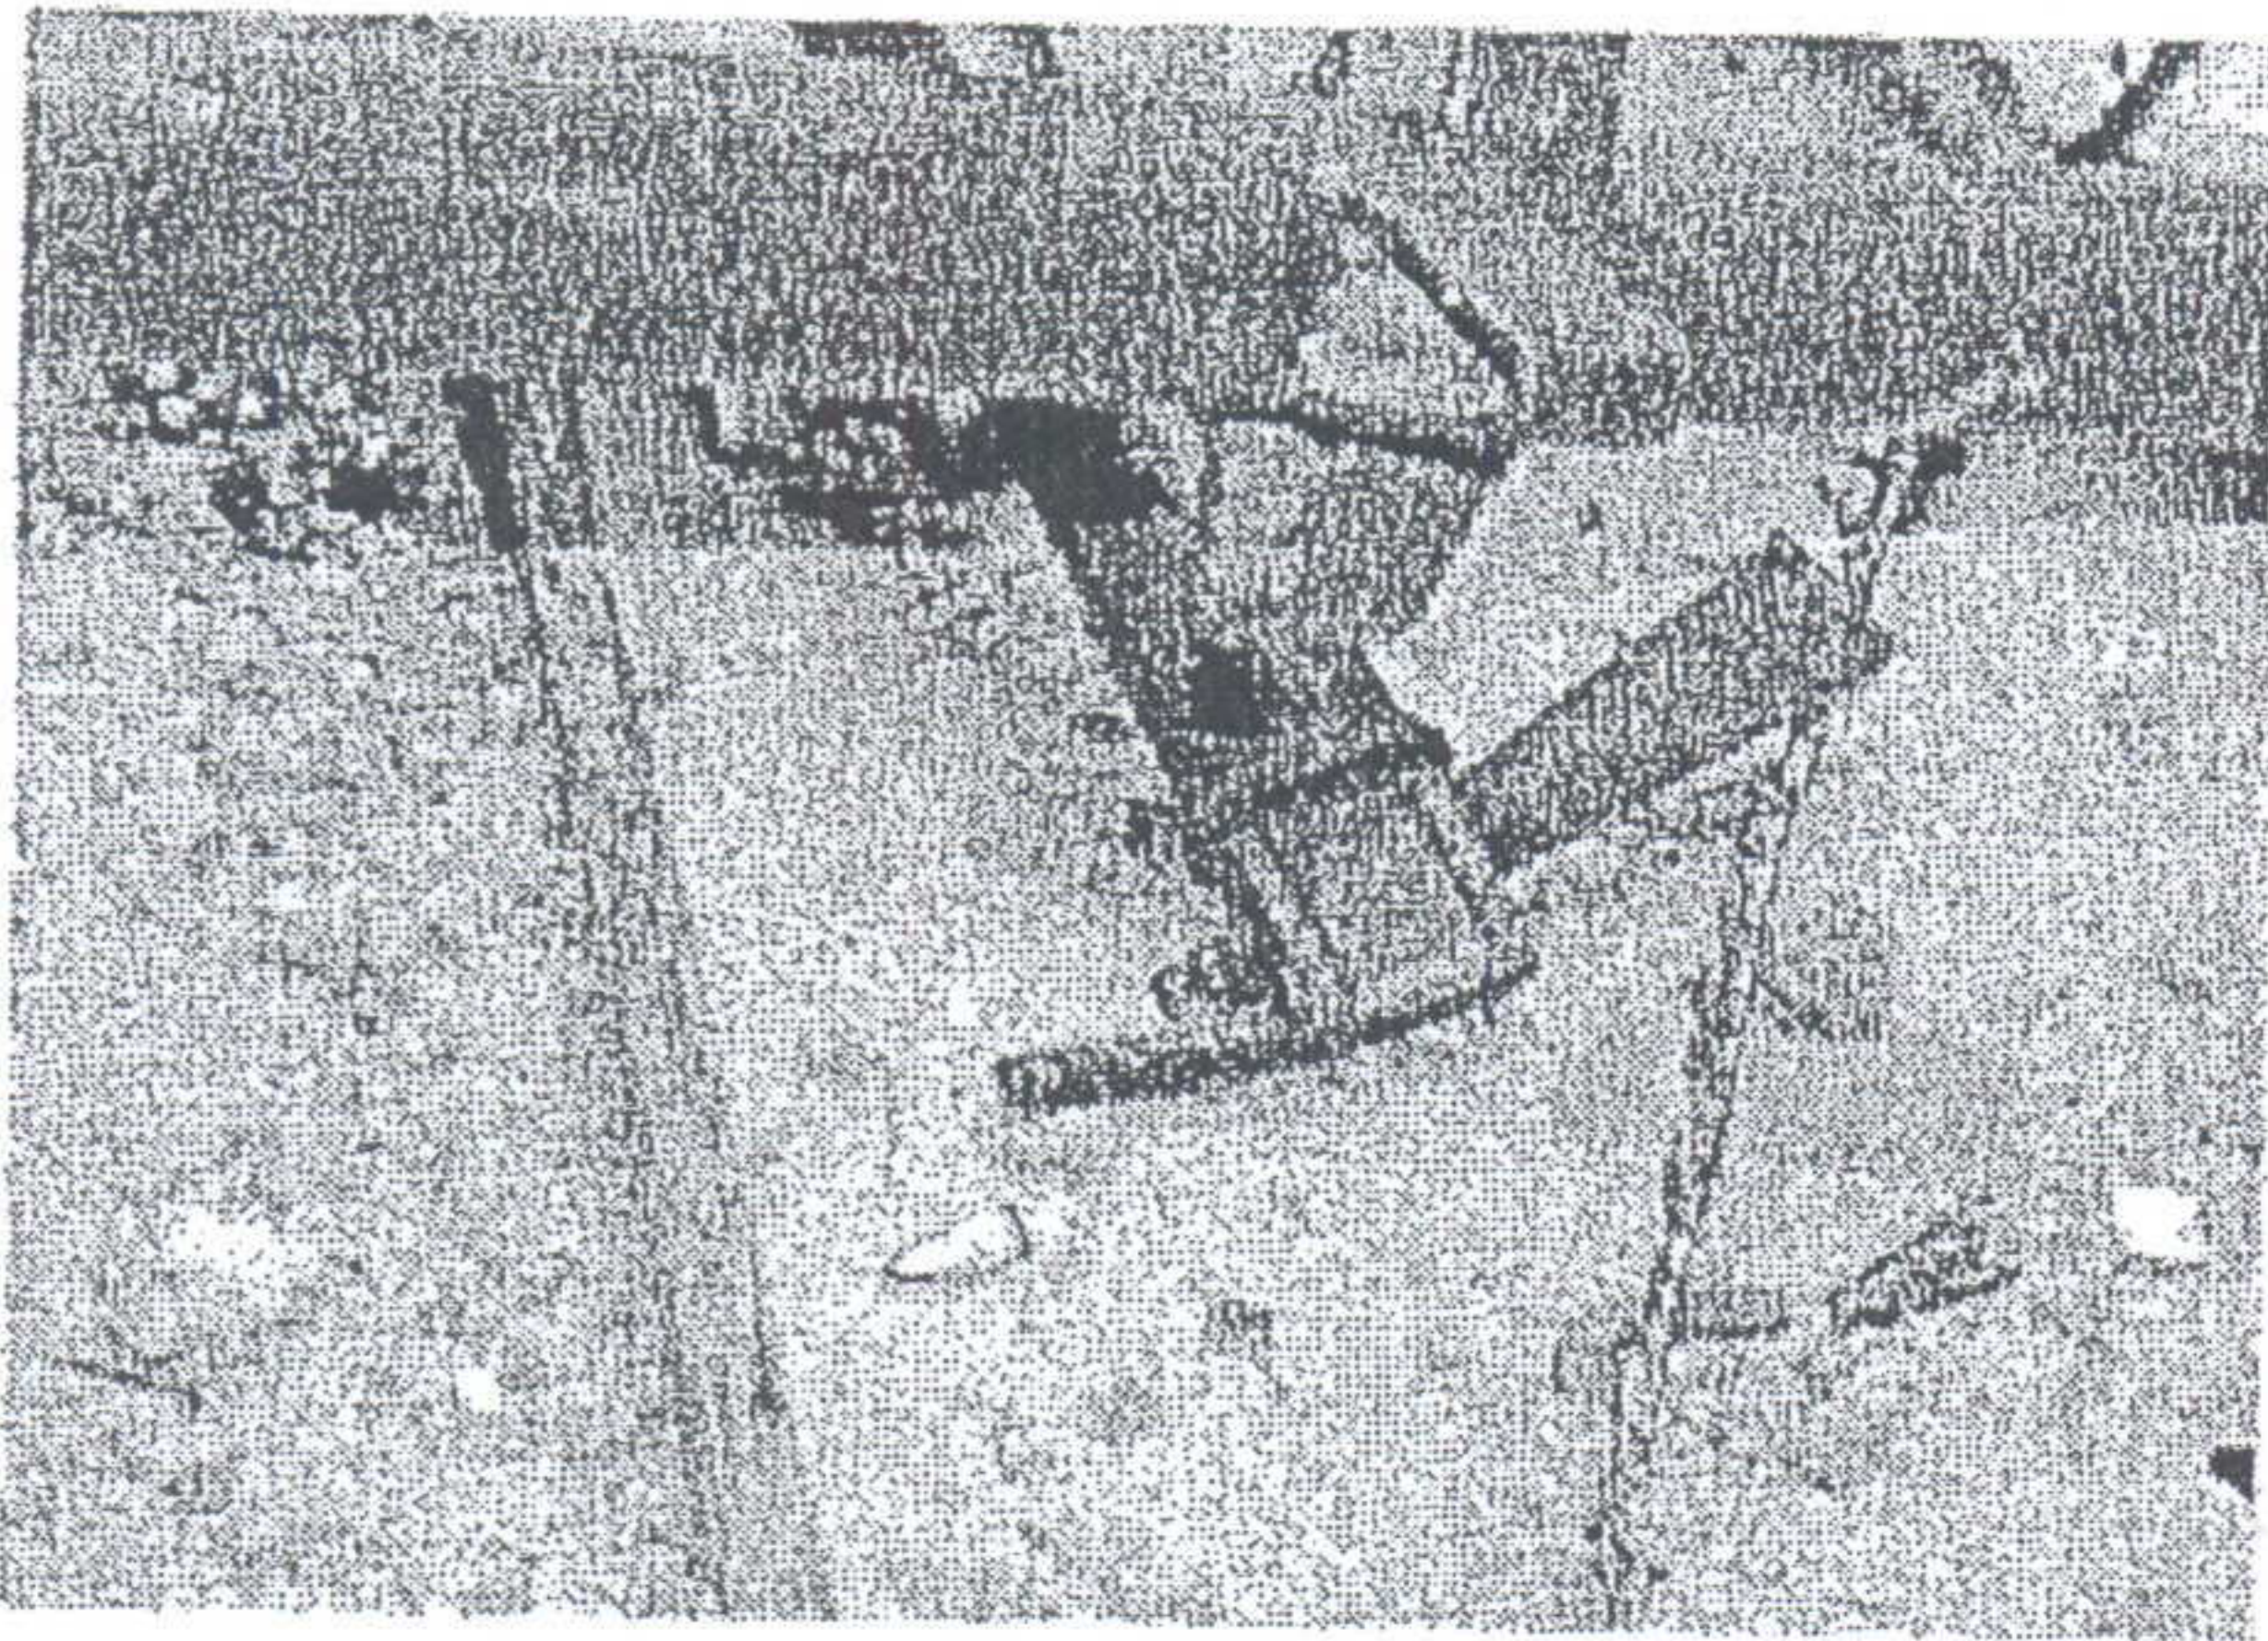
Evidence of modified end connector elements were also observed throughout the debris (see appendix I, pic. 21 to 24).

Pic. 21 Modified end connector on ledger of collapsed scaffolding. Note cut steel bar welded to end.

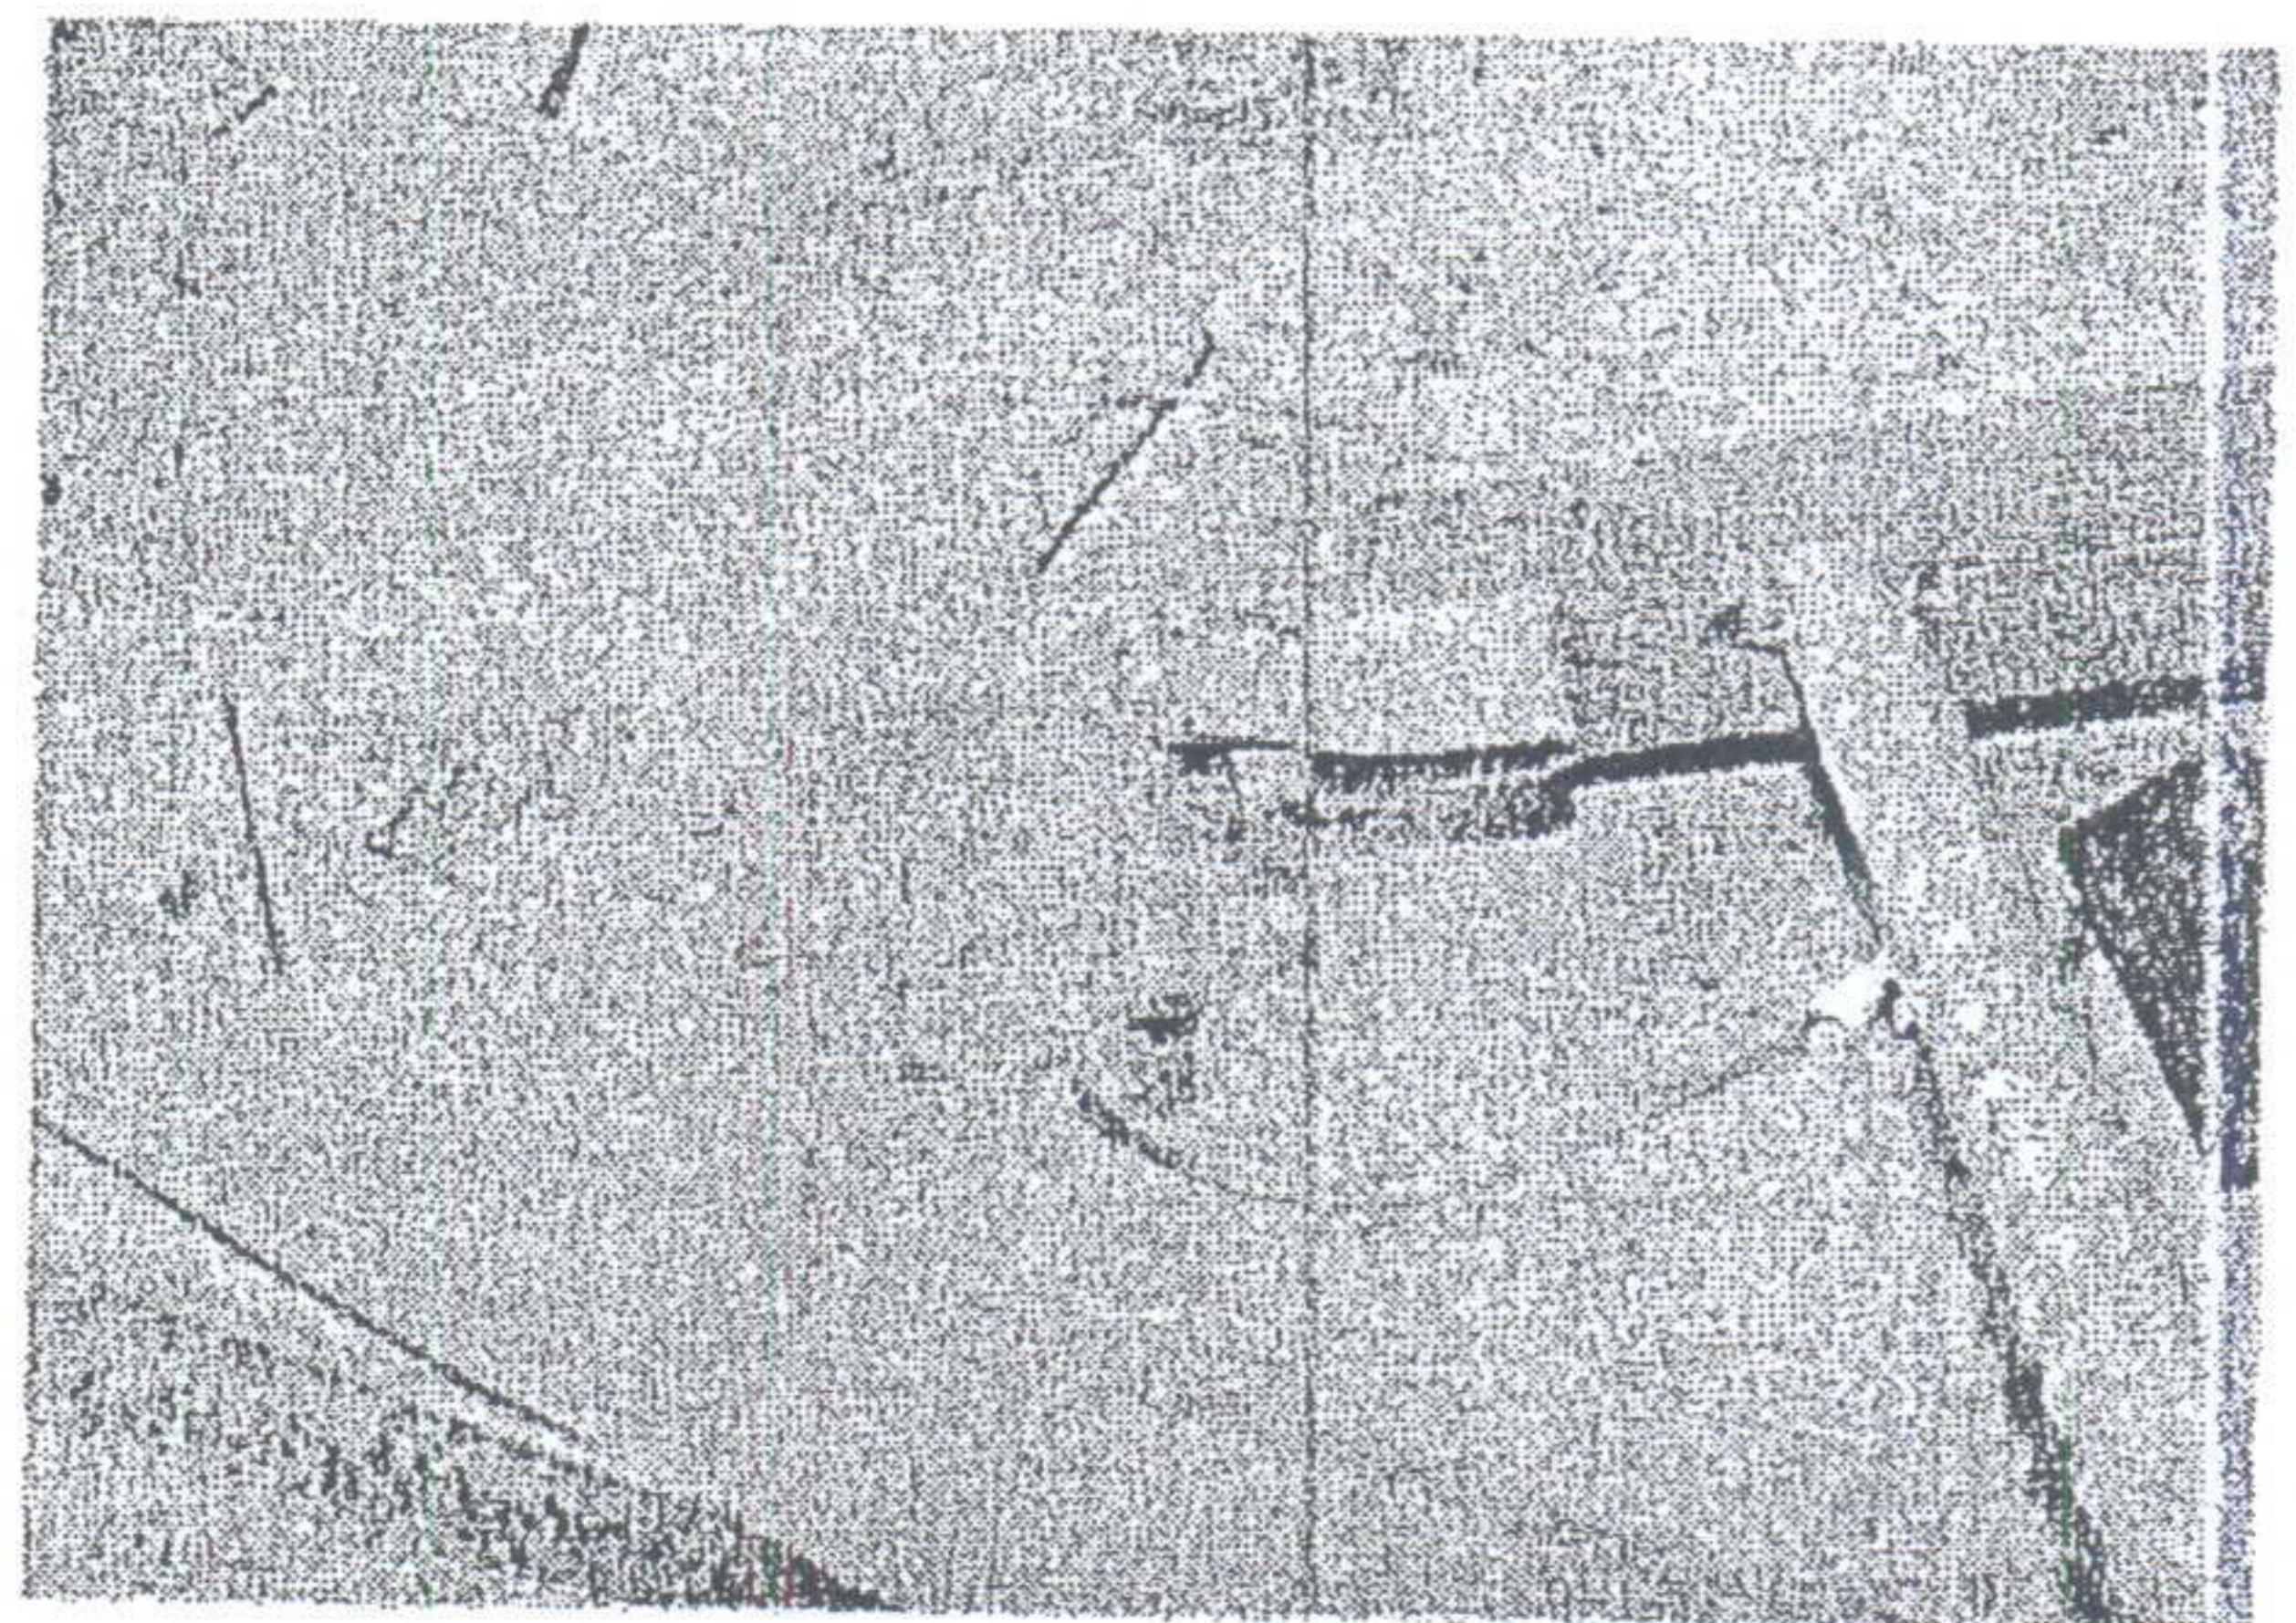
Pic. 22 Modified end connector on hop-up bracket of collapsed scaffolding. Note cut steel bar welded to end.
