# STRUCTURAL ASSESSMENT REPORT

COLLAPSE OF SCAFFOLDING, AT THE SITE OF  
THE NEW CUSTOMS & EXCISE BUILDING  
GOVERNMENT CAMPUS, RICHMOND STREET  
PORT OF SPAIN

DATED: 30<sup>TH</sup> OCTOBER, 2006

THE DESIGNS ENGINEERING BRANCH  
MINISTRY OF WORKS AND TRANSPORT

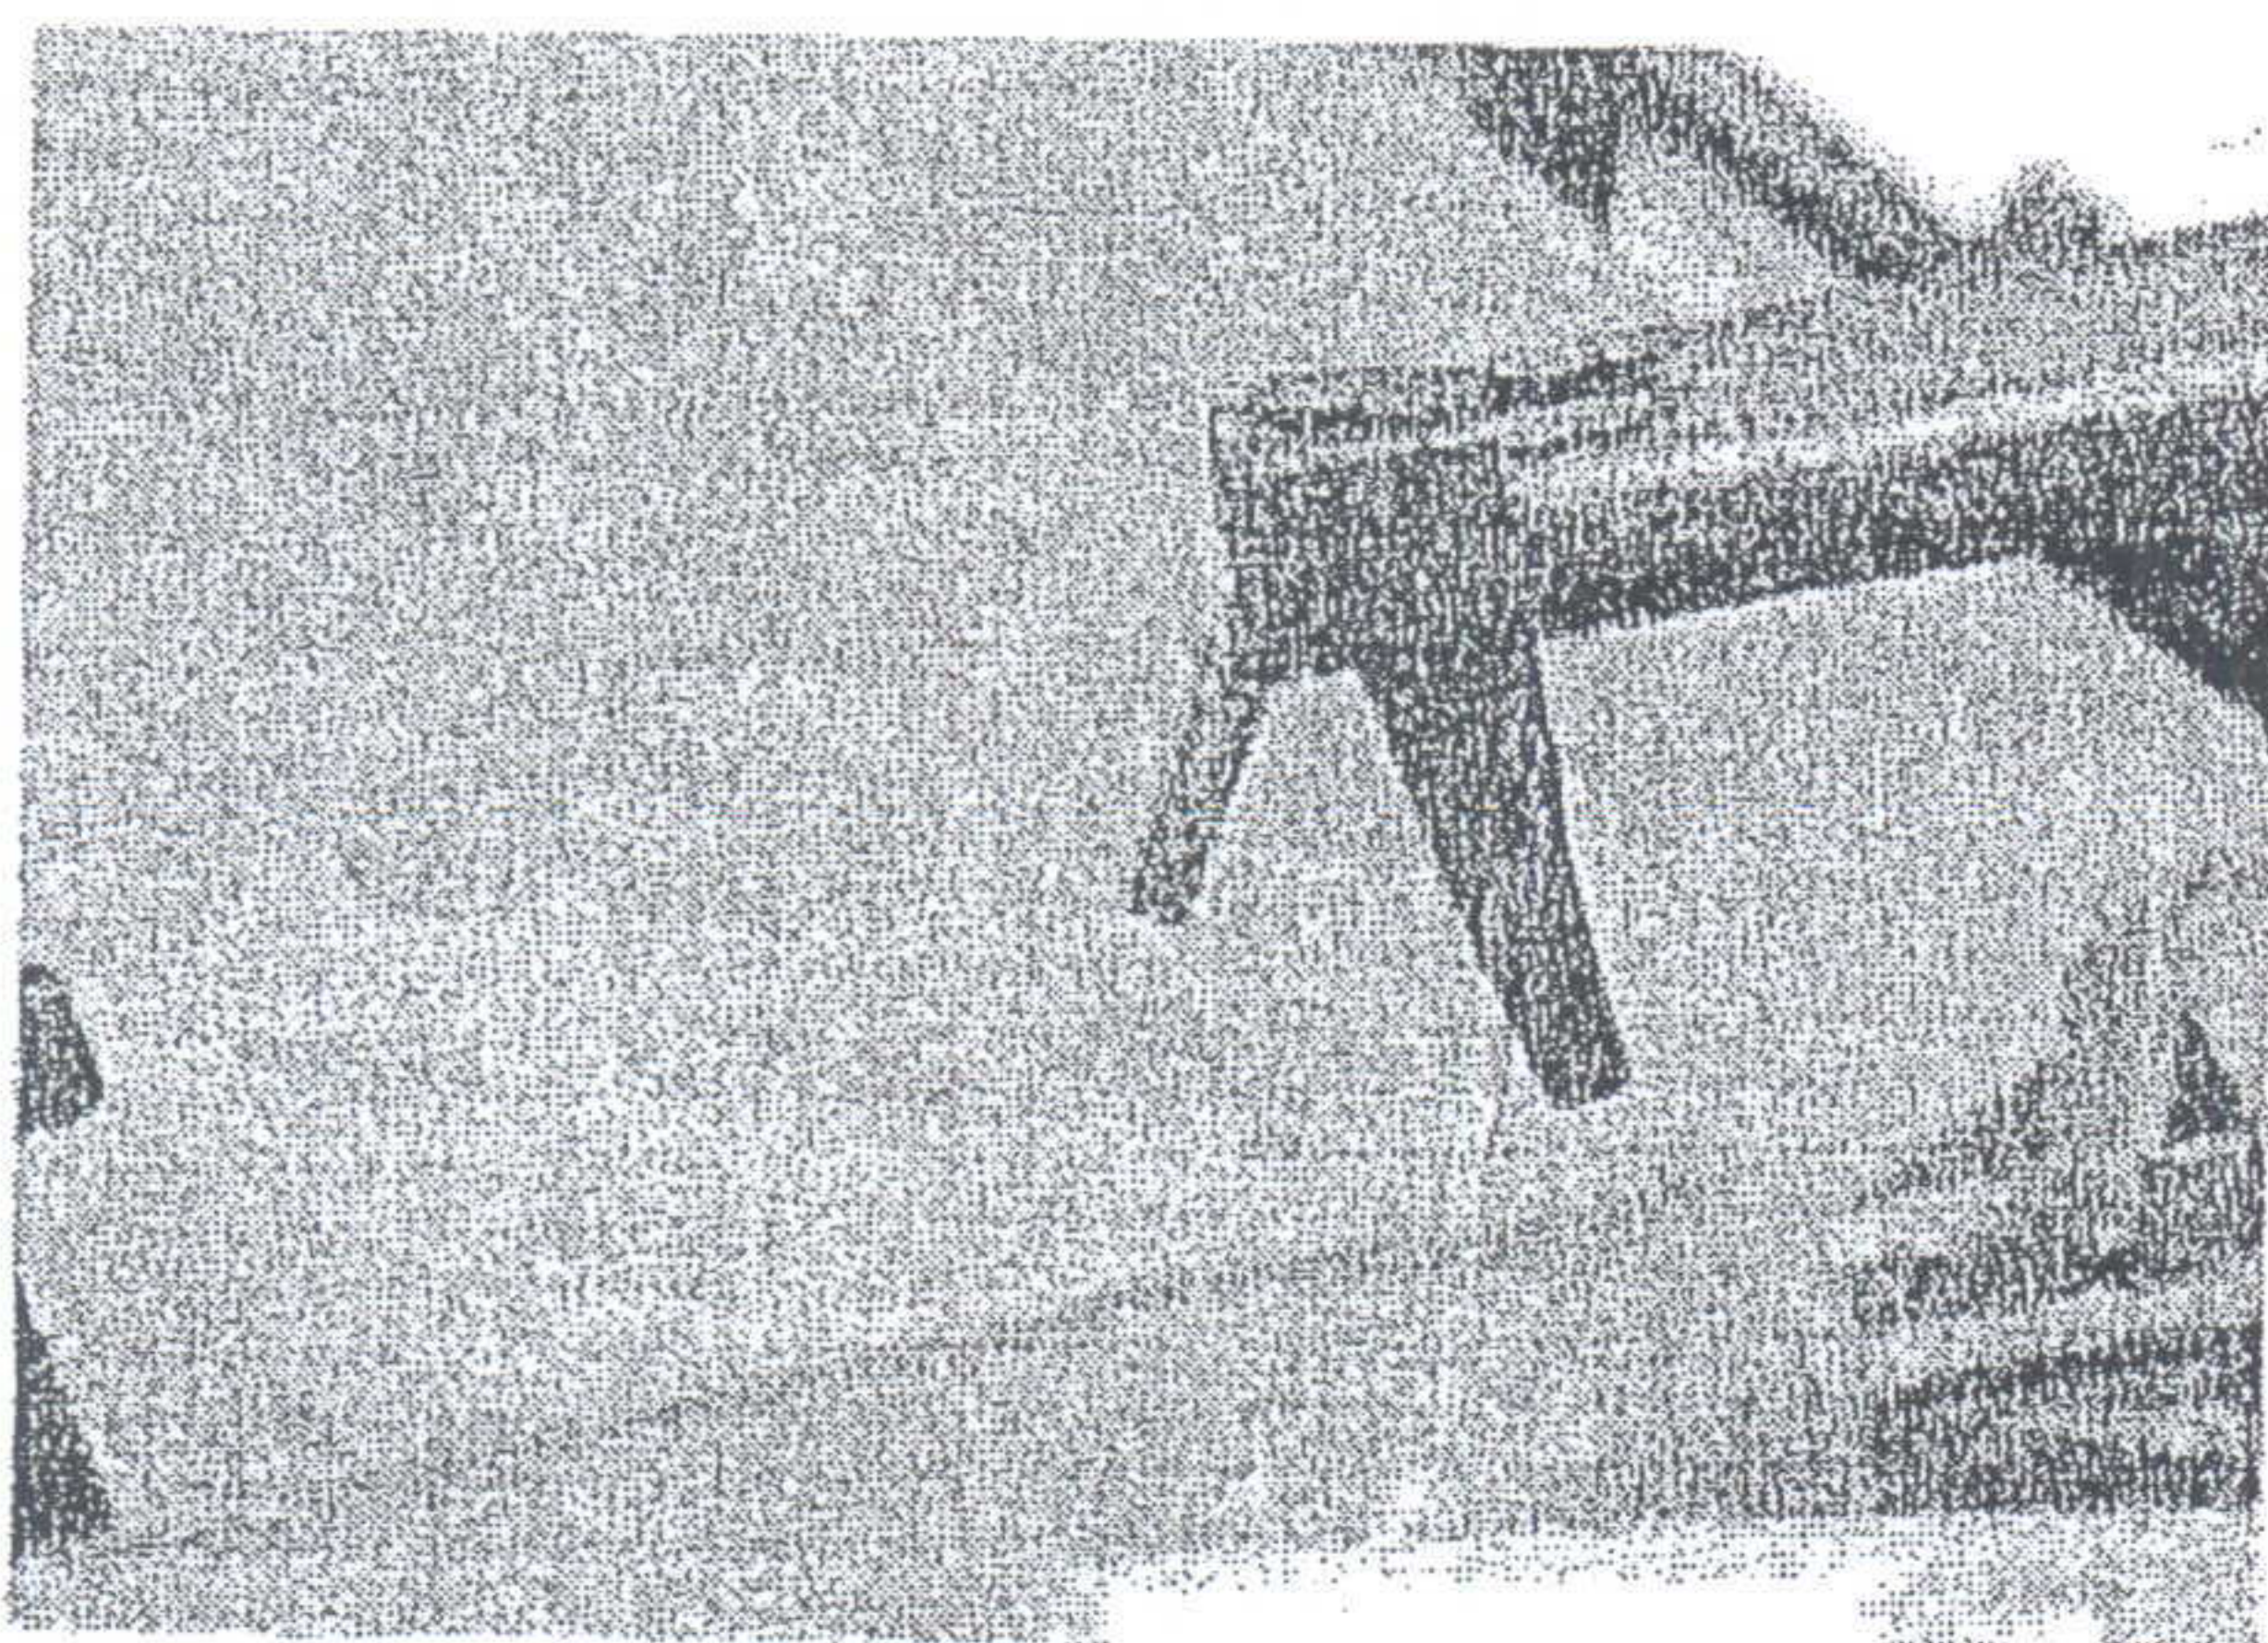
Evidence of modified end connector elements were also observed throughout the debris (see appendix I, pic. 21 to 24).

Pic. 23 Modified end connector on ledger of collapsed scaffolding. Note cut steel bar welded to end.

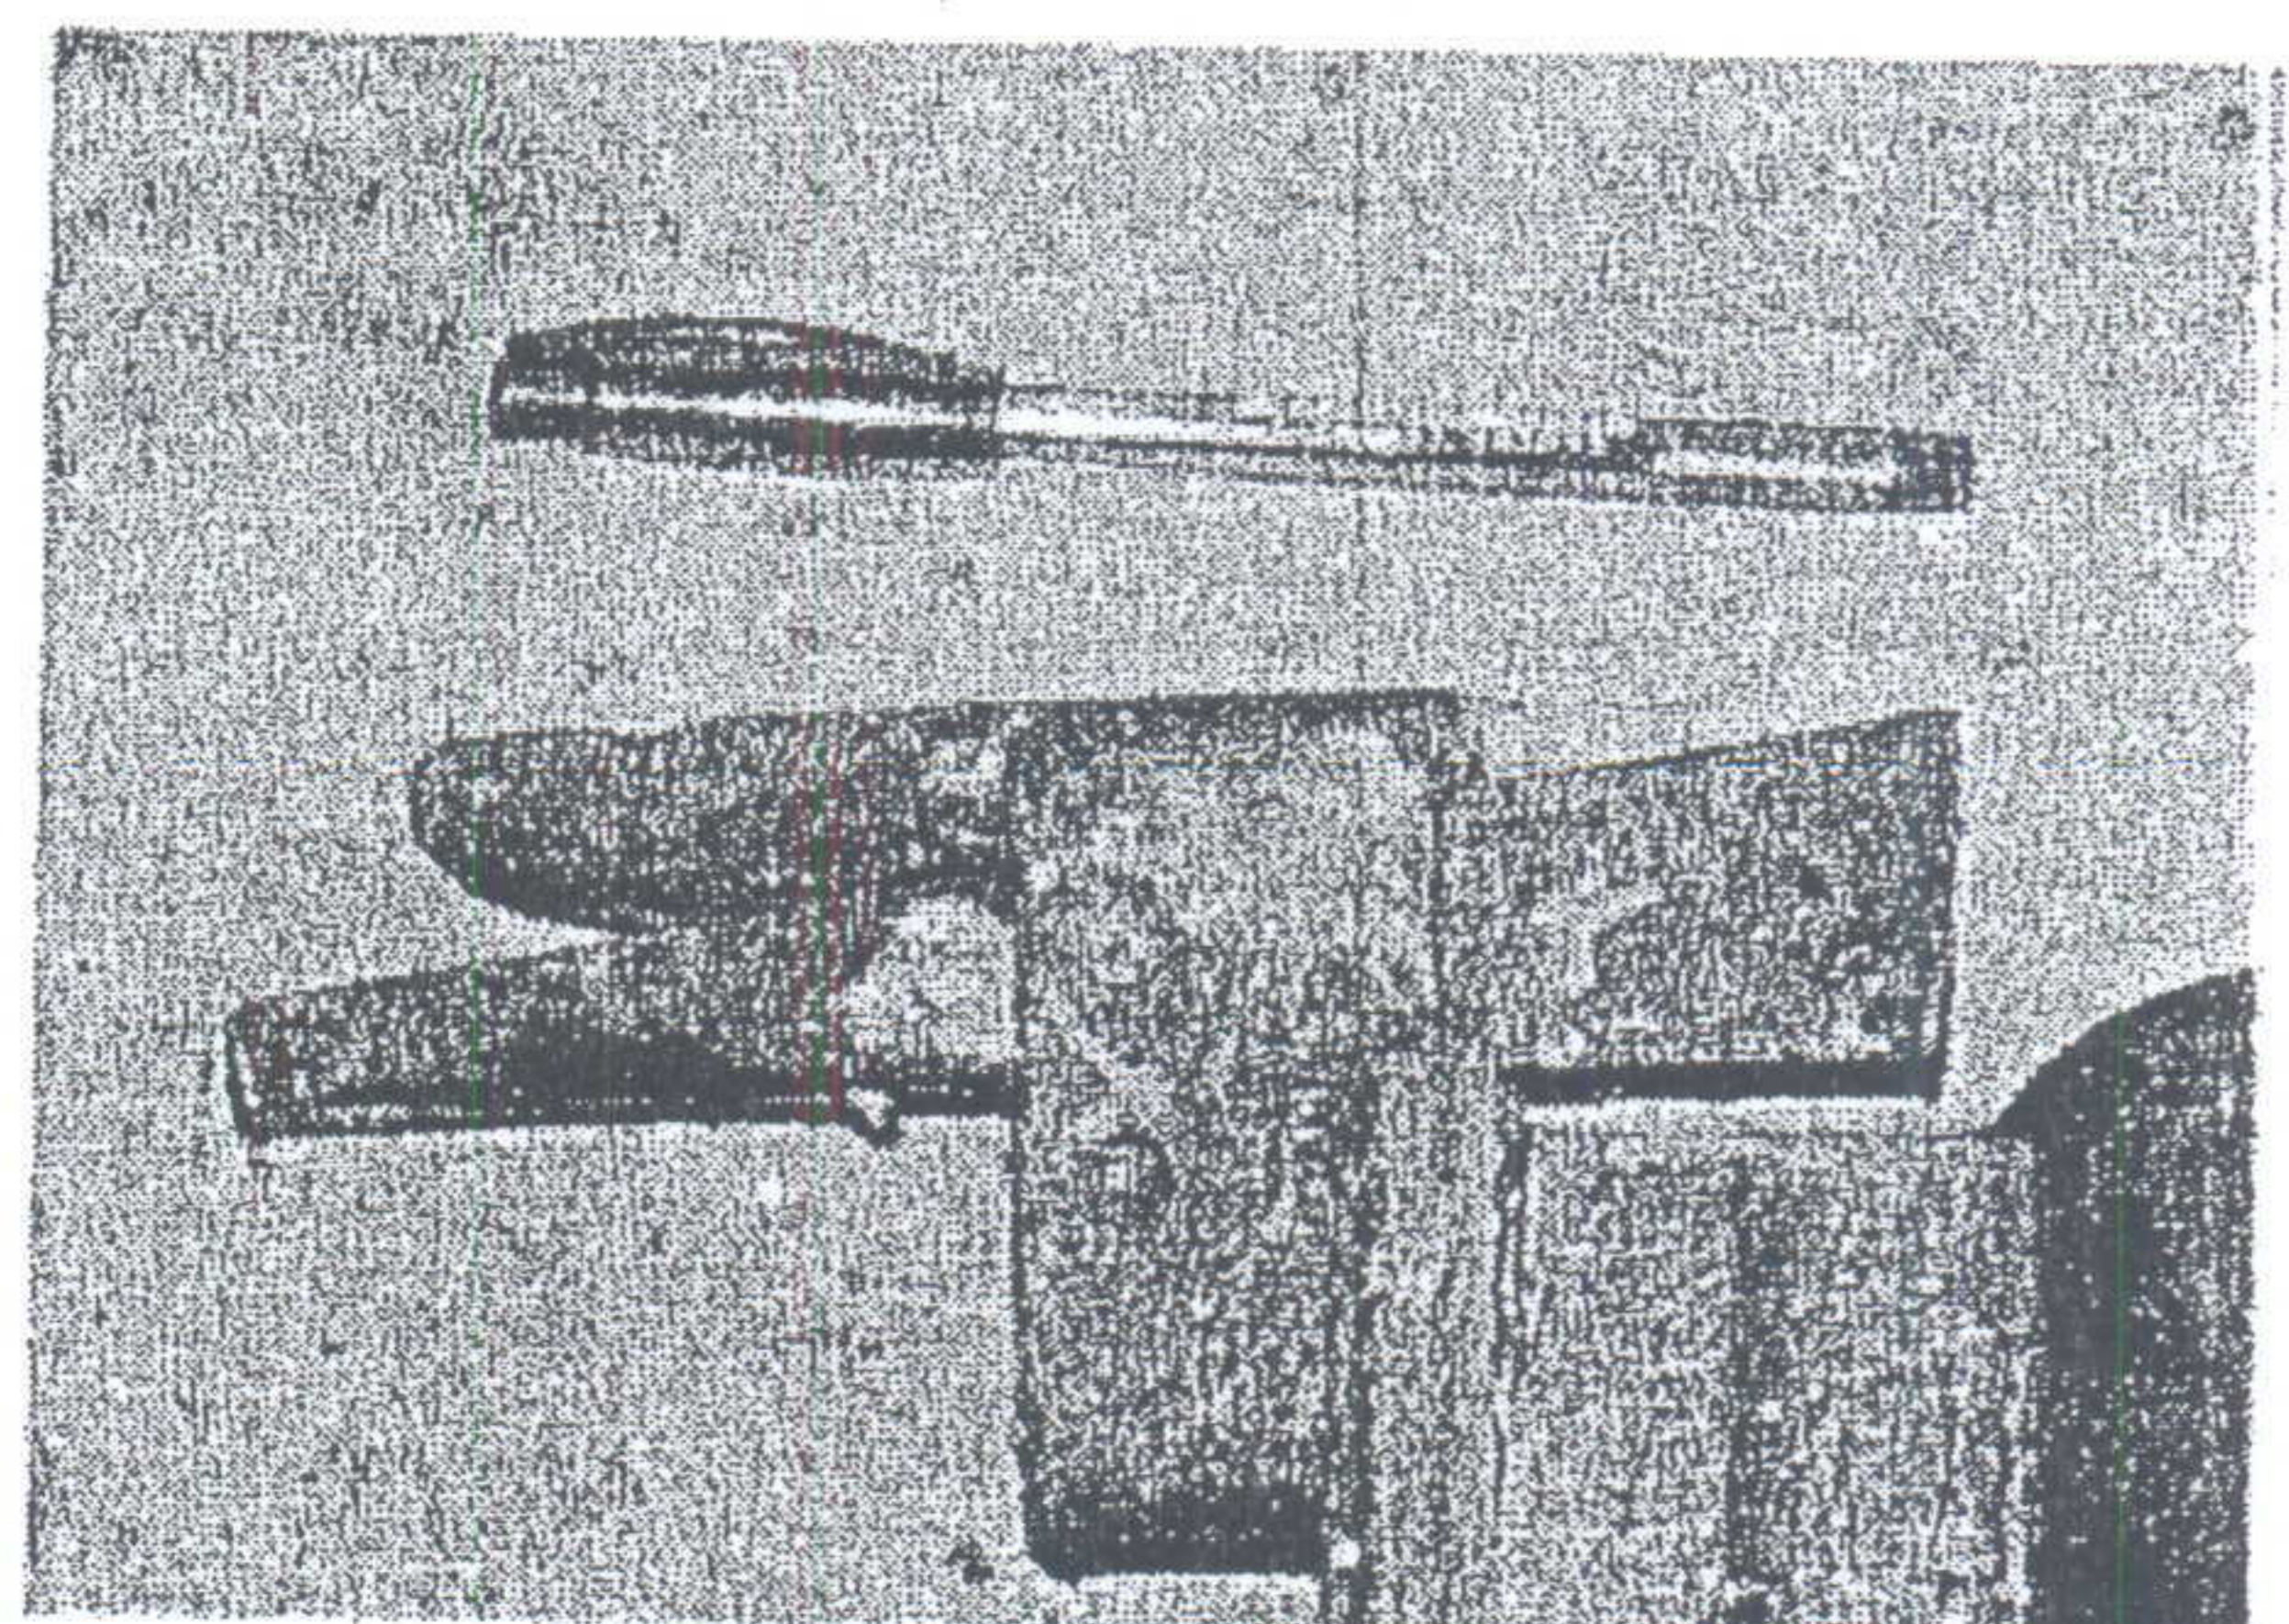
Pic. 24 Typical connector on transom of collapsed scaffolding.

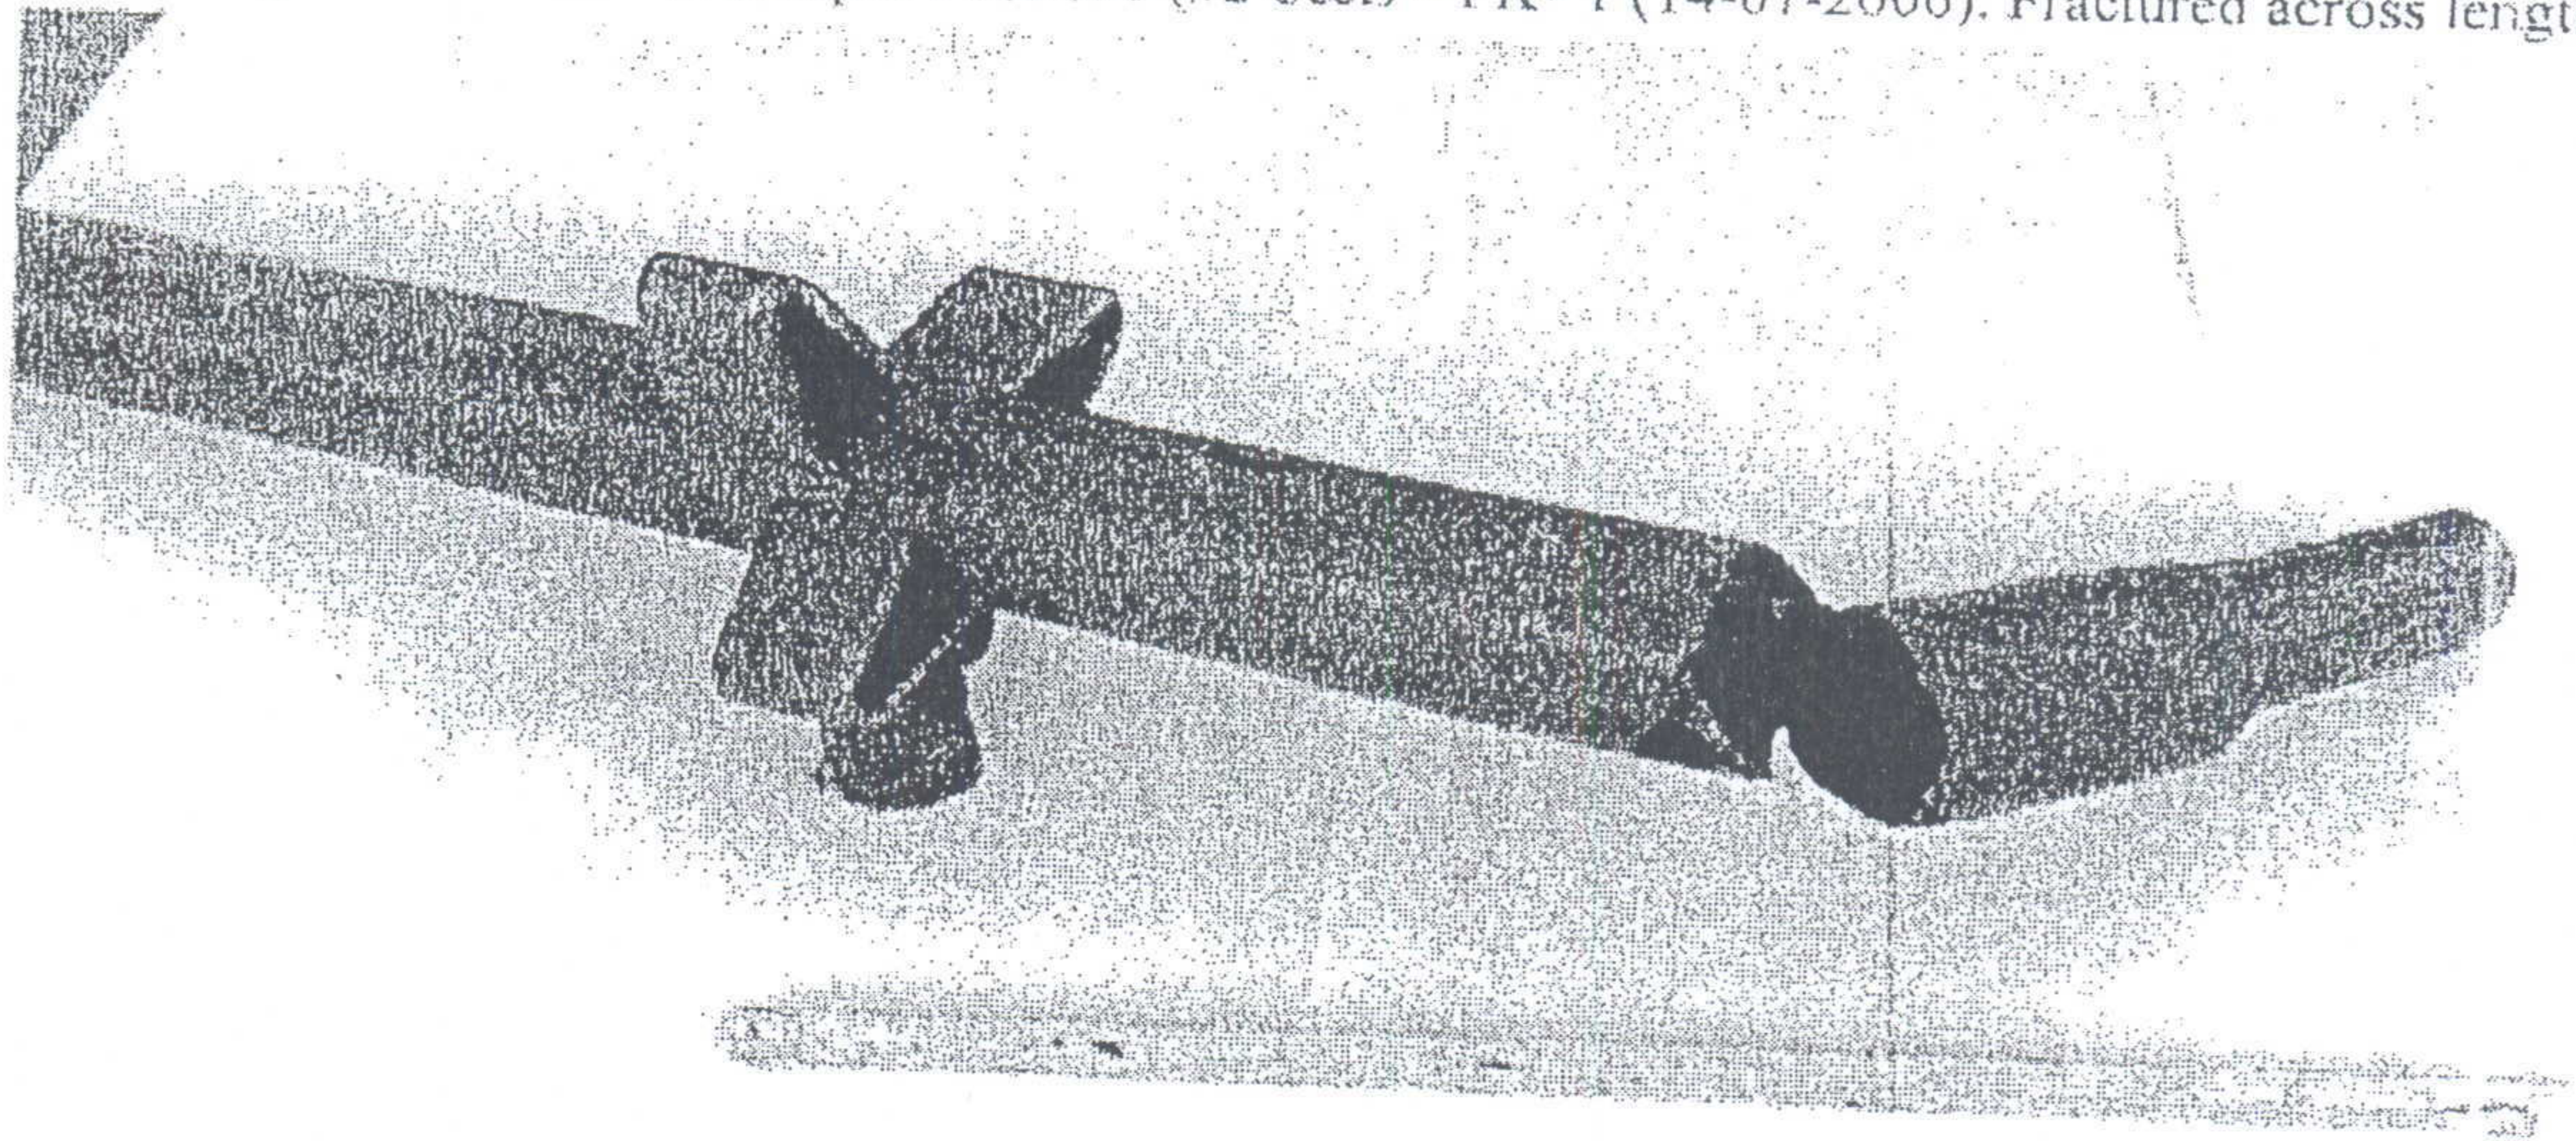
Figure 2: View of sample T065896 (#2 C&E – PK- 1 (14-07-2006). Fractured across length.

- The scaffolding pipe sample, Sample T065896 (#2 C&E - PK- 1 (14-07-2006)), shows severe corrosion on the internal surface of the pipe at the fractured section. See Figures 2, 3 and 4. The pipe has a welded patch and a metallic insert located between the main pipe and the extension. See Figure 4.
- The average wall thickness obtained in Sample T065895 is 4.09 mm. This sample did not show any signs of corrosion (internal and external) and was taken as a reference for assessing wall thickness. The fractured pipe, Sample T065896 (#2 C&E - PK- 1 (14-07-2006)) has an average thickness of 3.22

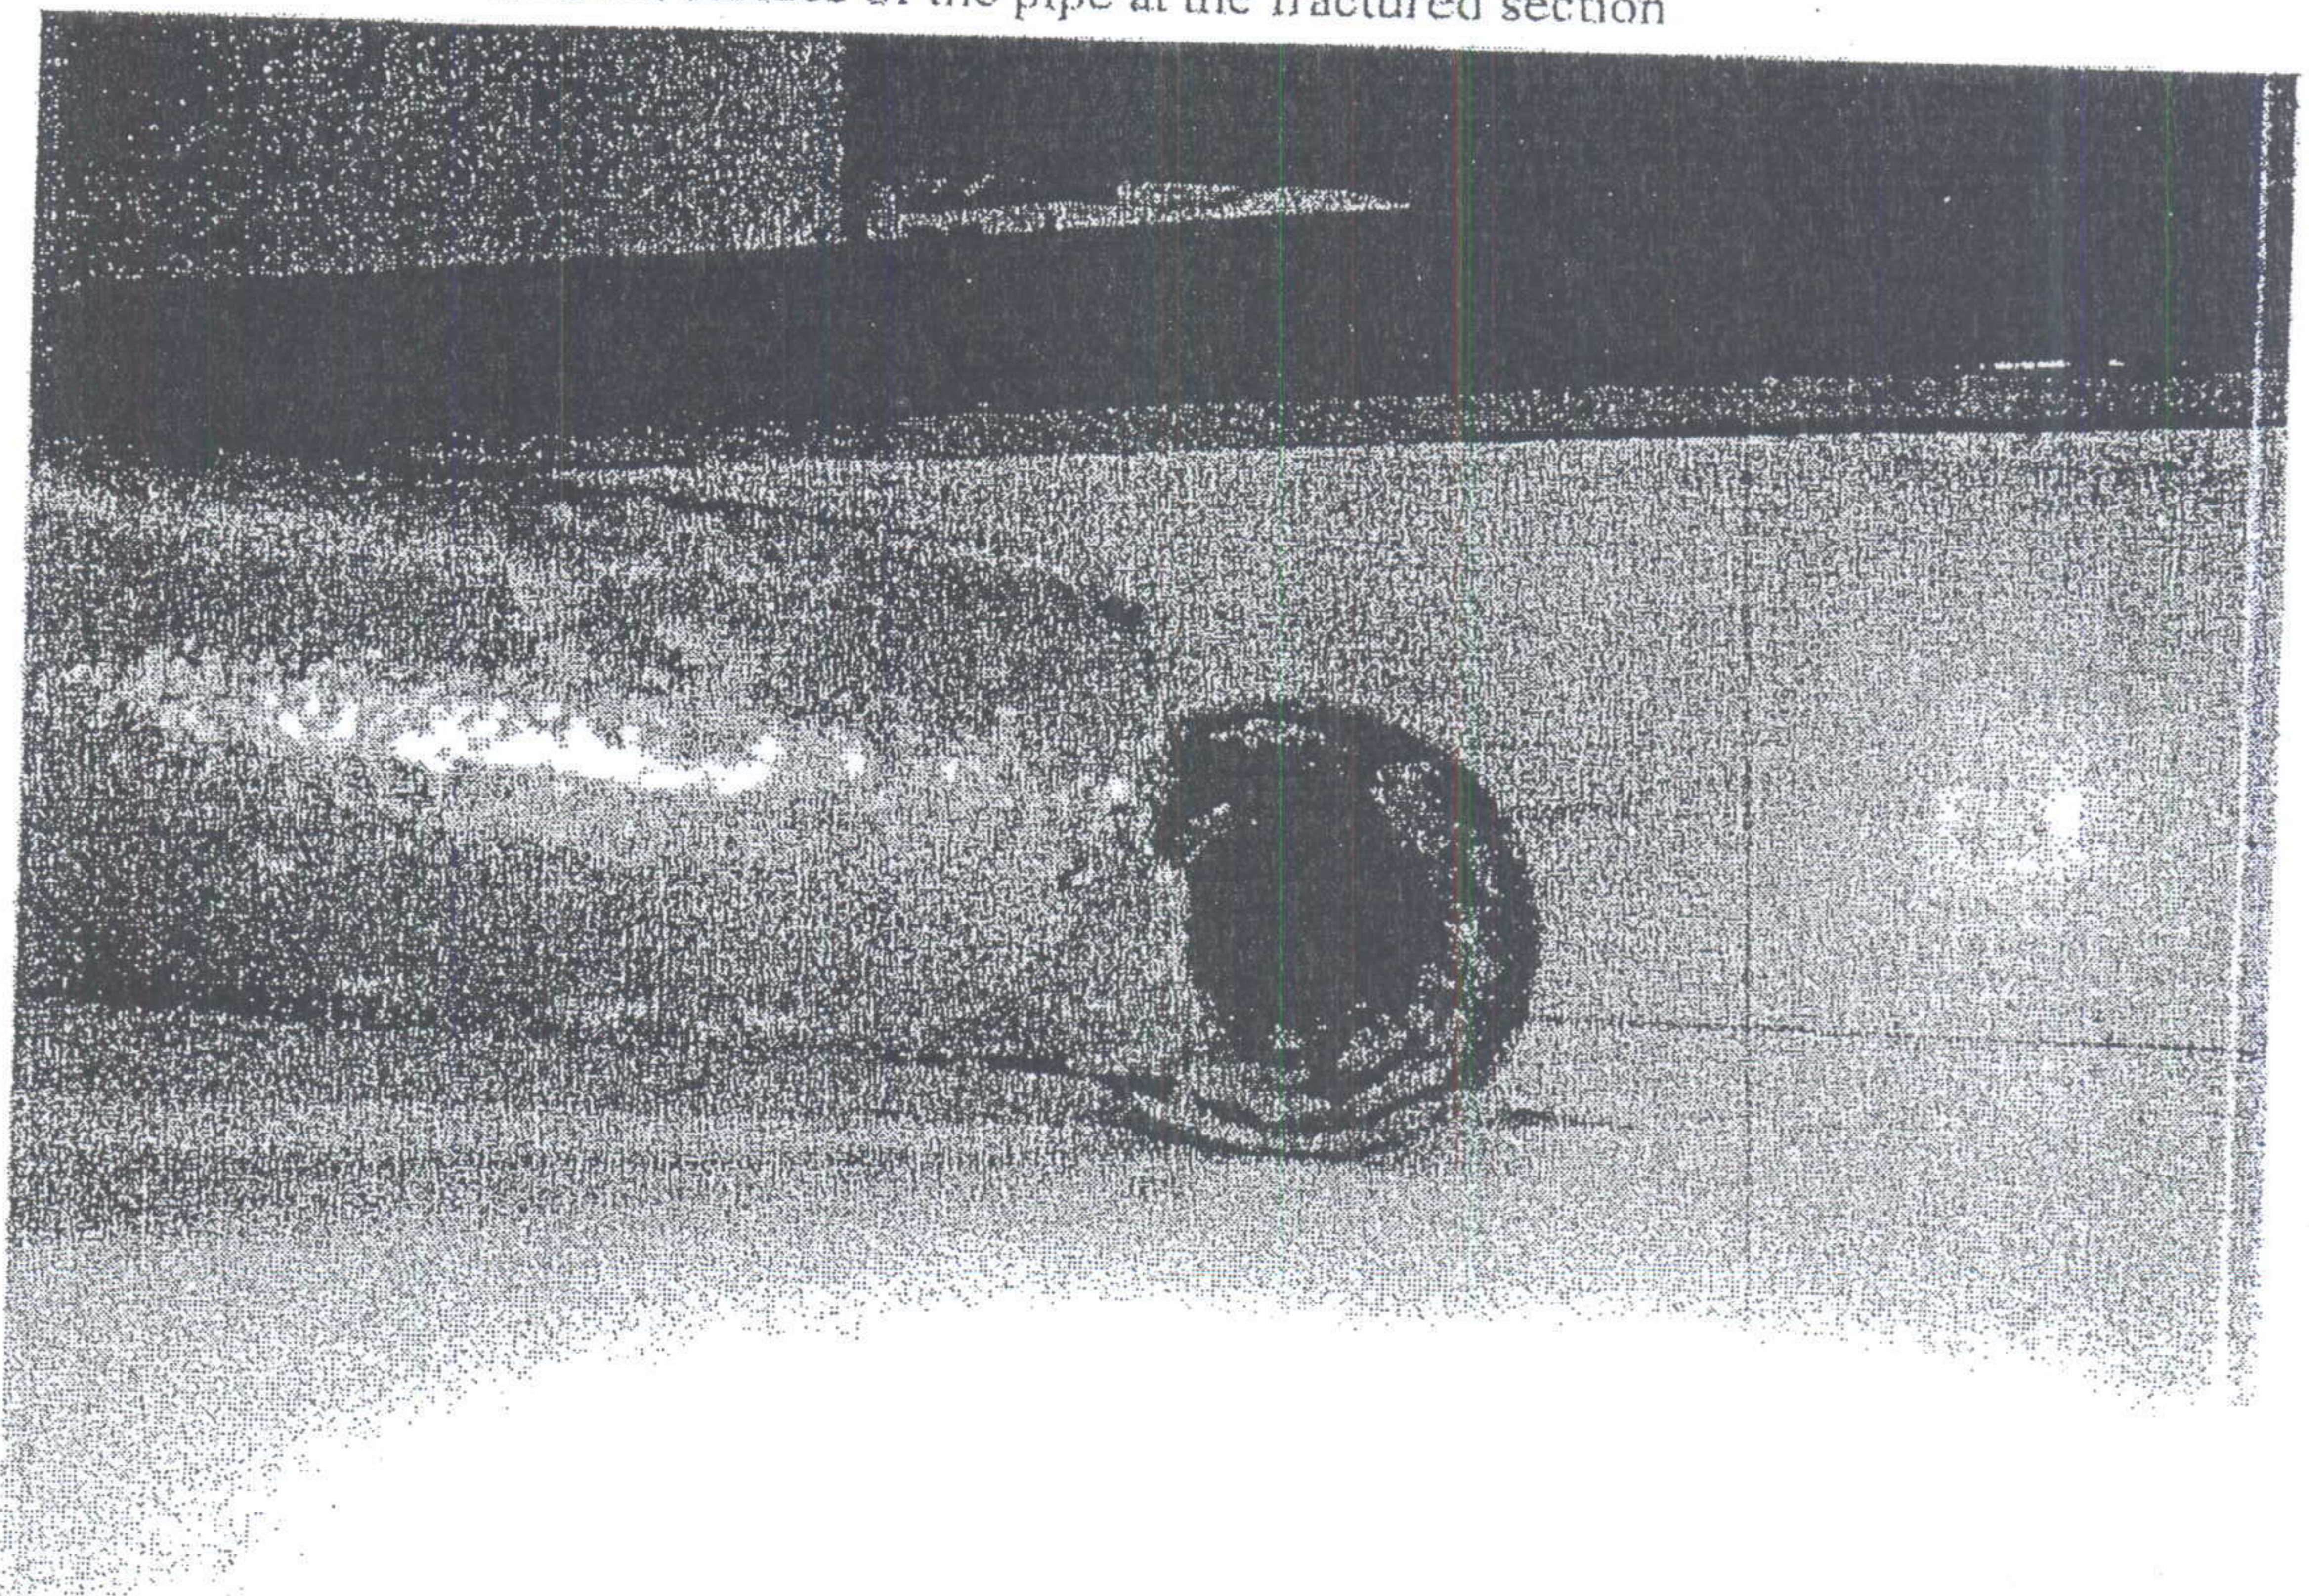
As outlined in the report on Material Testing a section of one of the samples (standard) extracted from the debris was corroded to the extent that there was a 70% reduction in wall thickness.

- i. An adverse change in the component properties resulting in localized areas of the structure being compromised (see appendix II, Figure 3. ).
- ii. An inability to attain the required fit necessary for the connector components to function as intended (see appendix IV pg. 3, "THE SYSTEM").

Figure 3: View of sample T065896 (#2 C&E – PK- 1 (14-07-2006), showing the corrosion on the internal surface of the pipe at the fractured section

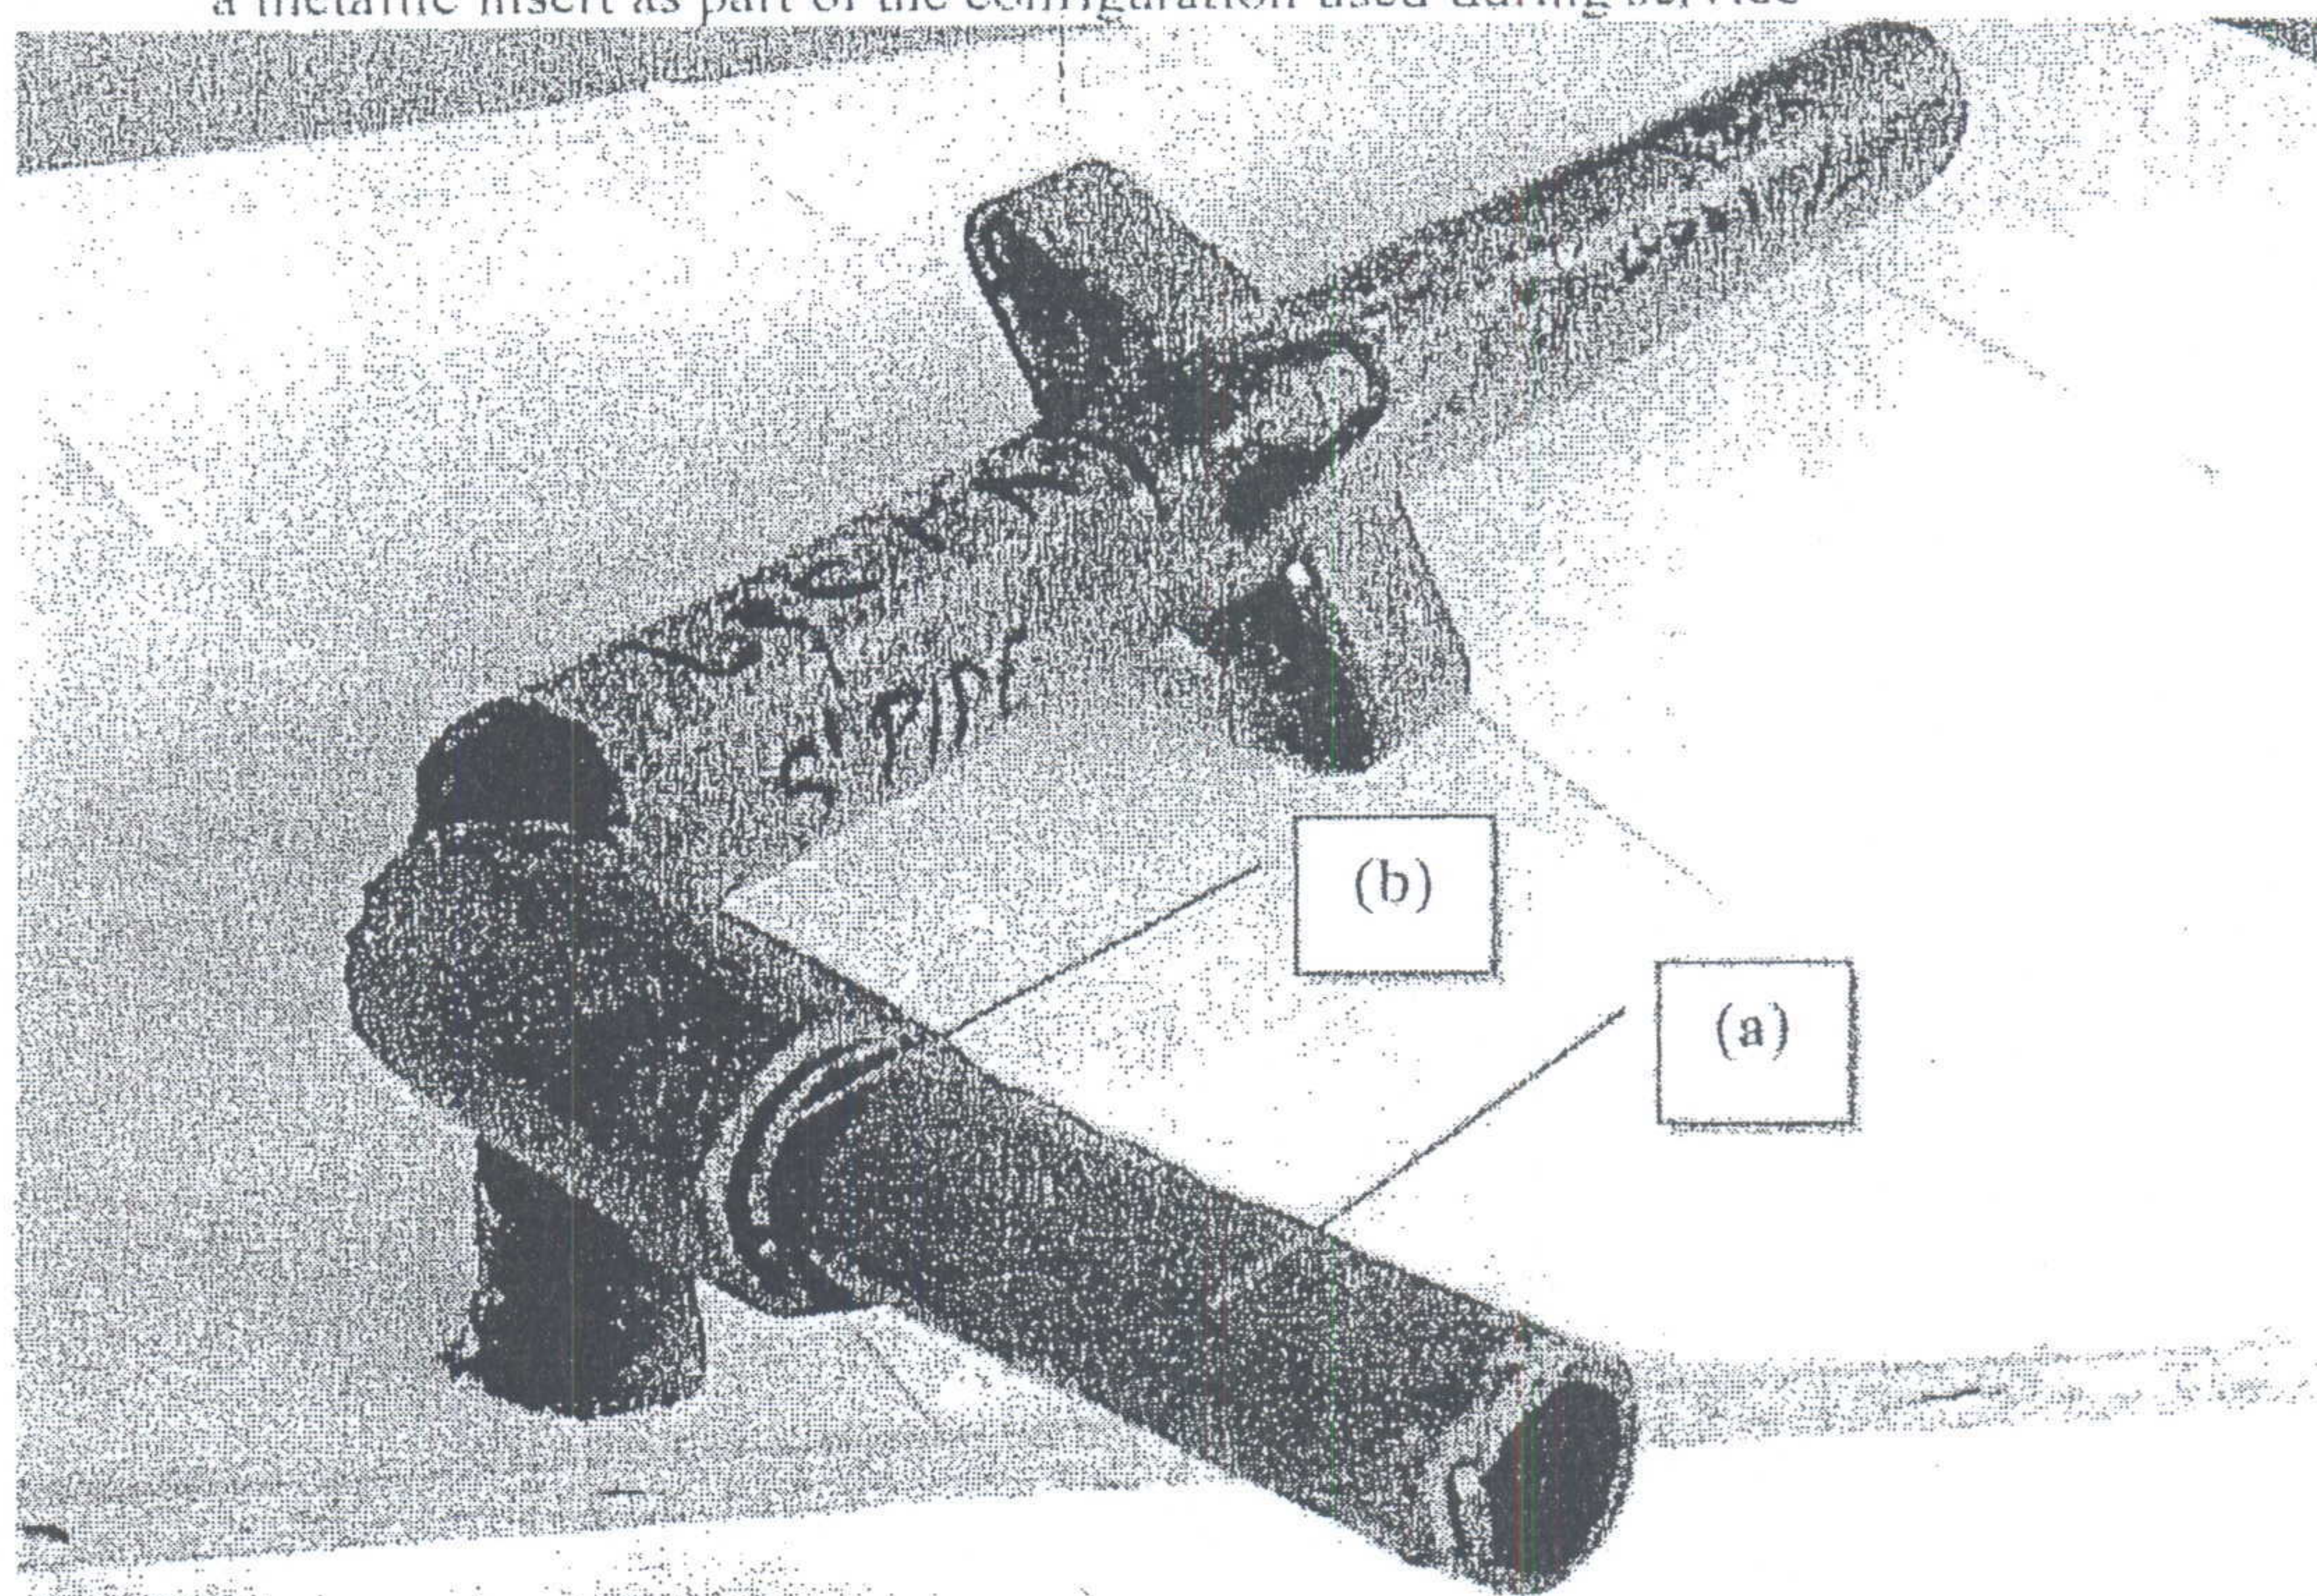
The report also indicated that this sample was modified and repaired.

Figure 4: View of sample T065896 (#2 C&E – PK- 1 (14-07-2006)), showing (a) a welded and (b) a metallic insert as part of the configuration used during service

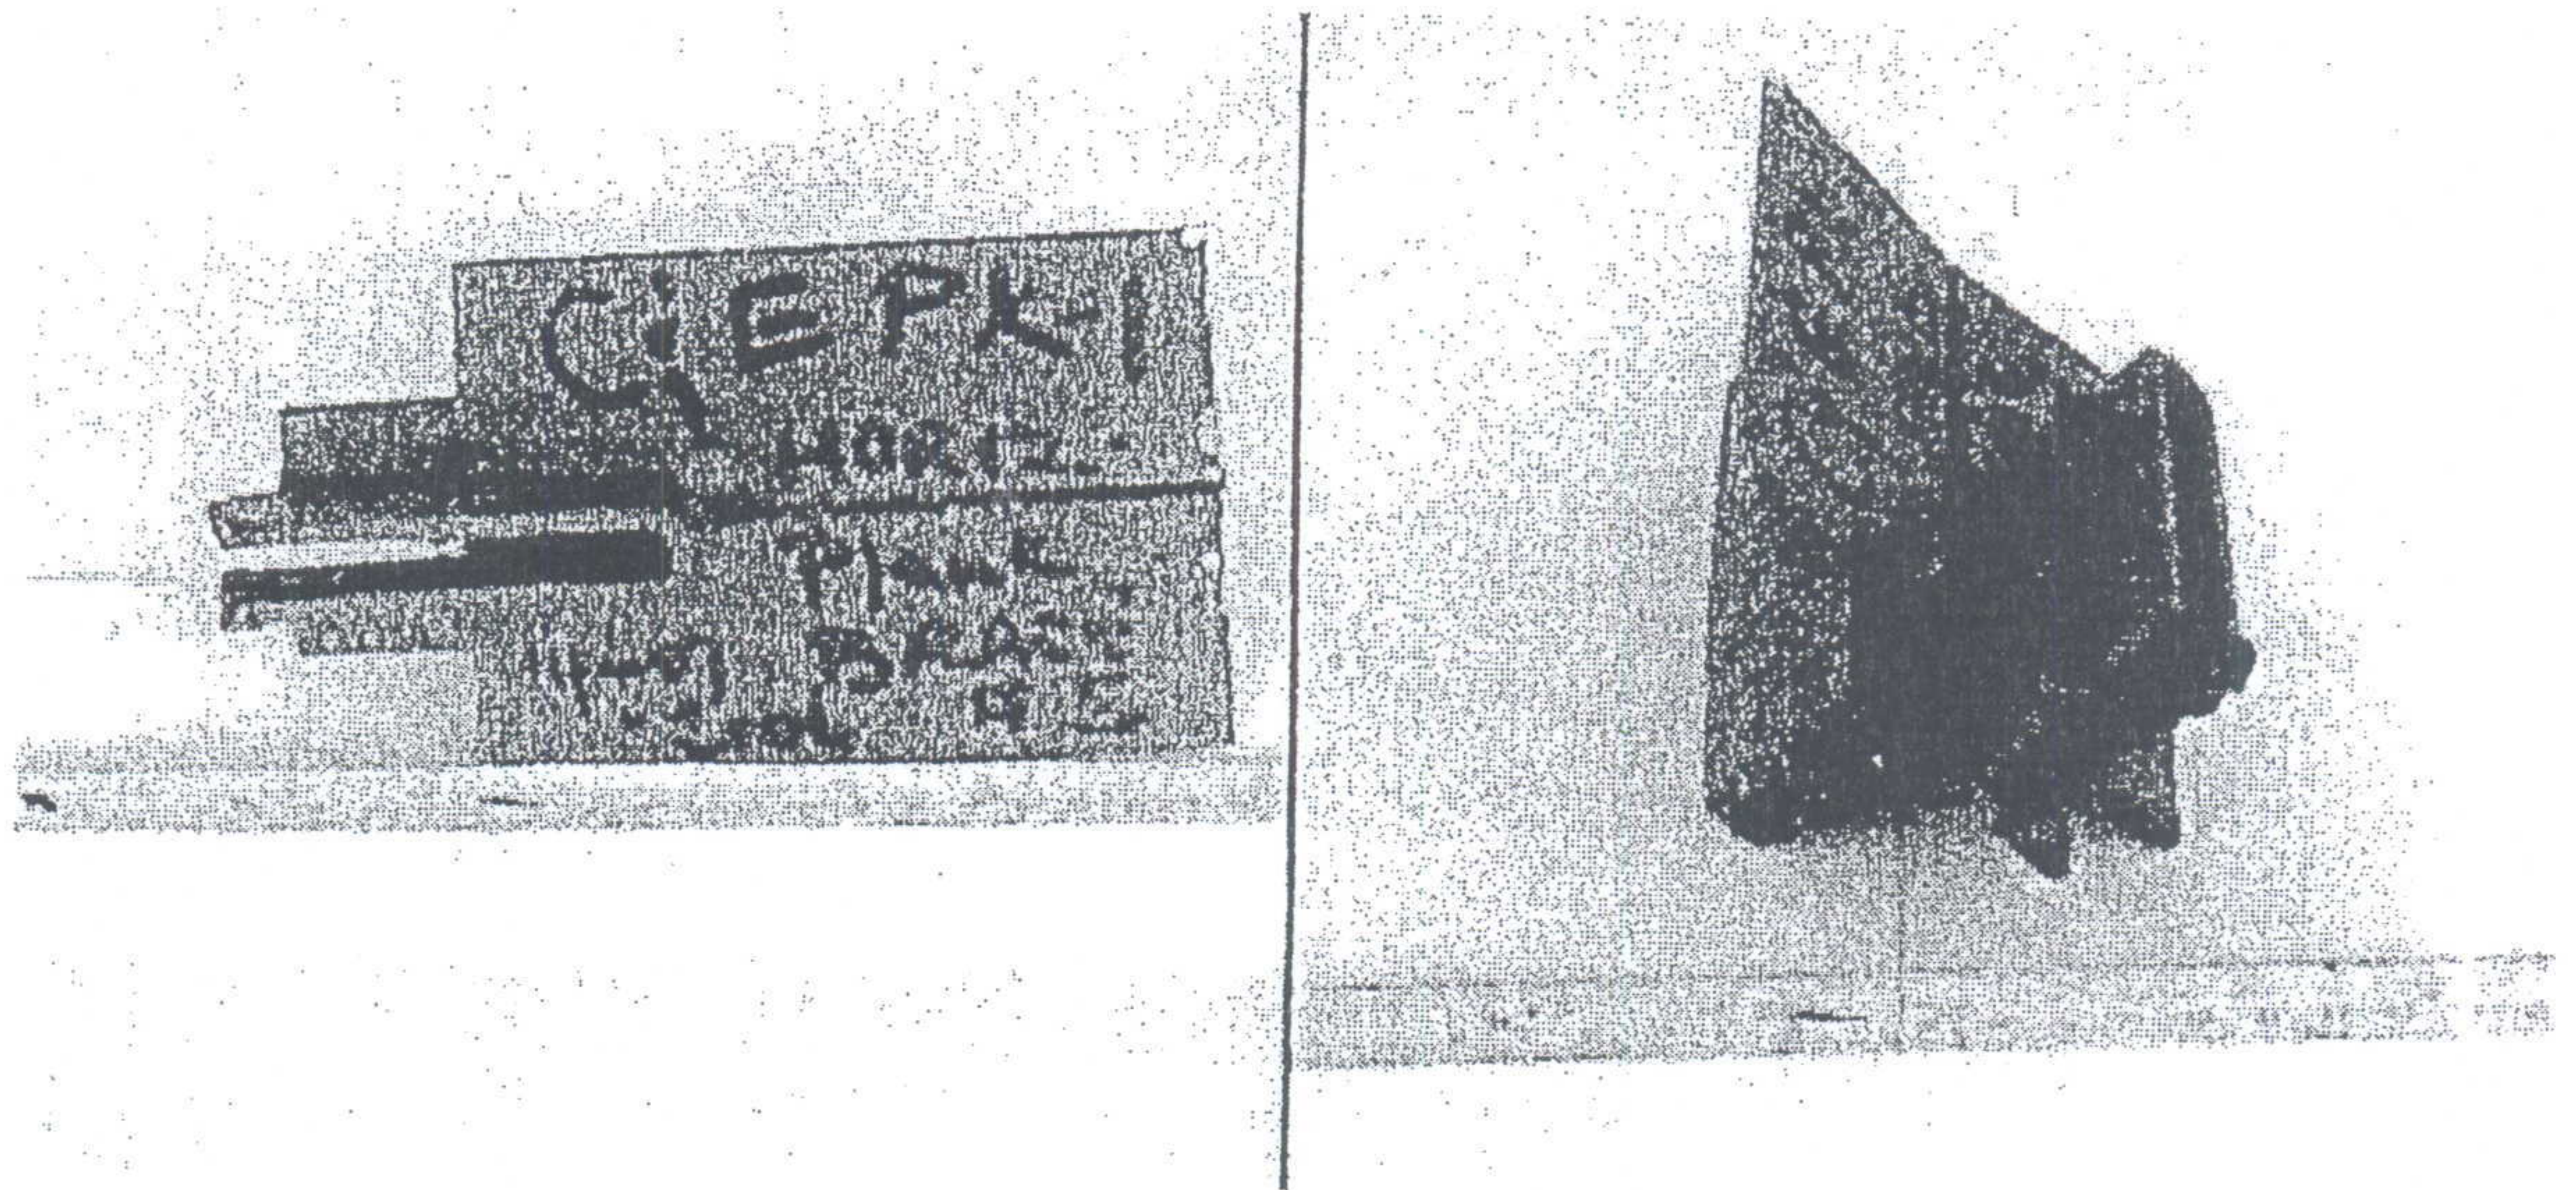
The report on material testing also found that a high level of stress was introduced during the welding operation joining rolled steel and cast metal. This sample appears to be the end connector element of a transom (double equal angles), (see appendix II, pg 4,5,6,9,10 & 11)

Figure 6: View of sample T065899 (#5 C&E - PK- 1 Horiz. Plank brace (14-07-2006)), showing the fractured brace.

- Sample T065899<sup>1</sup> (#5 C&E – PK- 1 Horiz. Plank brace (14-07-2006)) is a broken brace that contained a welded joint of rolled steel and cast metal. The weld was made by arc welding. Failure occurred at the weld. The hardness test shows a significant difference in hardness between the weld, heat affected zone (HAZ), and base metal, which indicates that a high level of stress was introduced at this location through the welding operation.
