# STRUCTURAL ASSESSMENT REPORT

COLLAPSE OF SCAFFOLDING, AT THE SITE OF  
THE NEW CUSTOMS & EXCISE BUILDING  
GOVERNMENT CAMPUS, RICHMOND STREET  
PORT OF SPAIN

DATED: 30<sup>TH</sup> OCTOBER, 2006

THE DESIGNS ENGINEERING BRANCH  
MINISTRY OF WORKS AND TRANSPORT

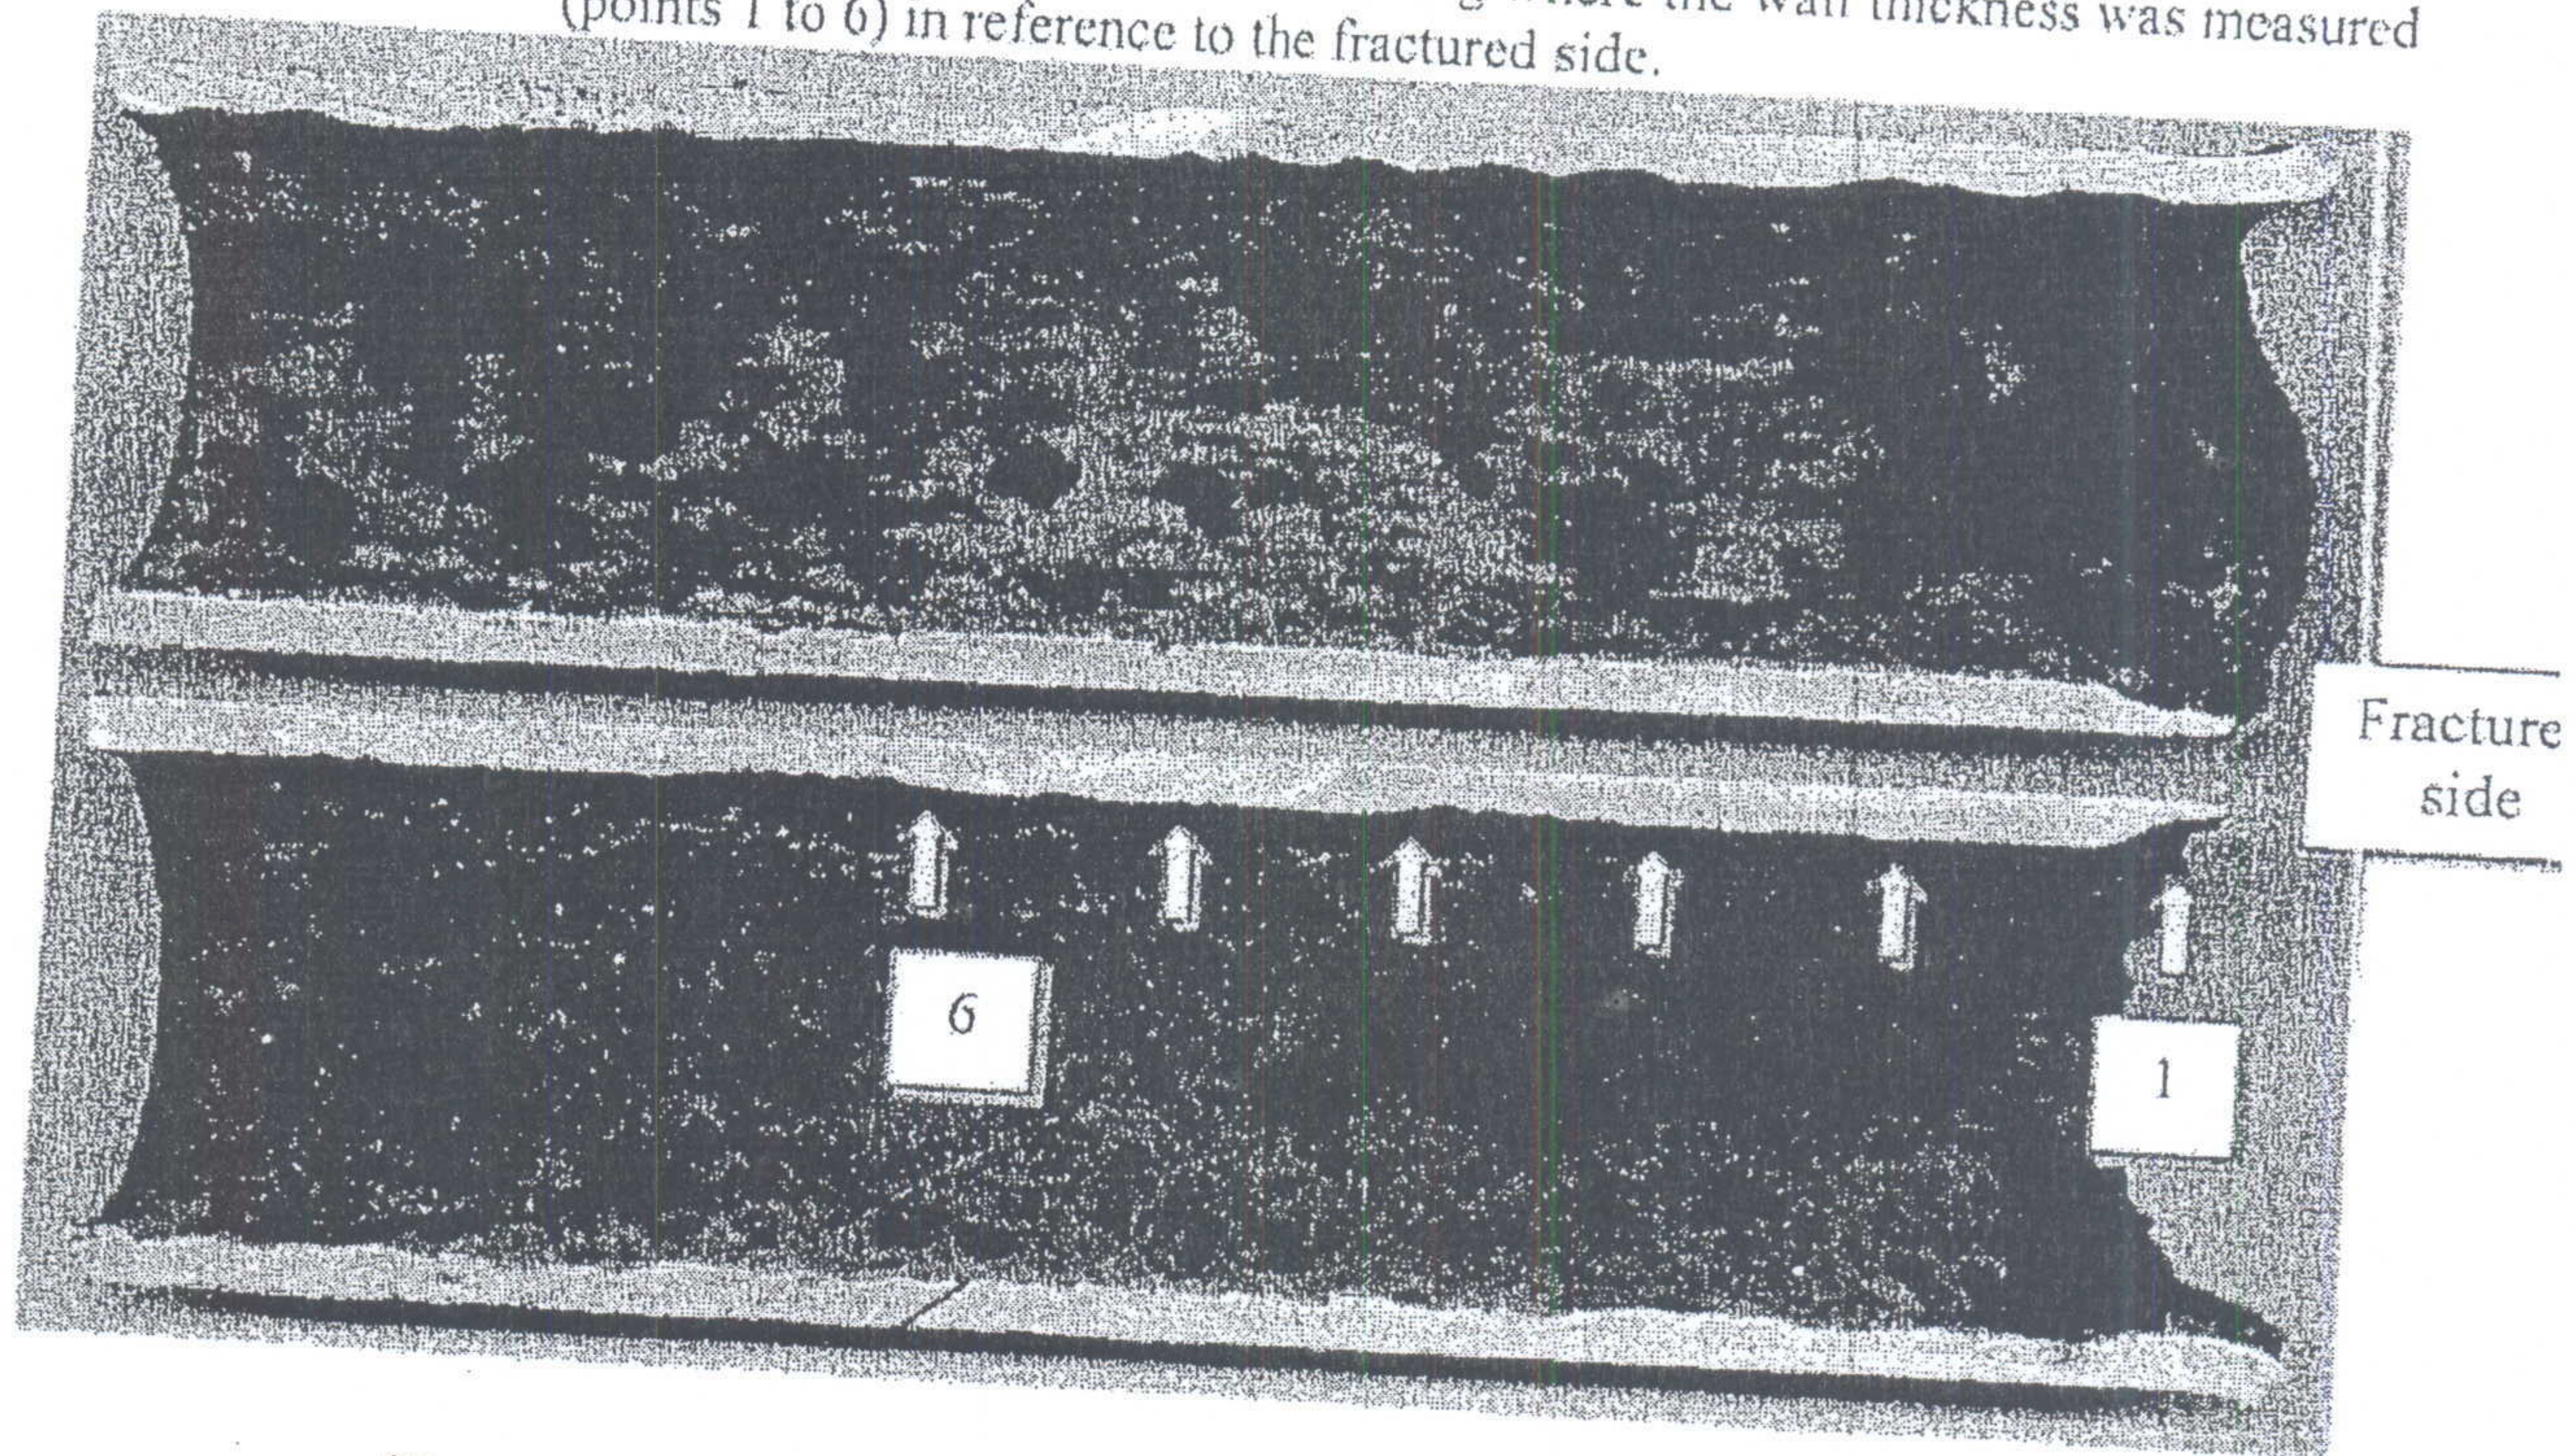
Figure 9

Table 2B  
Wall thickness of scaffolding pipe – Sample T065896  
(Longitudinal measurements)

Overview of samples T065896 showing where the wall thickness was measured (points 1 to 6) in reference to the fractured side.

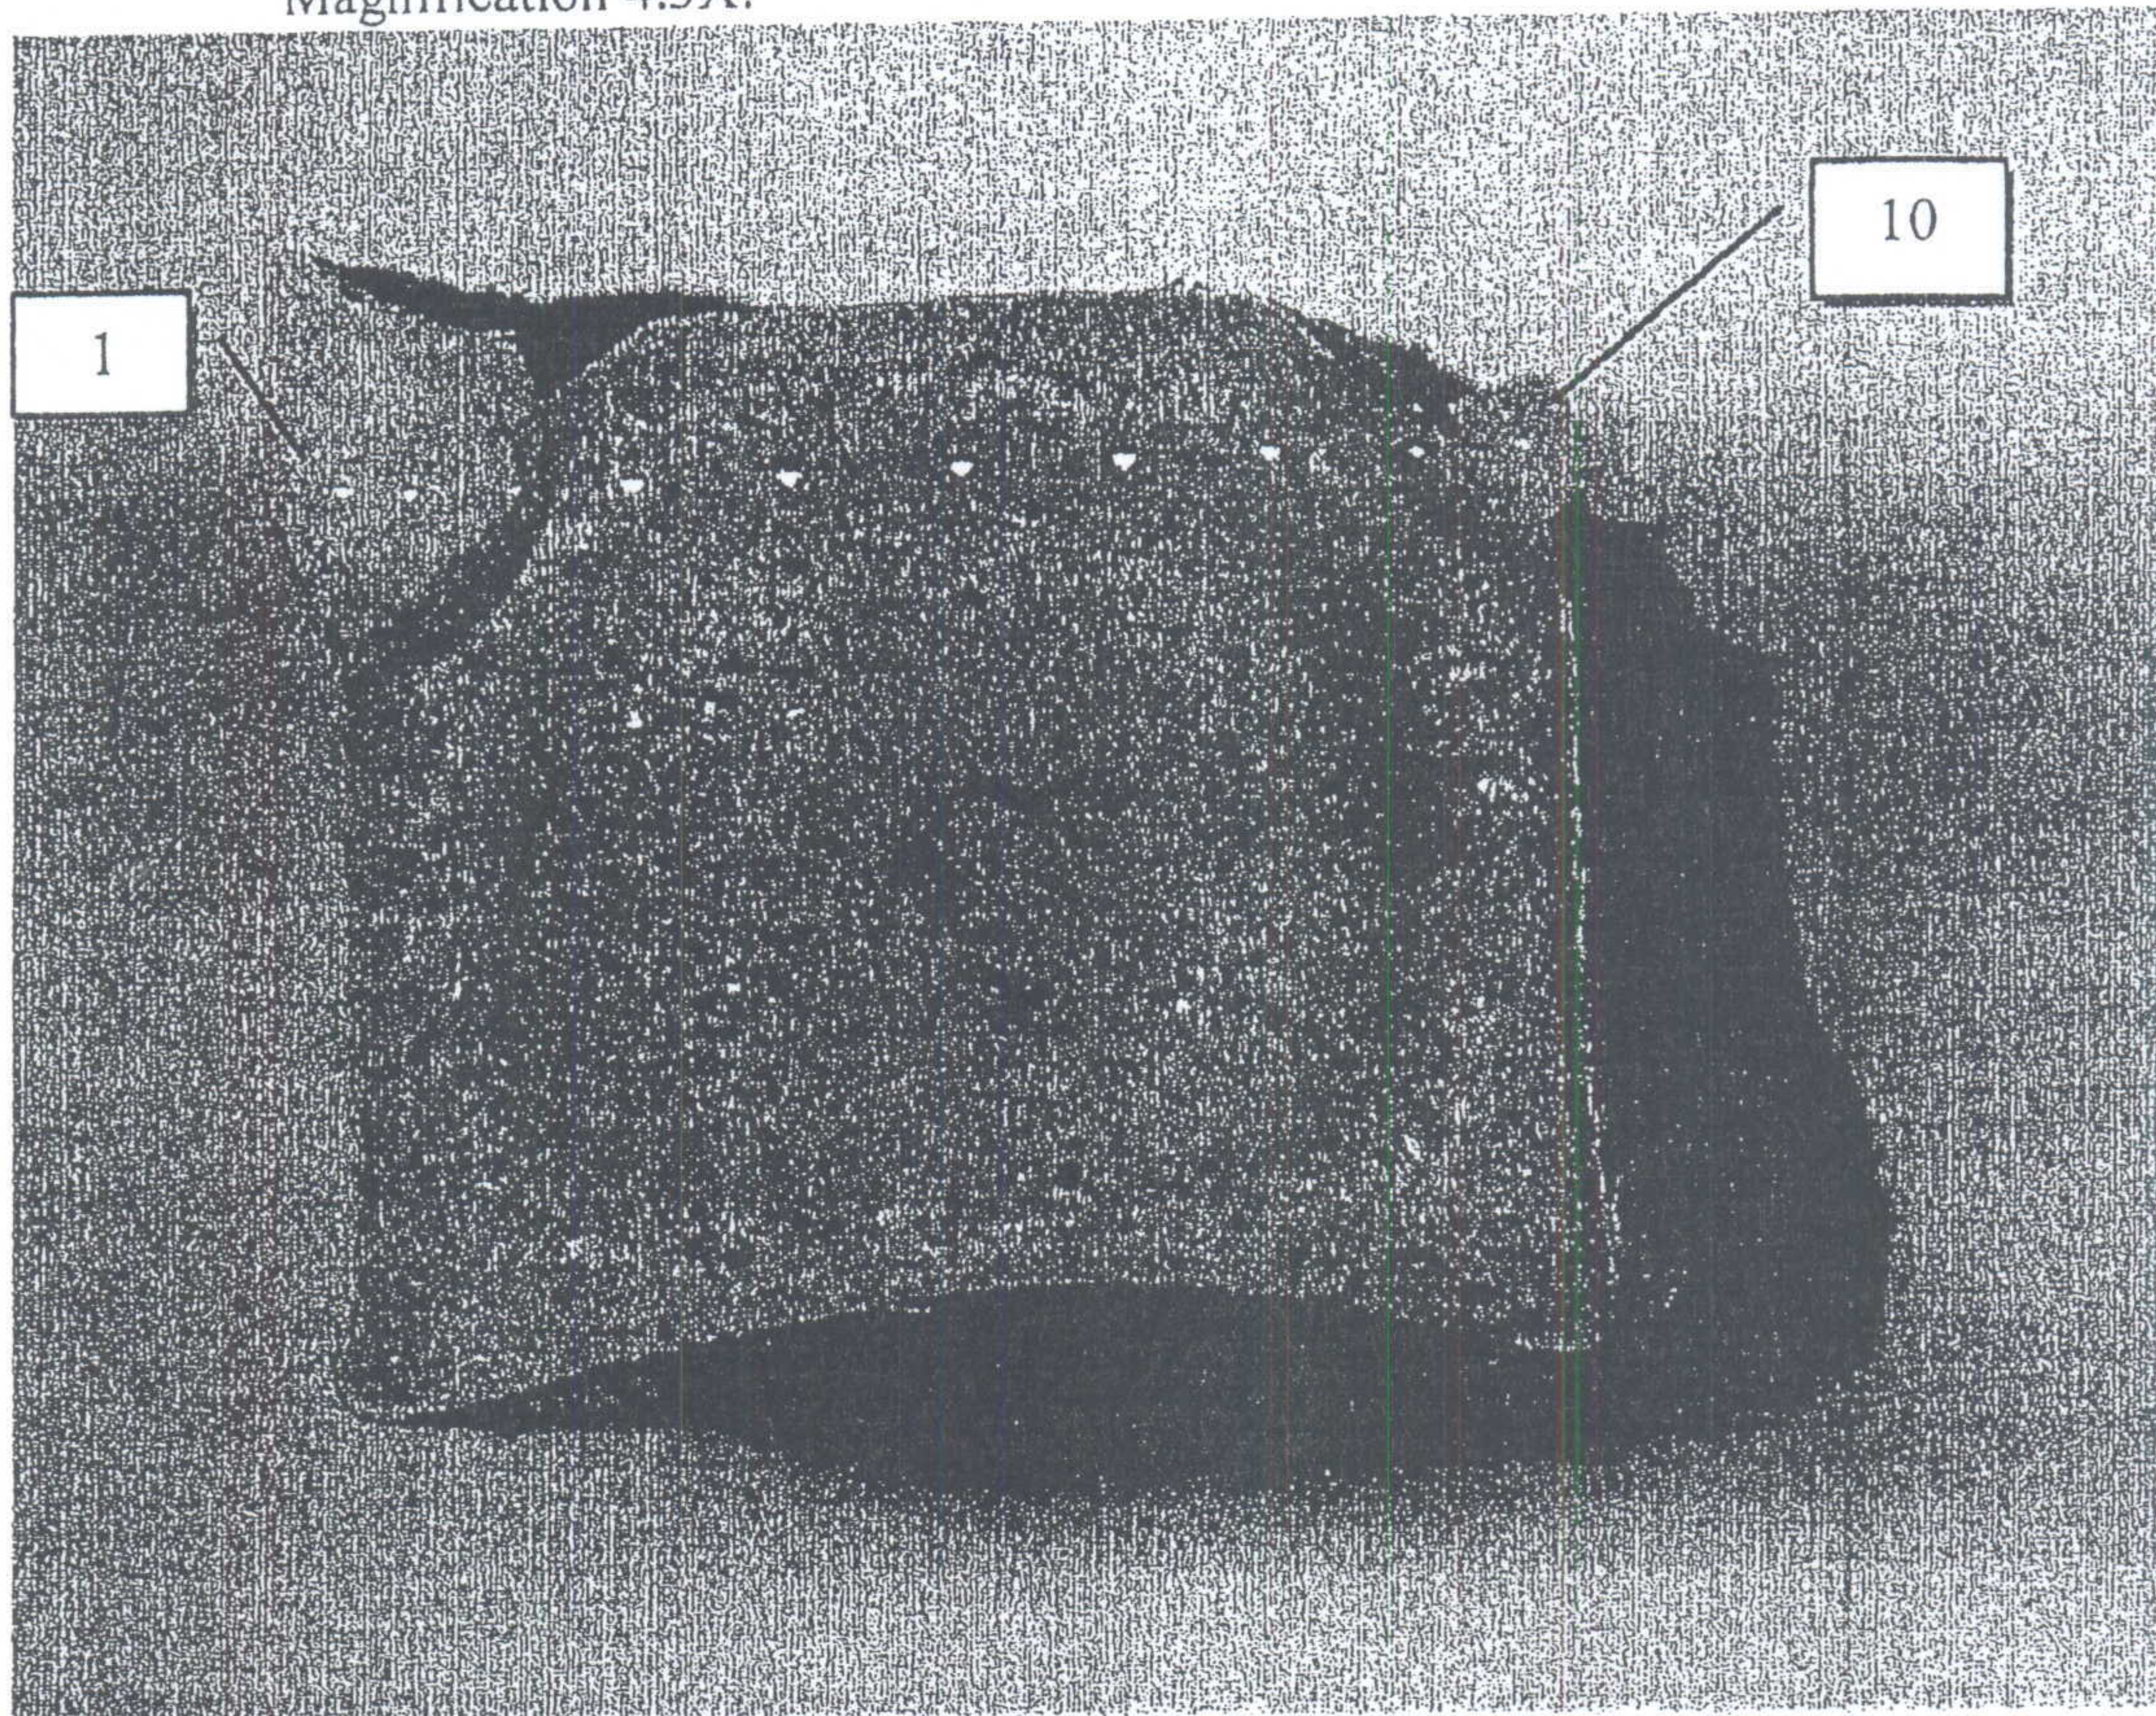
Table 4  
Vickers Hardness Test Traverse (HV<sub>10</sub>) (Sample T065900)

Figure 11 Macrograph of sample T065900 showing the indentations from the hardness test. Magnification 4.3X.
